Review History

- **FM1 IDPU PSR was held on March 2 2005**
 - **FM1 Boom PSR was held on March 31 2005**
- **This PSR covers the FM2 IMPACT Boom Suite, which has completed testing and is ready to ship to APL for integration with the Behind spacecraft.**

- **Planned Shipping May 24**
 - **Includes: FM2 IDPU, FM2 Boom, FM2 SWEA/STE-D, FM2 MAG, FM2 STE-U**
- **This PSR covers the unique information for the FM2 suite; refer to the FM1 PSR for common information**

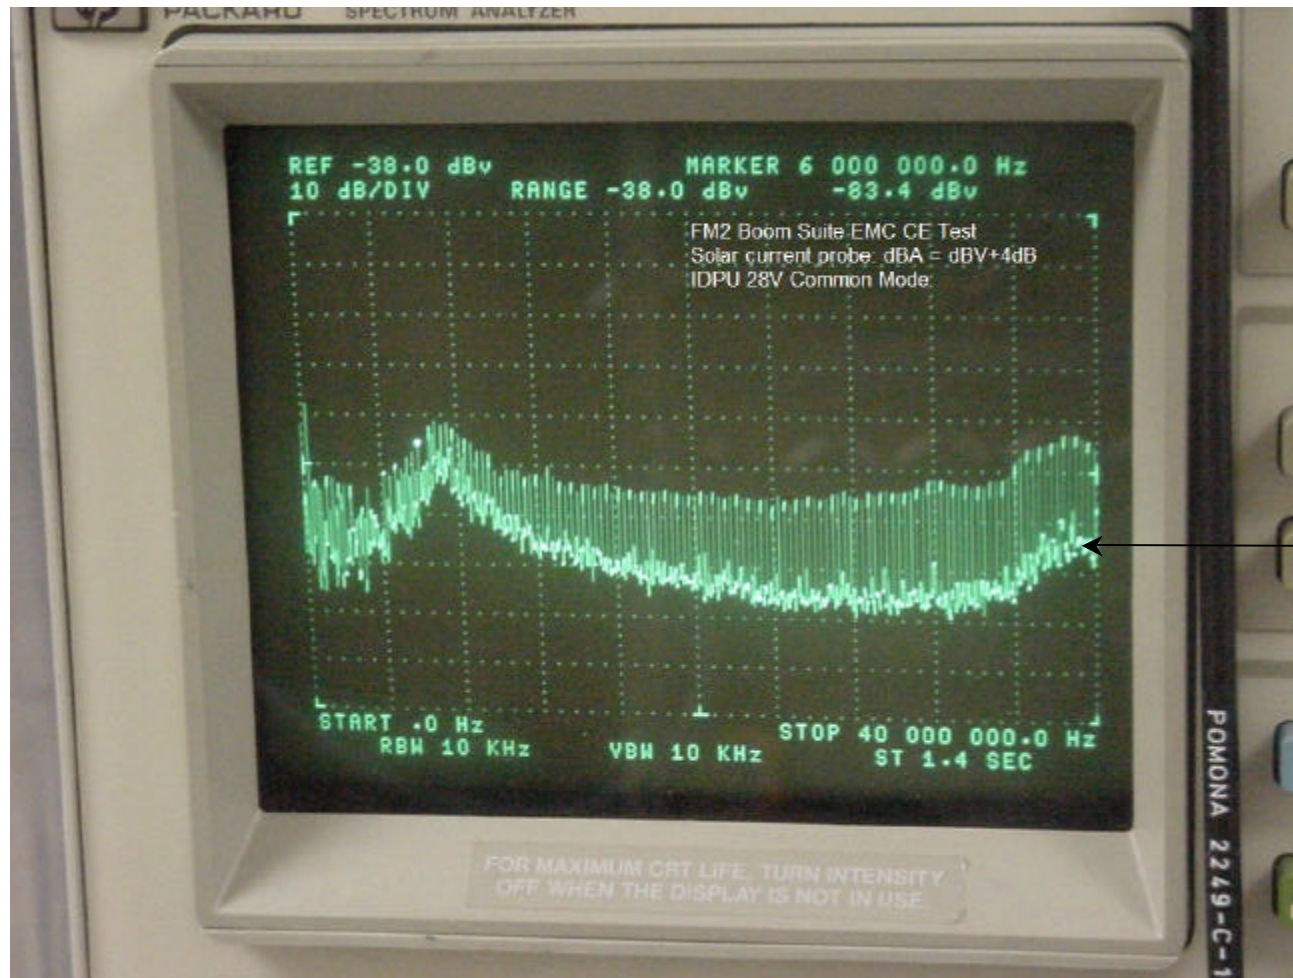
FM2 IDPU Common Mode Noise

- **The IMPACT Boom Suite was integrated and completed Acceptance EMC tests per the Project EMC Requirements document (7381-9030C) and the IMPACT FM2 Boom Suite EMC Test Plan**
 - Bonding & Isolation
 - CE01, CE03
- **Testing completed at U.C. Berkeley**
- **The IDPU Power Service showed a forest of power converter harmonics, up to 15dB higher than seen on FM1, and up to ~20dB over the specification in places**
 - Noise is in the multiples of 50KHz band and is crystal controlled.
 - Almost no noise seen when shielded power cable is used
 - STEREO EMC committee has some concern with this noise
 - Noise probably caused by a problem with the power converter input filter
 - Plan is to deliver as is and re-measure unit on the spacecraft. If levels are unacceptable, unit will be returned to UCB for rework.

20dBuA
requirement

- **IMPACT FM2 EMC Lien**
 - Requires a waiver or rework
 - To be decided after measurements on spacecraft
 - May require return of the unit to UCB
- **IDPU Flight Software is not complete**
 - Will be loaded from the POC via the commanding system when it is complete and passed acceptance tests
 - Should be in place prior to PLASTIC integration on the spacecraft

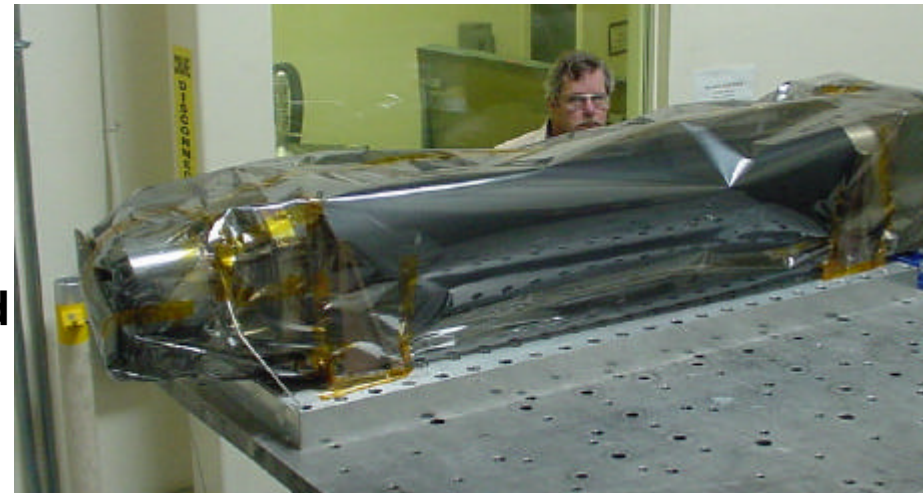
- **PFR1016, Boom Lock Pins**
 - **Glue residue from the assembly of the tubes was found in several Lock Pin bores.**
 - **The Boom was disassembled and all bores were cleaned.**
 - **No additional locking problems.**

- **PFR1020, FM2 Actuator Harness Fault**
 - **FM2 Hot Vacuum deployment failed on the primary circuit**
 - **Harness checked and fault localized.**
 - **Harness corrected and verified in Cold deployment.**
 - **This PFR has been signed-off and closed**
