# STEREO IMPACT

PROBLEM REPORT

PR-1005

SEP LVPS Top FM1

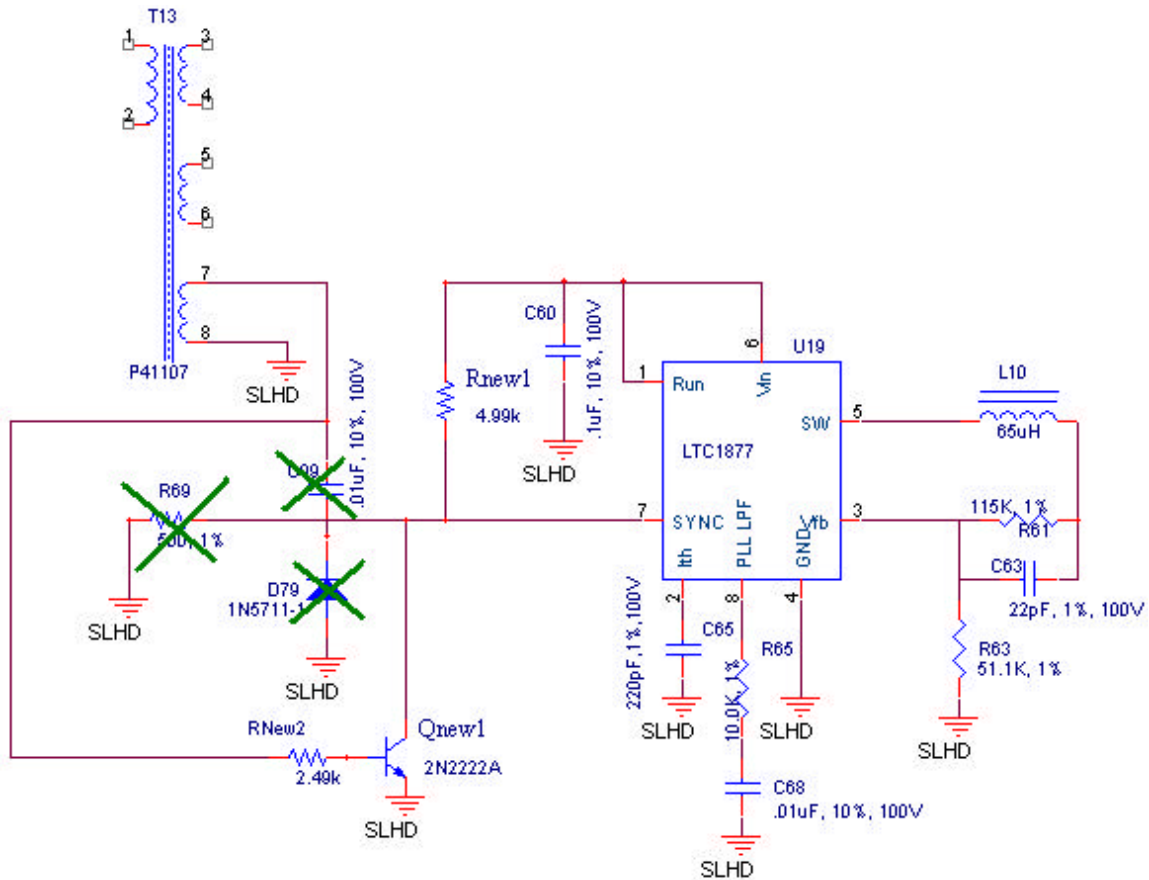
Figure 1: SEP LVPS Top board Schematic

The SYNC signal of LTC1877 should not receive any negative voltages. The Schottky Diode 1N5711-1 does not prevent negative voltages. When the SYNC signal pin goes negative the LTC1877 turns off. This is a design problem, not a layout issue.

1. Remove D79
2. Remove R69
3. Remove C99
4. Install a 2N2222A transistor as shown in Figure 1.
5. Connect the collector (Pin3) of Qnew1 to the cathode pad of D79
6. Connect the emitter (Pin1) of Qnew1 to the anode pad of D79
7. Connect a 2.49K $\Omega$  (Rnew2) resistor to the base of Qnew1 and to C99 (RNC50H2491DS)
8. Connect a 4.99K $\Omega$  (Rnew1) resistor from C91A (5.1V side) to SYNC of U19 (Figure 2 and 3) (RNC50H4991DS)
9. Use shrink tubing where the leads are exposed.
10. During staking process stake, Qnew1, Rnew1, Rnew2 and the Rnew2 feed-through hole.
11. Update the schematics with the changes made to the design.

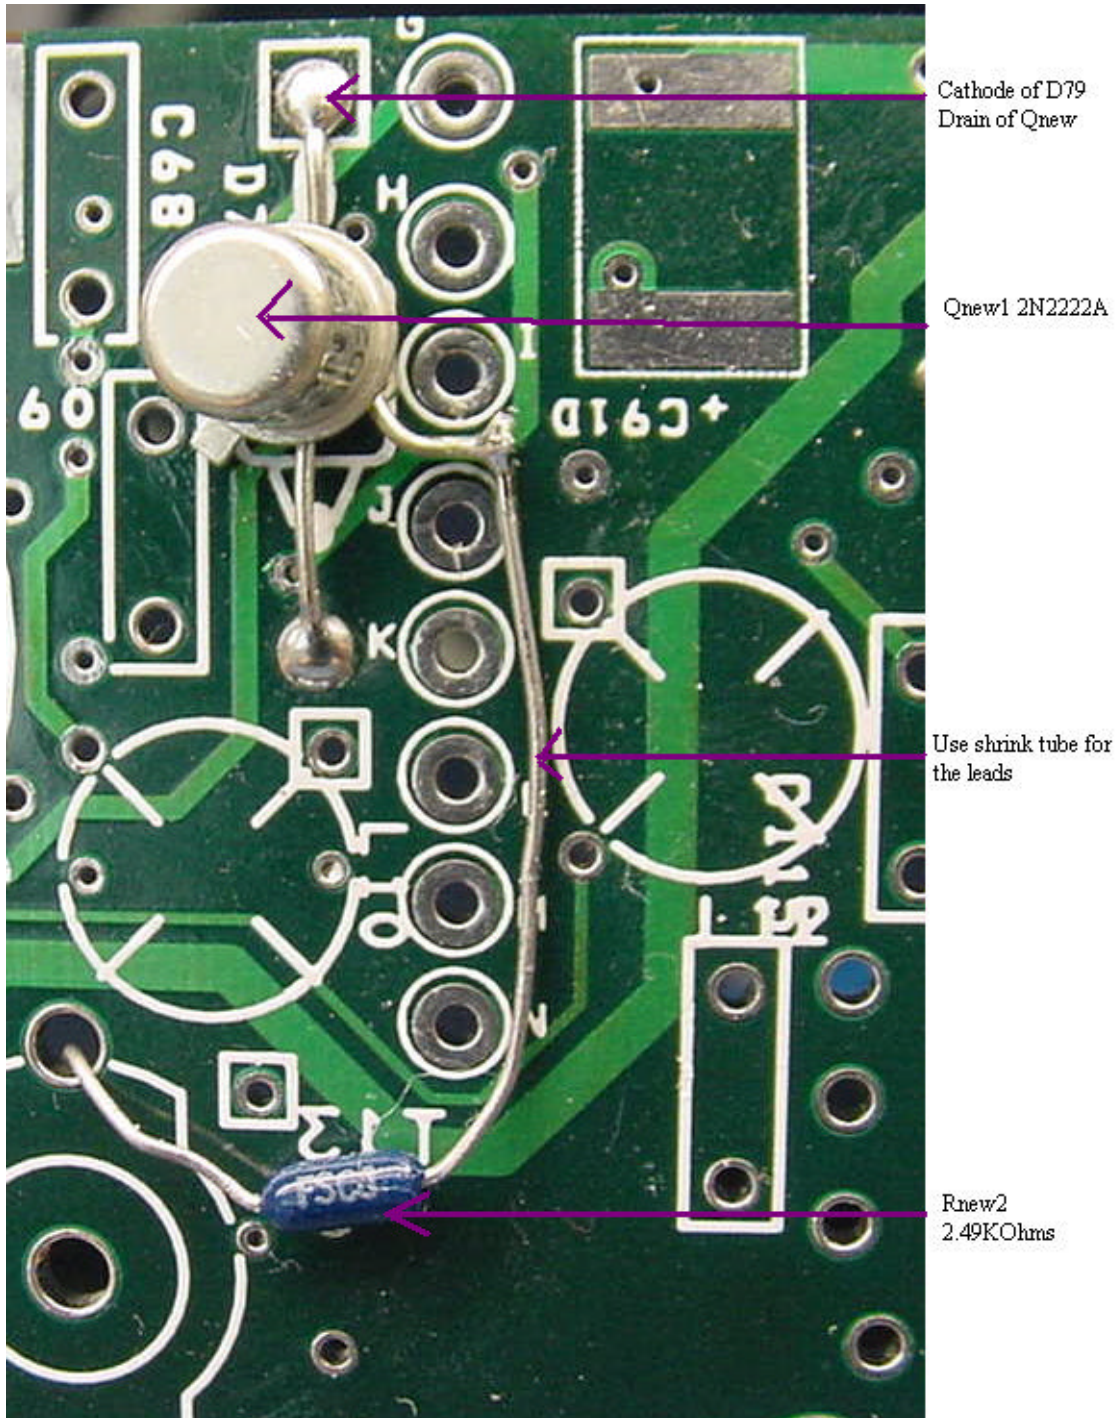
Figure 2: SEP LVPS Top Board Proposed Solution for PR-1005 (view from bottom)

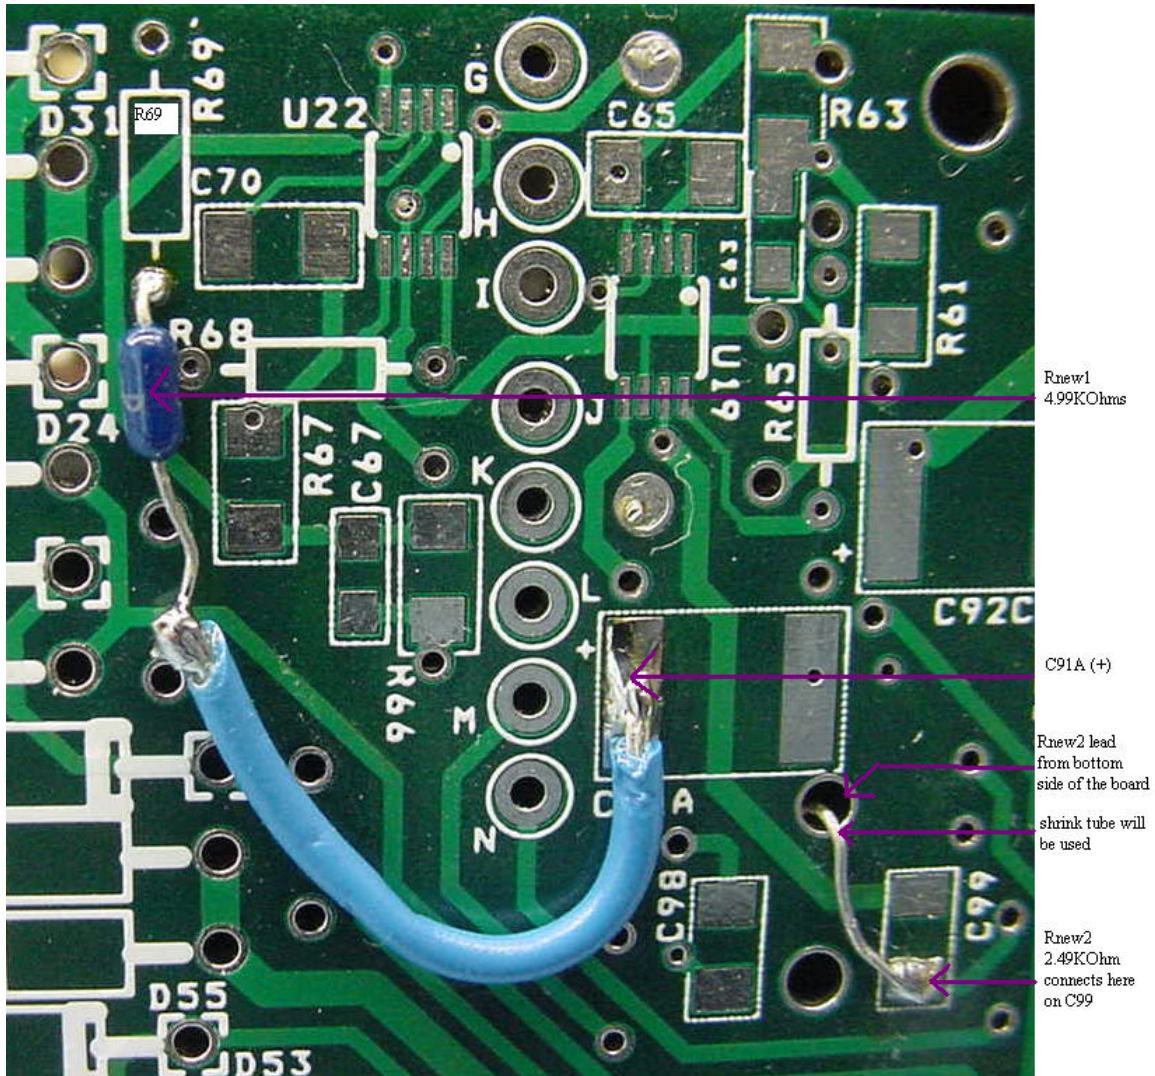
Figure 3: SEP LVPS Top Board Proposed Solution for PR-1005 (view from top)

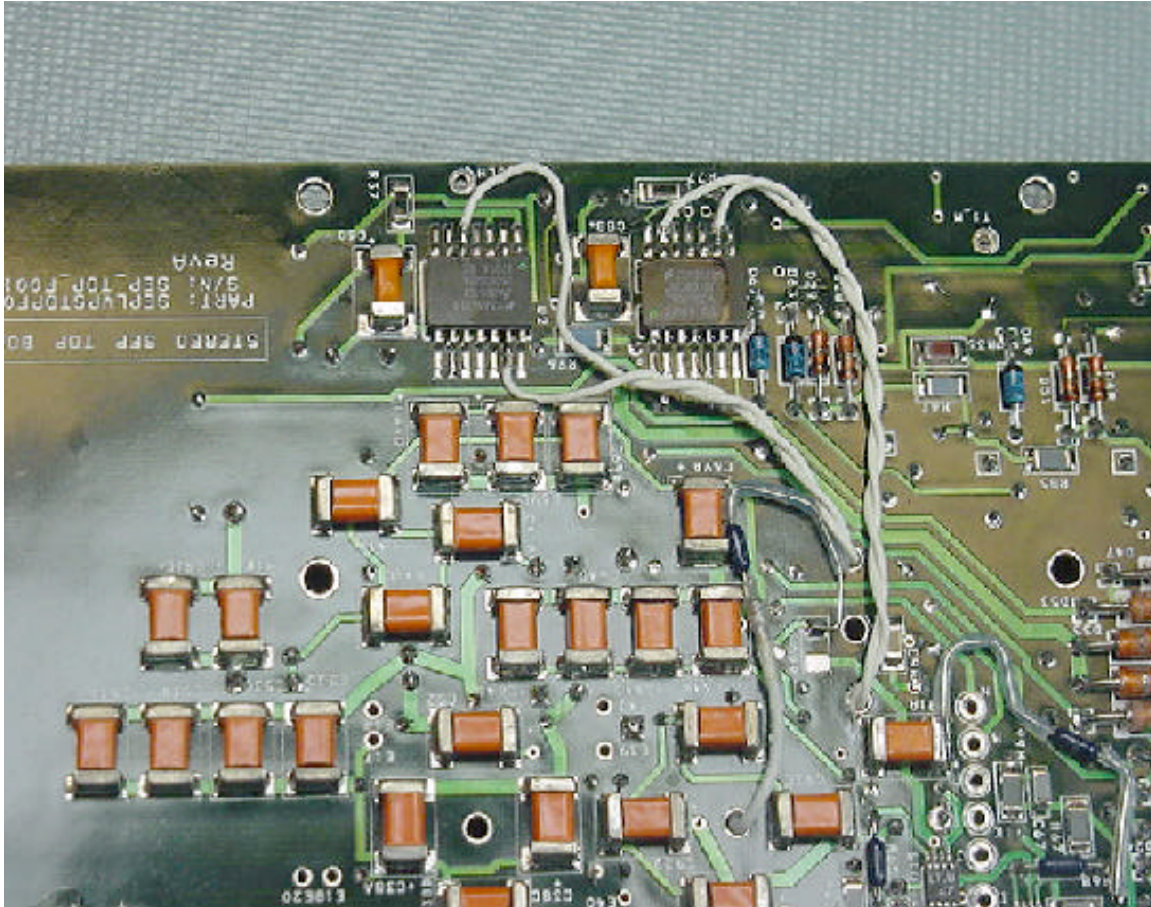
SEP TOP FROM TOP VIEW

SEP LVPS Board Top View – Post repair, pre-coat, pre-stake photos.

See attached photos of the post-repair and pre-coat, pre-stake photos. The transistor was debugged, shrink tubed and staked at the wires. A lash splice was used to make the repair. The schematics were updated and the fix was applied to FM2. Board level and then system level LVPS testing was successful.

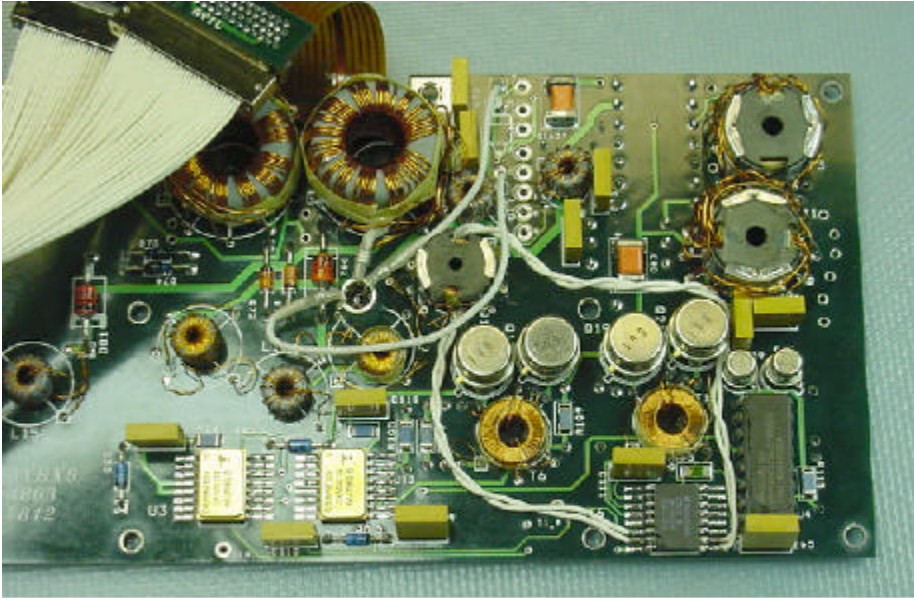
TOP BOARD FROM BOTTOM VIEW

SEP LVPS Top Board – Bottom View (post repair, pre-coat, pre-stake)
