STEREO IMPACT

PROBLEM REPORT

PR-1018
SIT HVPS FM2
Aug 25,2004

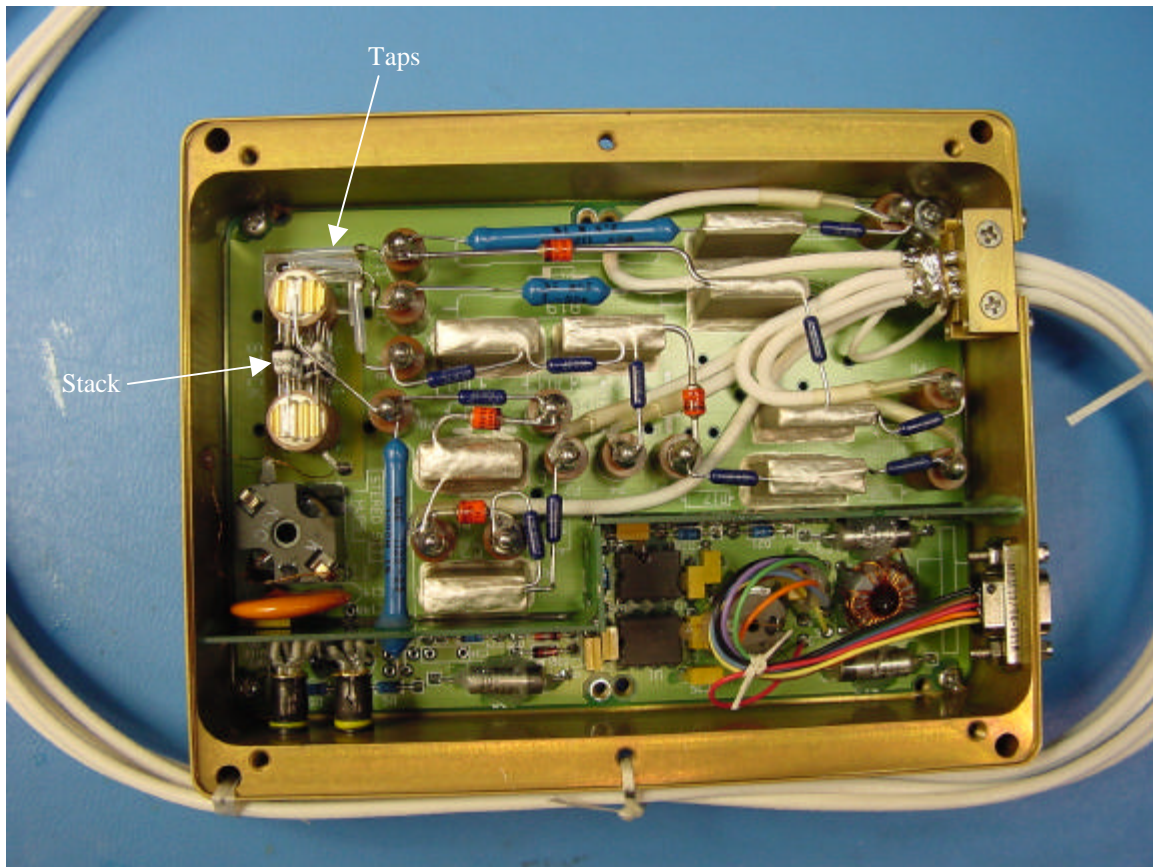
PR-1018

While assembling the unit, apparent separation of the multiplier stack at one of the tap points was noticed by the technician.

Microscopic investigation determined the stack was fractured at the point of the tap wire exit. This was most likely caused by excessive manipulation of tap wire during assembly.

Bake unit at 93 C for ten minutes to facilitate removal of stack.

Remove stack.

Replace stack with spare. Manipulate tap wires sparingly.
