STEREO IMPACT

PROBLEM REPORT

PR-1021

FM2 SWEASTED Therm.

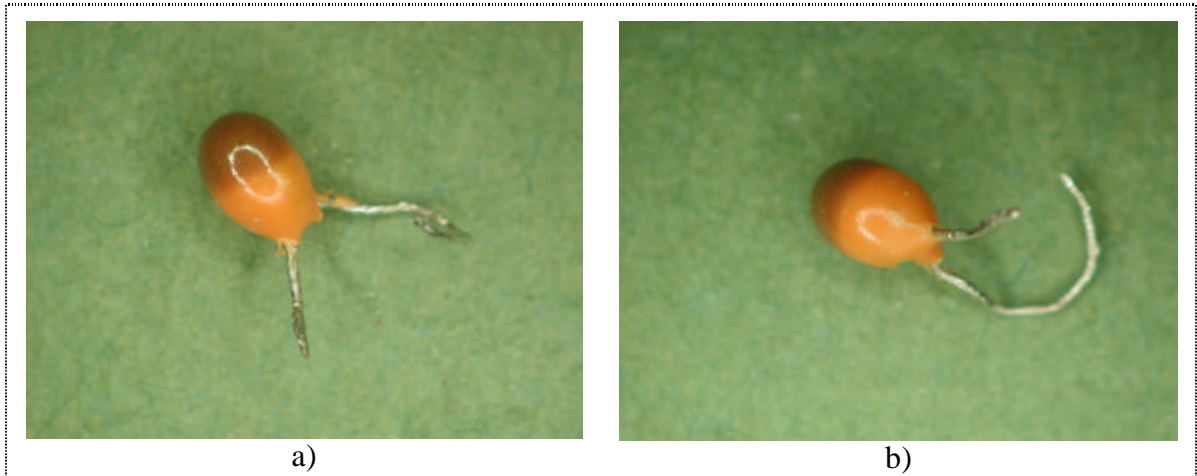
The [311P18-08S7R6](#) is a YSI 44900 series NASA space-qualified thermistor. The temperature-sensitive element in this part is a ceramic disk, which is made of a sintered mixture of metal oxides, with a negative temperature coefficient of resistance. To form the device two wires are soldered to silver contact electrodes on the surface of the disk and encapsulated with a droplet of epoxy. Figure 1 shows external views of the failed part as received.

Figure 1. Two external views of the failed part as received.

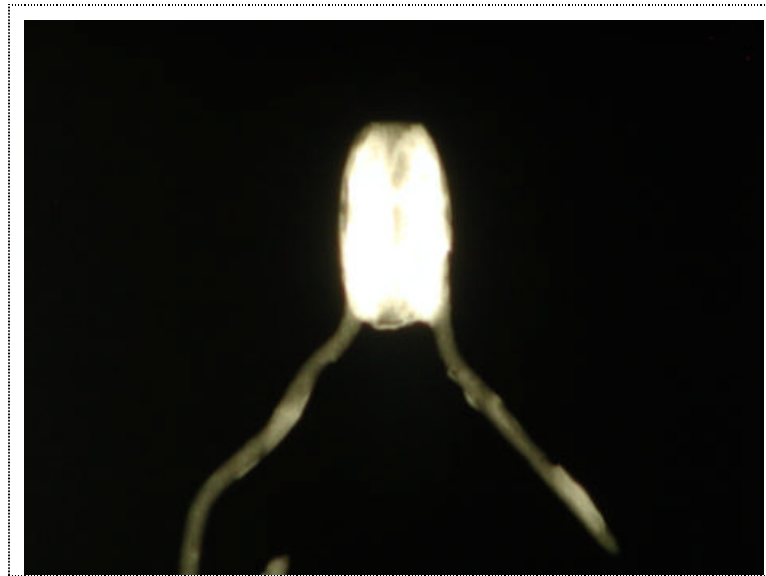
Radiography (see Figure 2) did not reveal any obvious anomalies.

Figure 2. An X-ray view of the failed part.

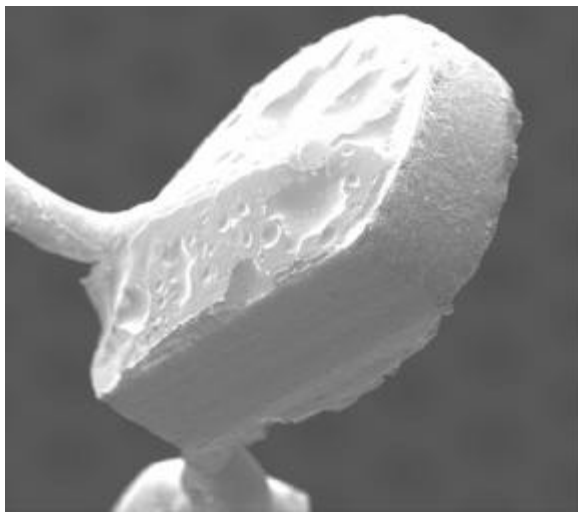
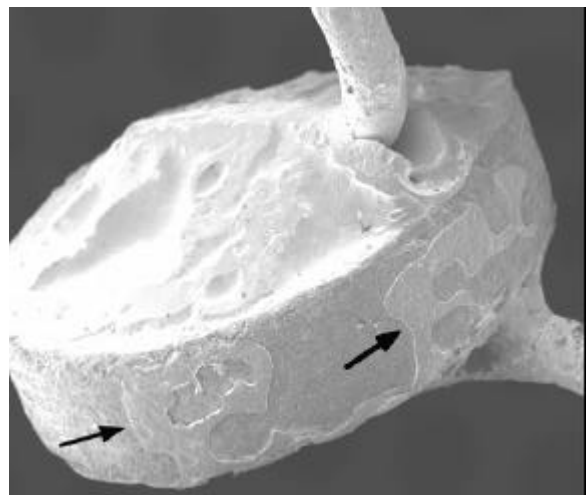
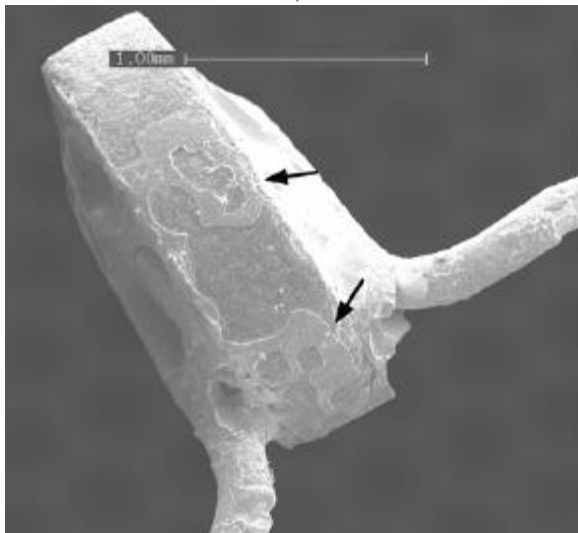
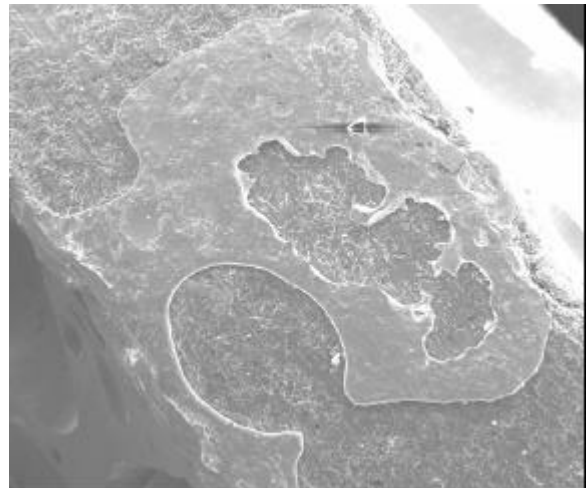
After decapsulation of the part in hot m-Pyrol, a short between the electrodes was found. Figure 3 shows several SEM views of the part. EDS analysis (see Figure 4) identified the short as a low temperature Sn/Pb solder.

A failure of 311P18-08S7R6 thermistor was confirmed. The part failed short circuited most likely during soldering onto the board due to solder reflow, which resulted in solder bridging between the electrodes of the ceramic disk. Both factors, a use of low-temperature solder to bond wires to the disk by the manufacturer and overheating of the part during soldering onto the board by a technician, have contributed to this failure.

Figure 3. SEM views of the failed part. Arrows indicate areas with solder reflow; Fig. 3d shows a close-up of the solder bridge.

The part was replaced by a spare from stock. Normal installation precautions (heat-syncing the part during soldering) were observed.

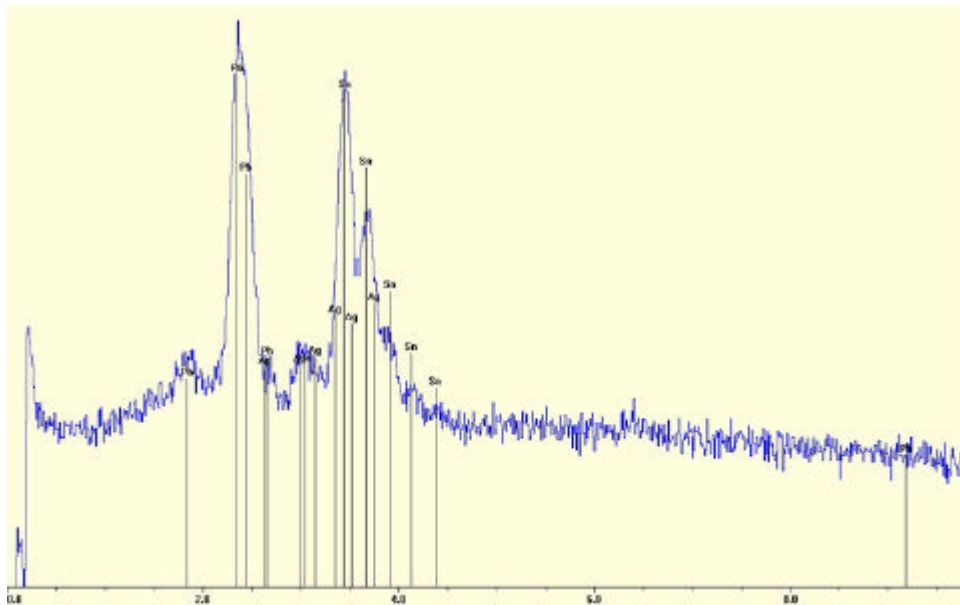
Figure 4. EDS of the solder bridge. Analysis indicated a composition close to low-temperature solder 60Sn/40Pb with a melting temperature of 183 °C.
