STEREO IMPACT

PROBLEM REPORT

PR-1025

FM1 SEP

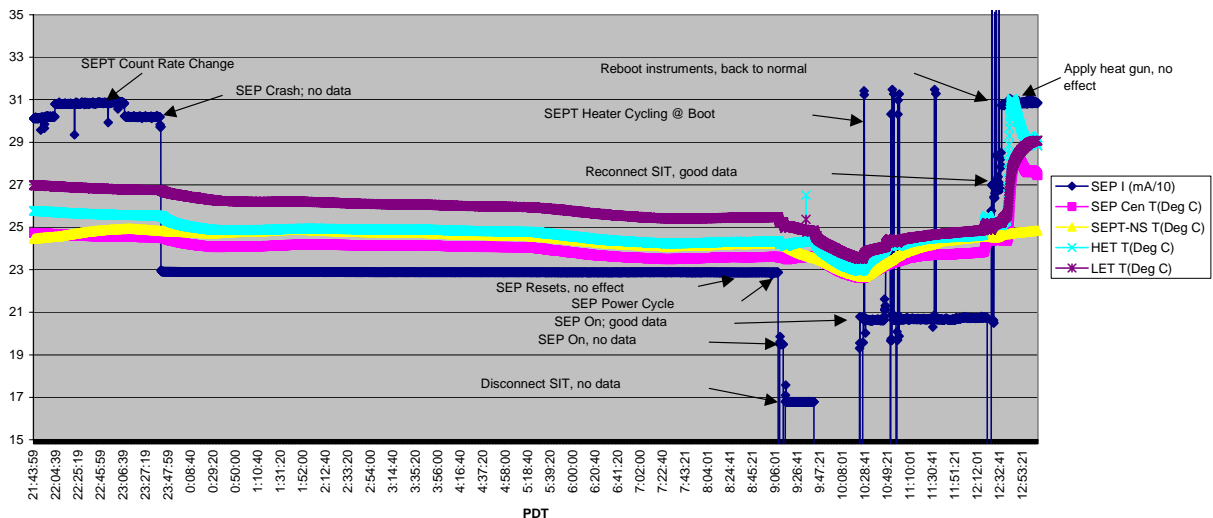
2004-10-15 - 2004-10-16 Data Logger

On October 15 at 23:30 PDT SEP stopped sending telemetry and reverted to a low power state (slightly above its normal power-on level). See attached timeline extracted from the data logger that tracks currents and temperatures. When we came in the next morning of October 16 we performed the following diagnostics:
