STEREO IMPACT

PROBLEM REPORT

PR-1026

PLASTIC LVC FM2

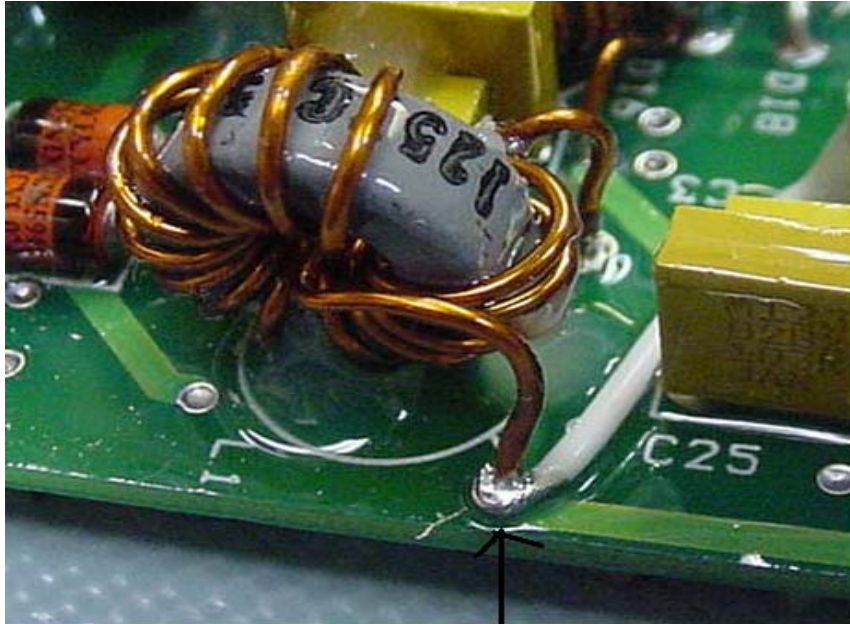
The 2.5VDA Output Voltage on Plastic LVC was shorted to chassis. The resistance was about 1 ohm.

The screws and connectors were disconnected while monitoring the short to the chassis. When the bottom right screw was removed the short to chassis disappeared. The PCB was removed from its box. Pin 1 of L1 is very close to the box. After isolating box and installing the pcb back into it the problem was eliminated. There was a problem with the flight board layout that has caused traces to be routed close to the edge of the board and/or the mounting hardware.

short to chassis

Solution of 2.5V net shorting to chassis:

1. Remove the previous repair wires from L1 pin 2
2. Add another wire (#24 AWG) using lash splice and isolate the connection using shrink tubing.
3. Stake the wires on the new location shown in Figure (blue dot) below using Uralane 5753.
4. Connect the wire on C13 via (shown in figure below)
5. Cut the trace connecting to Pin 2 of L1
6. Epoxy the cut trace using Scotch Weld 1838B/A Green.
7. Place a G10 material along the trace covering Pin 2 of L1.
8. The Plastic LVPS Main board will be raised using ~0.03" thick washers at the corners of the LVC.
9. Record the part number for the screws used to raise the board:

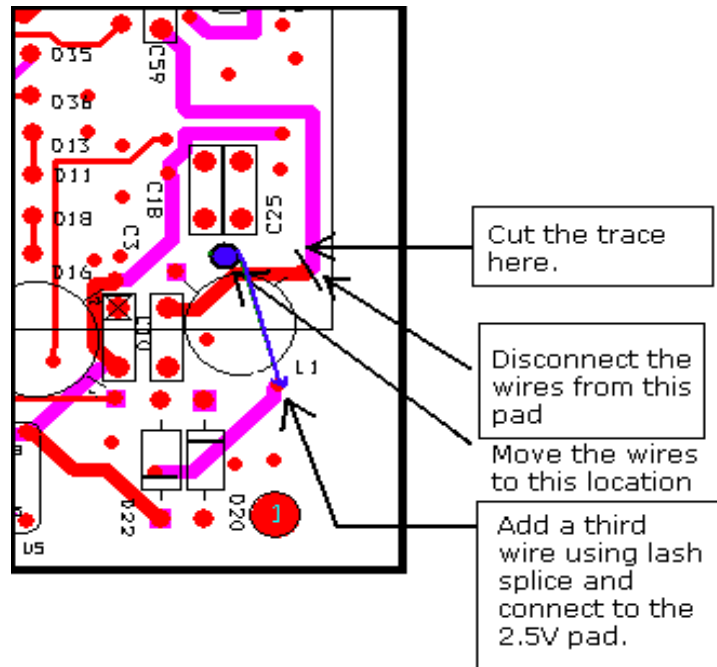
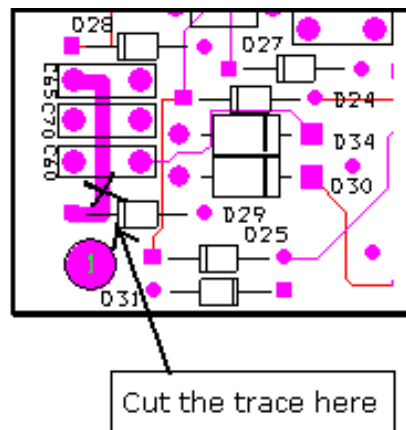
Solution for possibility of D29 shorting to chassis (FM2 only)

- 1- Cut the trace connecting the input ground to C65 (as shown in figure below)
- 2- Epoxy the cut trace using Scotch Weld 1838B/A Green.
