STEREO IMPACT

PROBLEM REPORT

PR-1027

FM1 IDPU T.Vac.

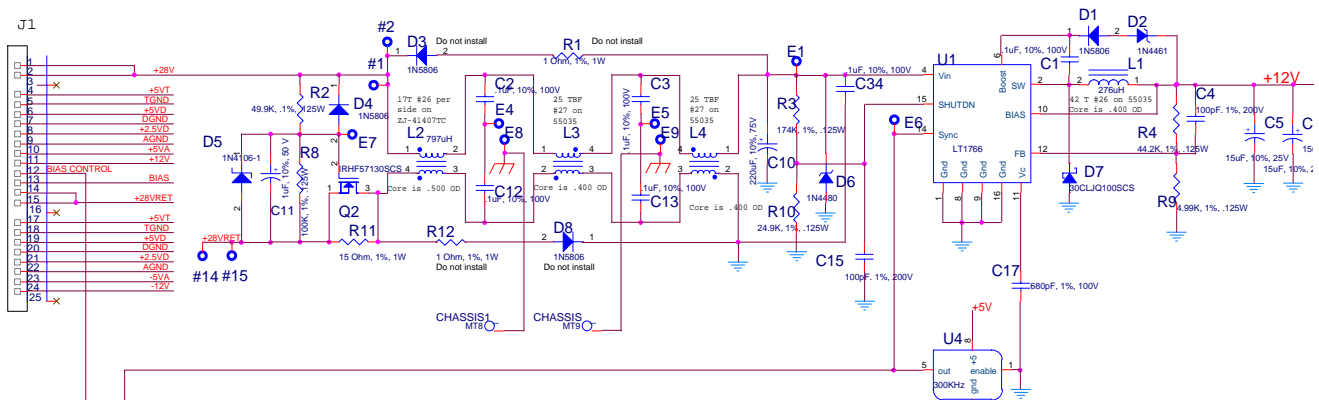
IDPU LVPS Front End

Thermal vacuum was discontinued after the first operational cycle and the unit was tested on the bench. It continued to fail to start at bus voltages less than 26V. The failure and unusual turn-on current transient is consistent with the soft start circuit not turning off (Q2 not tuning on; see schematic next page). Using the ETU IDPU supply we were able to replicate the problem by shorting across D5 to disable the soft start turn off. We opened the flight IDPU and measured the resistance across D5, which was found to be ~1 ohm. We also noticed that R11 was discolored (which is consistent with the soft start circuit not functioning correctly, since all the instrument current was now running continuously through this resistor while in vacuum and hot for several hours).

There are a few components that could have caused this failure. We started by removing D5, which proved to be the source of the problem. The short went away and the diode by itself was shorted. We checked D4 (in circuit) and it was functioning correctly.

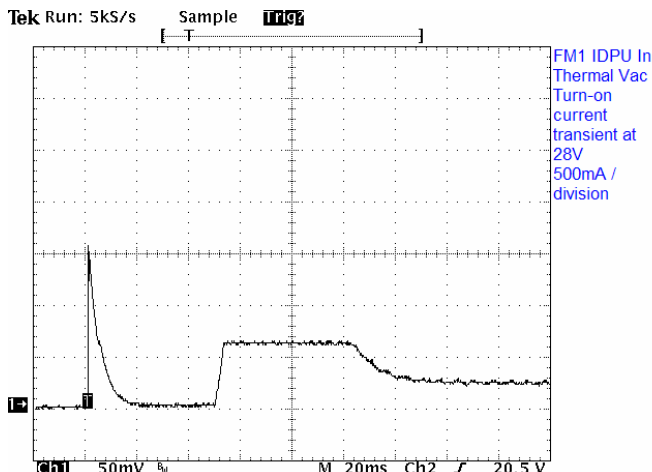
Unusual Turn-on Transient

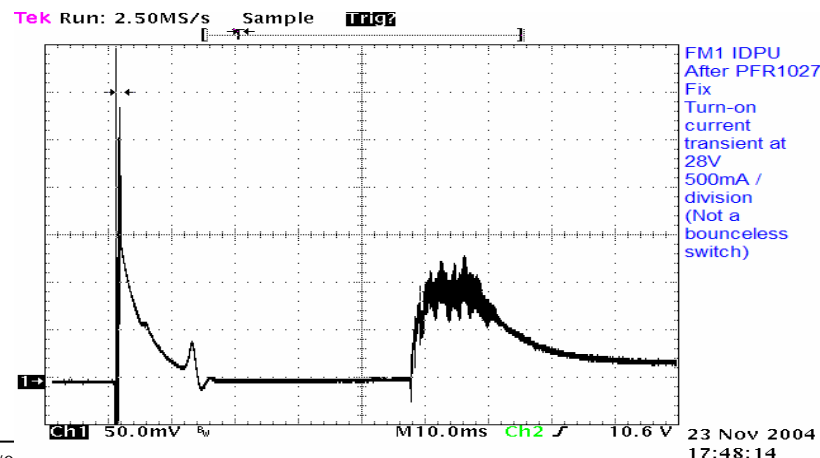
Normal turn-on transient (after fix)

Removed and replaced D5 (JV4106-1, LDC 8704) and R11 (RWR81N15R0FS). Retested on the bench; now turns on down to 20V and has a nominal turn on transient. The nominal power level of the IDPU dropped 10% (since we are no longer wasting power in the 15 ohm resistor). Since the power level has been at the higher level since integration of the IDPU, this dates the failure to before integration but after the supply-level turn-on test. Resumed t/v test at cycle 3.

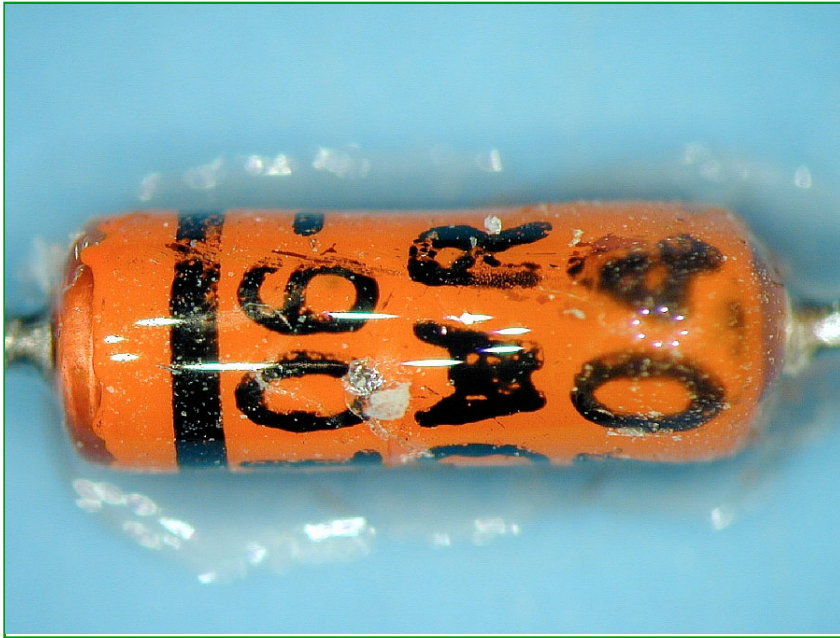
Figure: 1A

External Visual inspection revealed no anomalies on the device.

Optical macrograph of the device as received.

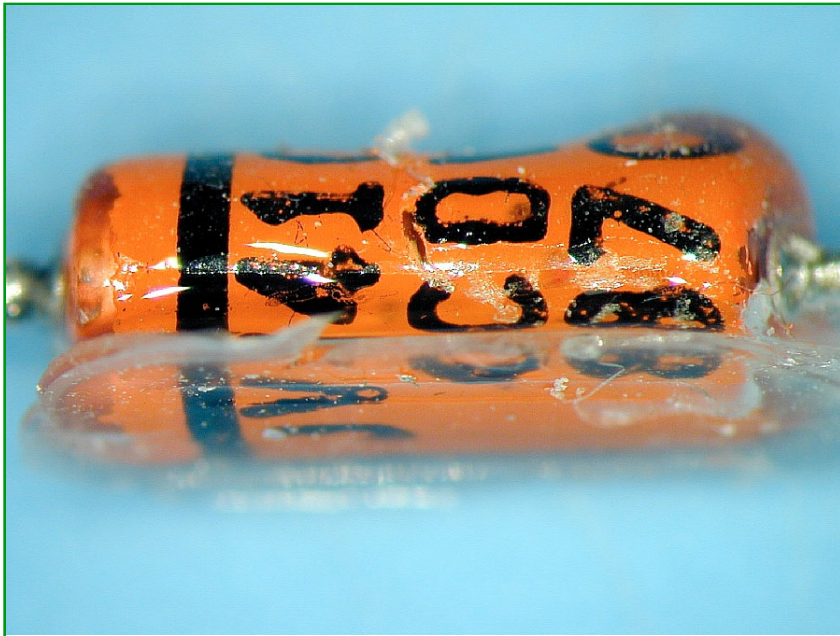
Figure: 1B

Rotated view of the device.

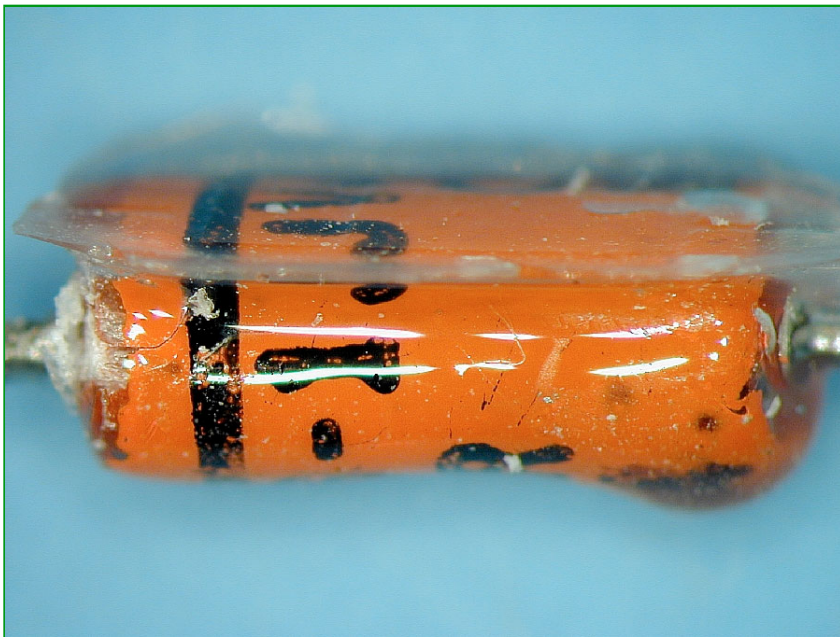
Figure: 1C

Rotated view of the device as received.

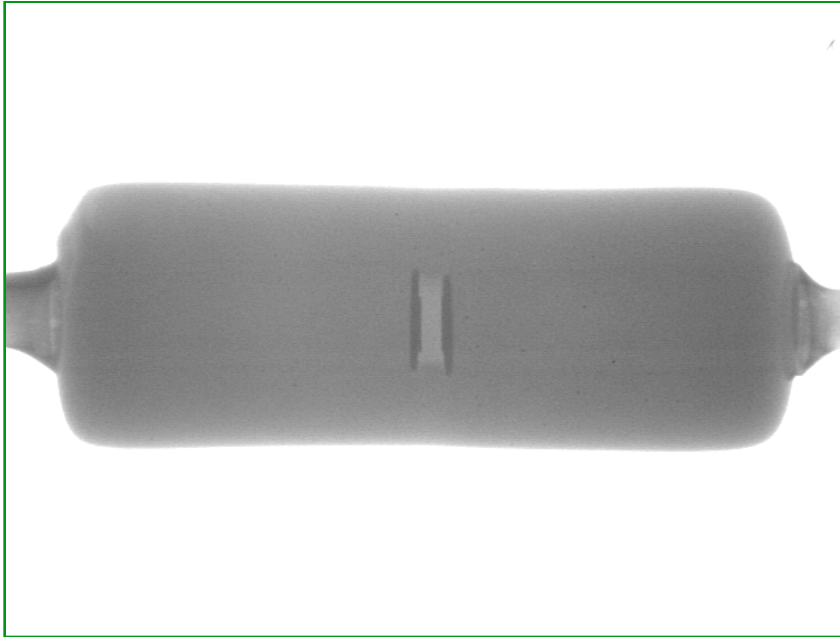
Figure: 2A

Radiographic Inspection was performed using a Fein Focus 160.24 Radiographic Inspection System. X-ray images were generated in top and side views in the "as received" condition. Examination of the X-ray images revealed no obvious anomalies.

X-ray image of the device.

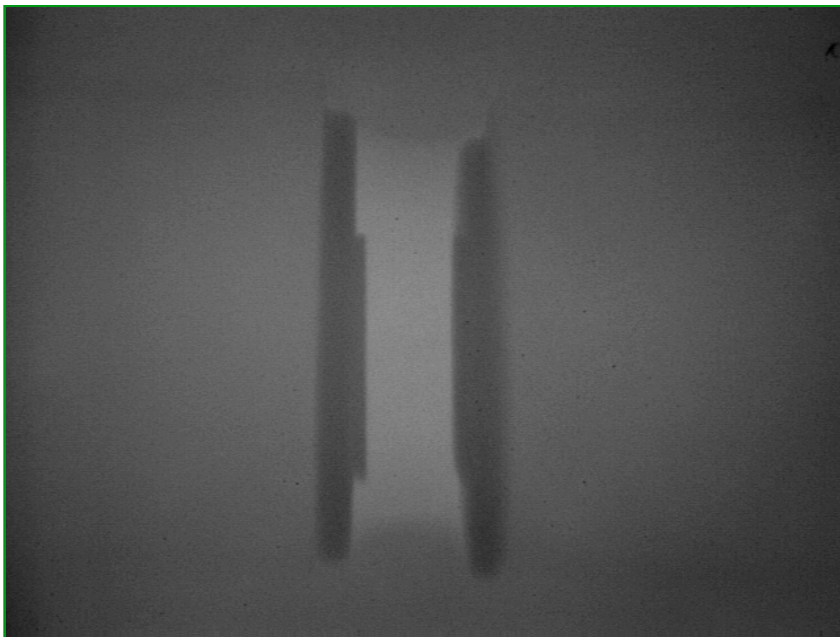
Figure: 2B

Close up view of the die in figure 2A.

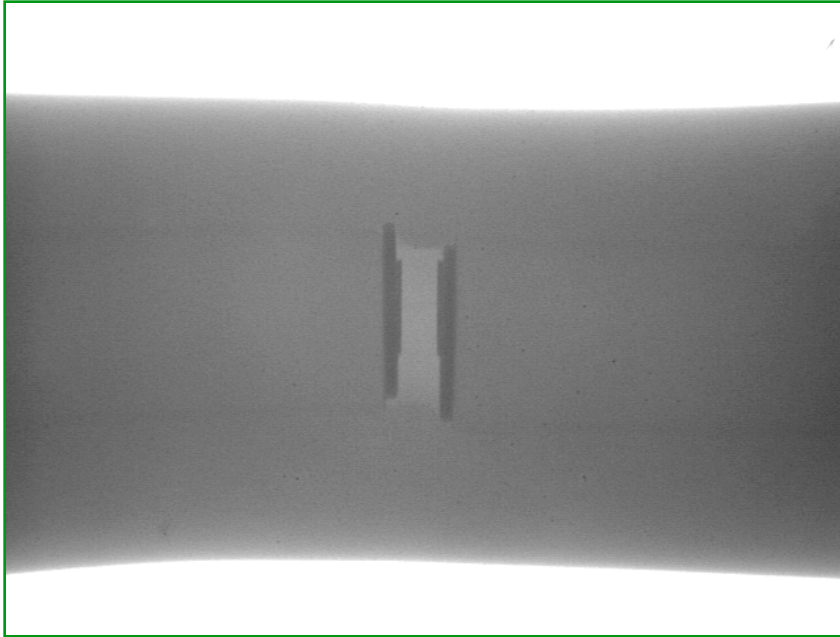
Figure: 3A
Sample:
Subject:
Rotated X-ray image of the device.

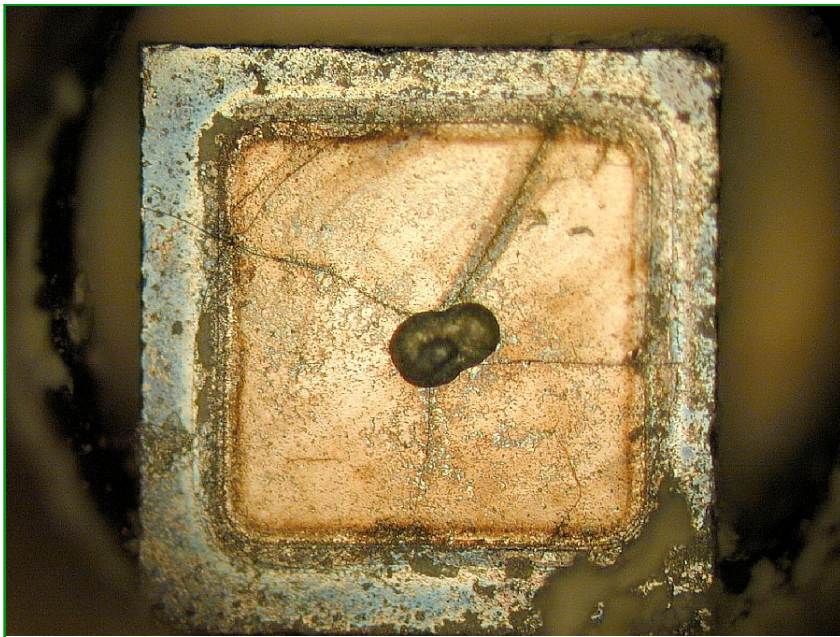
Internal Visual inspection revealed a severe damage site in the center of the die and multiple cracks emanating from the damage site.

The observed damage on the diode was due to a long term overcurrent condition. This resulted in the localized heating, and subsequent alloying and cracking of the die. Based on discussions with personnel involved in the testing of the application circuit, the initiating cause of the failure may have been an ESD event caused during assembly of the board, or similar type transient during probing of the board. This would have led to a leakage site (possibly in the 10s of Kohms) that allowed normal operation initially and gradually dropped in resistance over time as the alloying progressed.

Figure: 3B
Sample:
Subject:
Die micrograph of the device after decapsulation. Note the alloying and cracking of the die.

Disposition: Damaged devices (D5 & R11) were replaced. For D5, a newer LDC was used (Microsemi, D/C 0150) and the assembly was retested on the bench showing a nominal turn "ON" transient and output power level (Within specification). The IDPU Thermal-Vac was reassumed, thereafter.
