STEREO IMPACT

PROBLEM REPORT
PR-1035
FM2 SWEA Anode 12
2005-02-17

Failure Analysis Report

Charge Sensitive Pre-Amp & Discriminator Hybrid

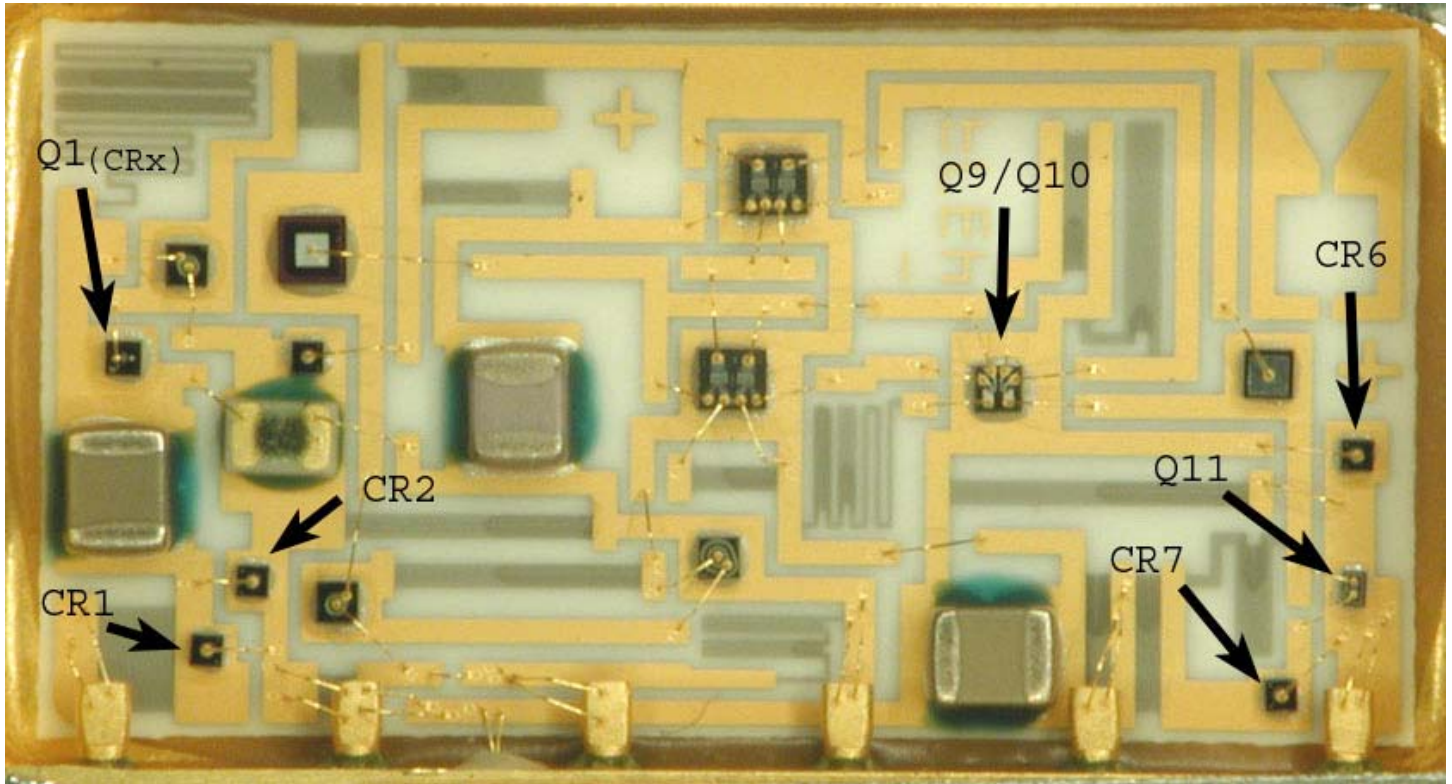
SN 239 was delidded for internal examination. It was immediately observed that the Q9/Q10 transistor die in this device was of the same pedigree as the one in SN 206. The Q9/Q10 transistor die in SN 228 was a different pedigree (as noted in Q50148FA). Figure 1 shows the internal construction and identifies the location of circuit elements discussed in this report.

Figure 1. Overall view of the A111F (SN 206) substrate with several circuit elements identified. CR1 and CR2 are input protection diodes (to ground). CR6 and CR7 are output protection diodes, to ground and V+, respectively. Q1 is a transistor die with only the base wire bonded, using the collector-base diode as a circuit element. Q11 is the output transistor.

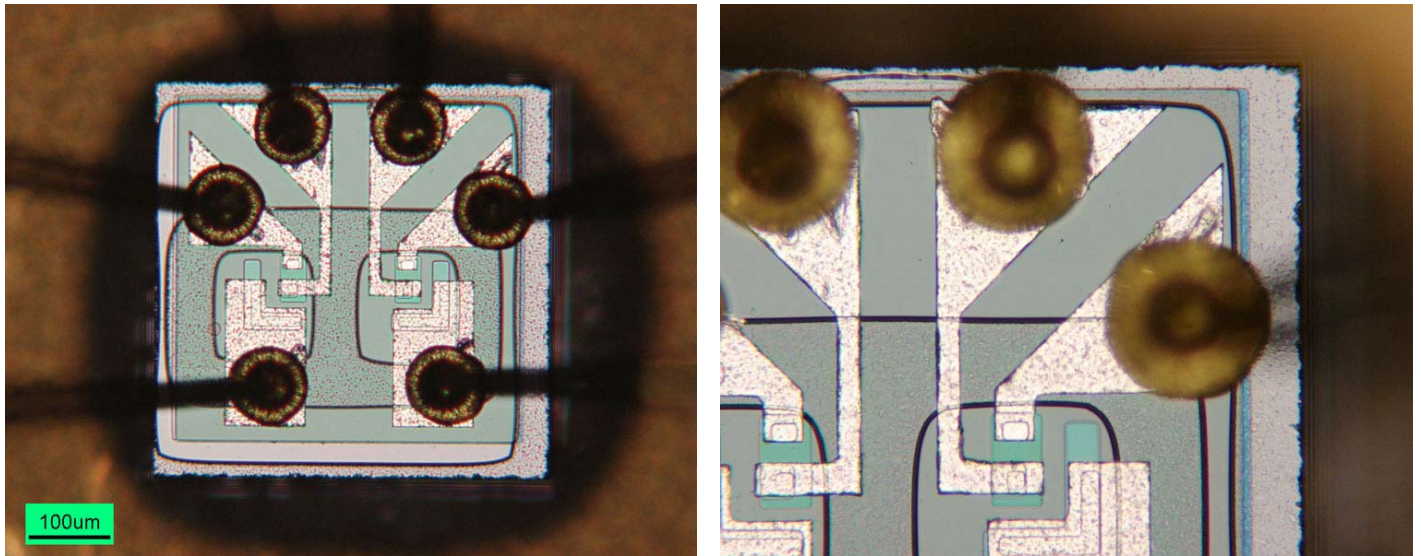
It was also observed that the same wire bonds that were poorly placed at the Q9/Q10 transistors in SN 206 were likewise poorly placed in SN 239. Optical inspection appeared to show that the base and emitter ball-bonds at Q10 were touching the unpassivated die edge and that the emitter ball-bond at Q9 was touching the unpassivated die edge. SEM inspection further documented these observations. Figures 2 and 3 show these findings.

Internal examination found ball bonds at the Q9/Q10 die placed such that the base and emitter circuit elements were shorted to the die substrate (and thus ground). These shorts were found to be in the 3 to 4-M Ω range (at the limited test current). It is not known if these values would cause a malfunction of the circuit.

Figure 2. Optical images show Q9/Q10 transistor(s) die and poorly placed gold wire ball bonds.

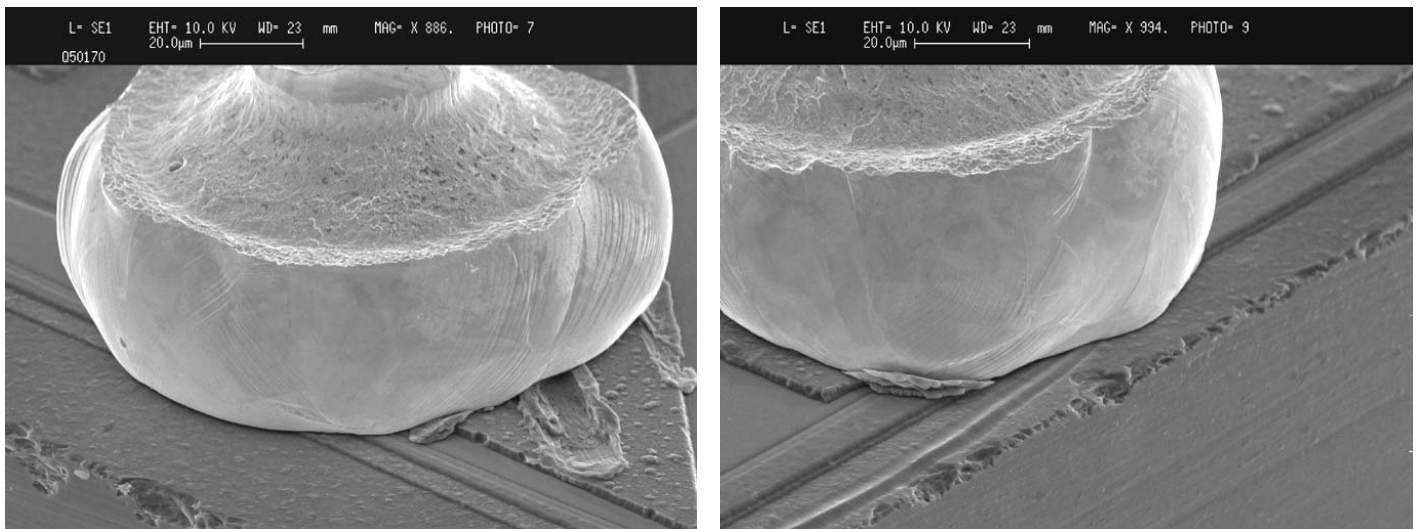
Prior to removing the ball bonds from Q9 and Q10, the emitter, base and collector all had non-linear type characteristics, in the range of 3 to 4-M Ω , between the bond pad and the backside substrate of the die. After the ball bonds were removed, these characteristics went away and essentially zero leakage current was observed between these circuit elements. Changes in the characteristics of the emitter-base and collector base diodes were less significant, nonetheless, the forward bias collector-base showed the most improvement.

Figure 3. SEM images of ball-bonds touching the unpassivated die edge. Left – Q10-base, right – Q9-emitter.

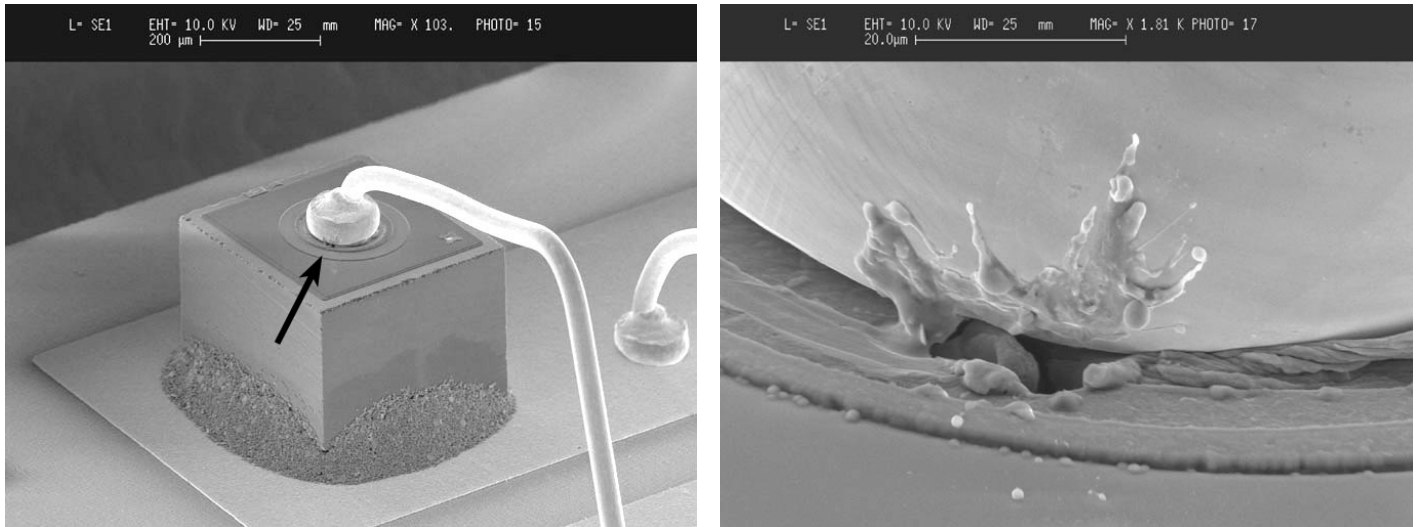
SEM inspection revealed an area of localized damage to output protection diode CR6 (similar damage was found on CR6 in SN 228). Figure 4 shows this damage area.

CR6 was isolated and probed, and found to be shorted. The other output protection diode as well as the two input protection diodes were isolated and probed and found to be OK. Also, output transistor Q11 was tested and found to be OK.

Internal examination also found electrical overstress damage to output protection diode CR6. Electrical characterization confirmed CR6 was shorted to essentially zero ohms. It appears that the device suffered a fast transient, low energy, electrical overstress event between the output and ground, pins 6 and 2, respectively.

Figure 4. SEM images show damage site on output protection diode CR6.

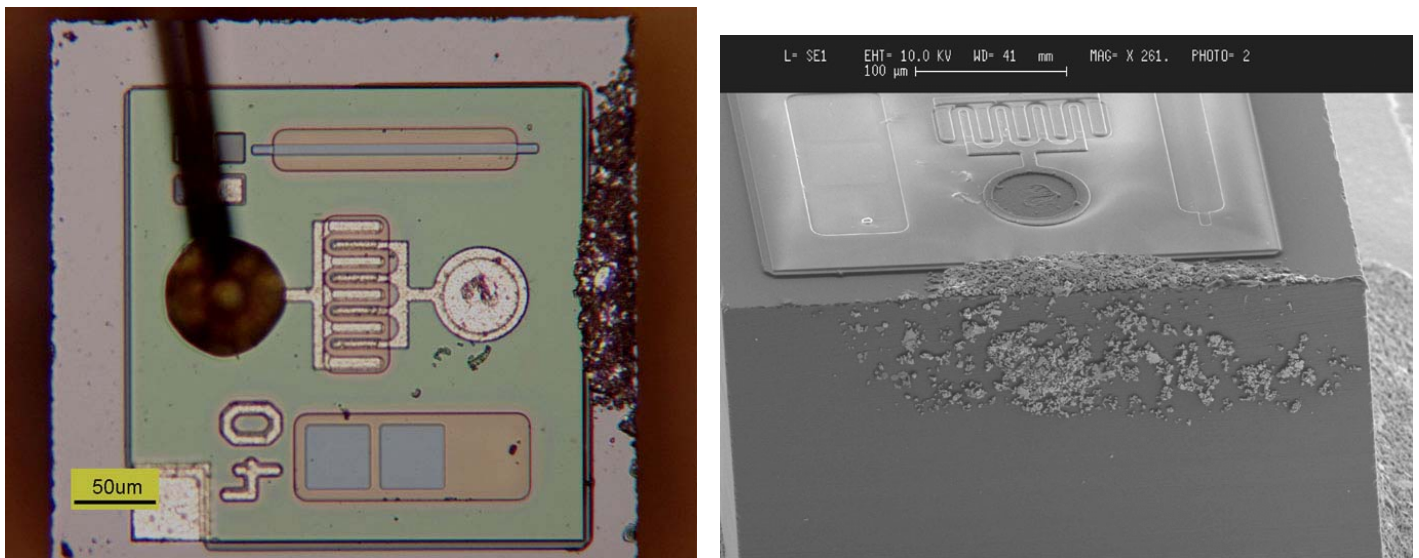
Optical inspection found silver-filled die attach epoxy on the top die surface of Q1. This is an unacceptable workmanship defect, but did not play a part in the device failure. Figure 5 shows this finding.

Internal examination revealed an unrelated manufacturing workmanship defect that deposited silver filled die attach epoxy on one of the die surfaces. This condition was not related to device failure.

Figure 5. Optical and SEM images show silver-filled die attach epoxy on the top surface of transistor die Q1.
