STEREO IMPACT

PROBLEM REPORT

PR-1037

FM2 SWEA Anode 11

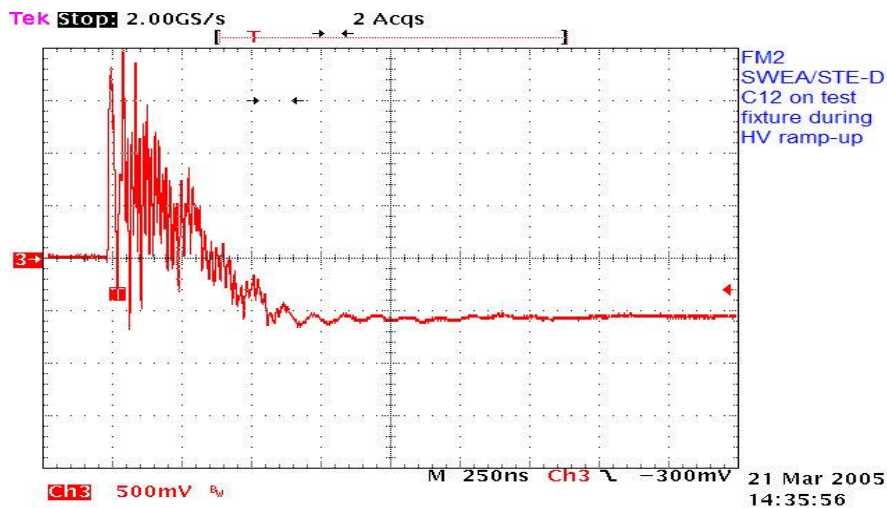
The unit was again disassembled and diagnosed. U12 was again found to be failed. The rest of the parts in the signal chain for all amplifiers were measured and found to be nominal. The decoupling capacitor for channel 11 (C12 – see schematic below) was removed from the decoupling board and tested under bias. It was found that the part exhibited fast transients, particularly while the bias voltage is being ramped up. Transients exceeded 2 volts in spite of protection diodes in the test circuit similar to those in the instrument, indicating the transient is faster than the diode can react. This could be the cause for the U12 failures.

C12 and U12 were replaced with spares from CESR flight stock.
