STEREO IMPACT

PROBLEM REPORT

PR-1040

FM2 SWEA LVPS

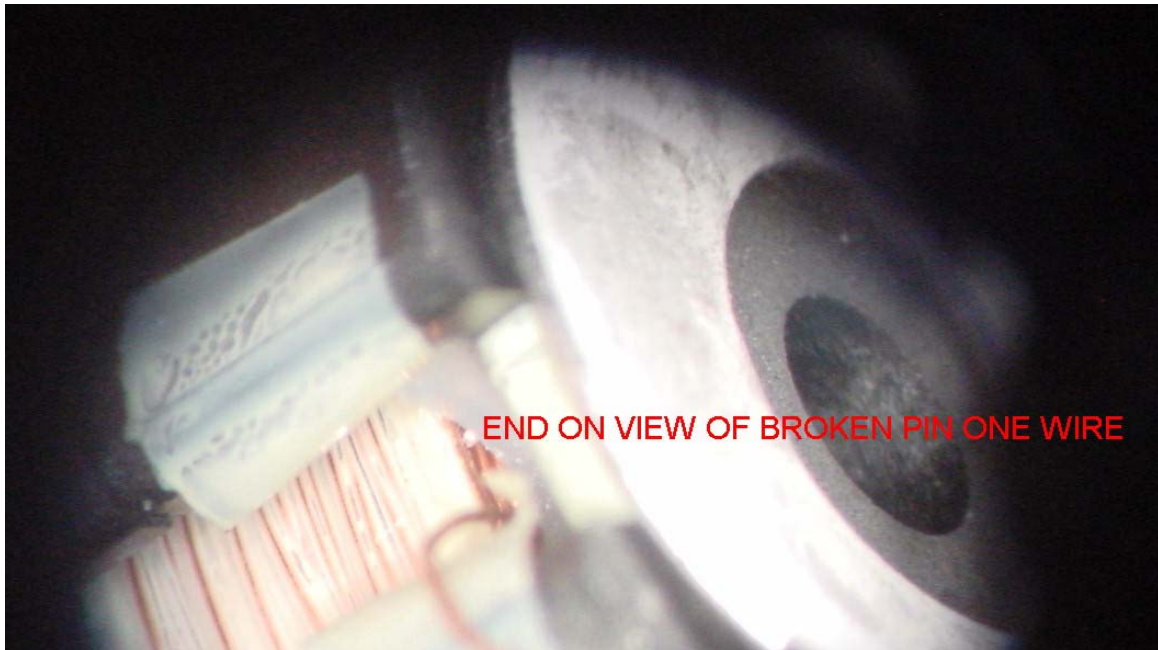
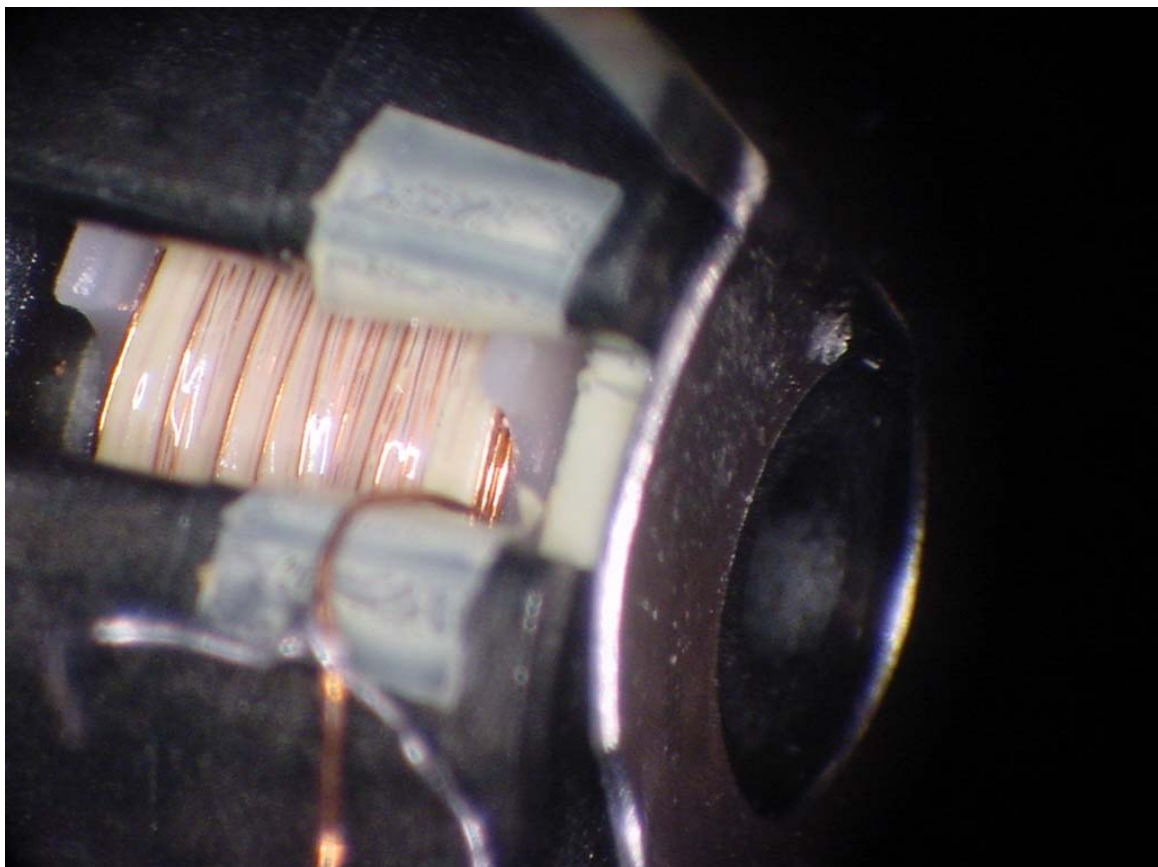
The unit was disassembled and diagnosed. The problem was isolated to the T2 transformer in the SWEA LVPS. It was found that the transformer bobbin was floating in the core, raising concerns that the bobbin motion during vibration could have resulted in a broken wire. The transformer was carefully removed and it was indeed found that a transformer wire was broken. The reason the bobbin was loose in the core is that no staking had gotten in to hold them together when the core was staked to the board, as is usually the case. This was prevented by some kapton tape that had been added around the core to deal with a problem with the board layout. This is common between the two SWEA supplies and the STE-U bias supply in the IDPU (note only STE-U is effected by this potential failure mode, not the rest of the suite). Moving the tape slightly and inserting some staking material between the bobbin and core can fix this. An analysis shows not overstress occurred elsewhere in the system as a result of this failure (partly due to the short duration of the excess current).

1. SWEA FM2 - Replaced the transformer in the LVPS with a bobbin staked to the core (SN003 replaced with SN004; SN004 passed the normal screening.) Performed a one axis workmanship vibrate and completed 4 cycles of thermal vacuum testing.
