STEREO IMPACT

PROBLEM REPORT

PR-2003

LET L1 Detector

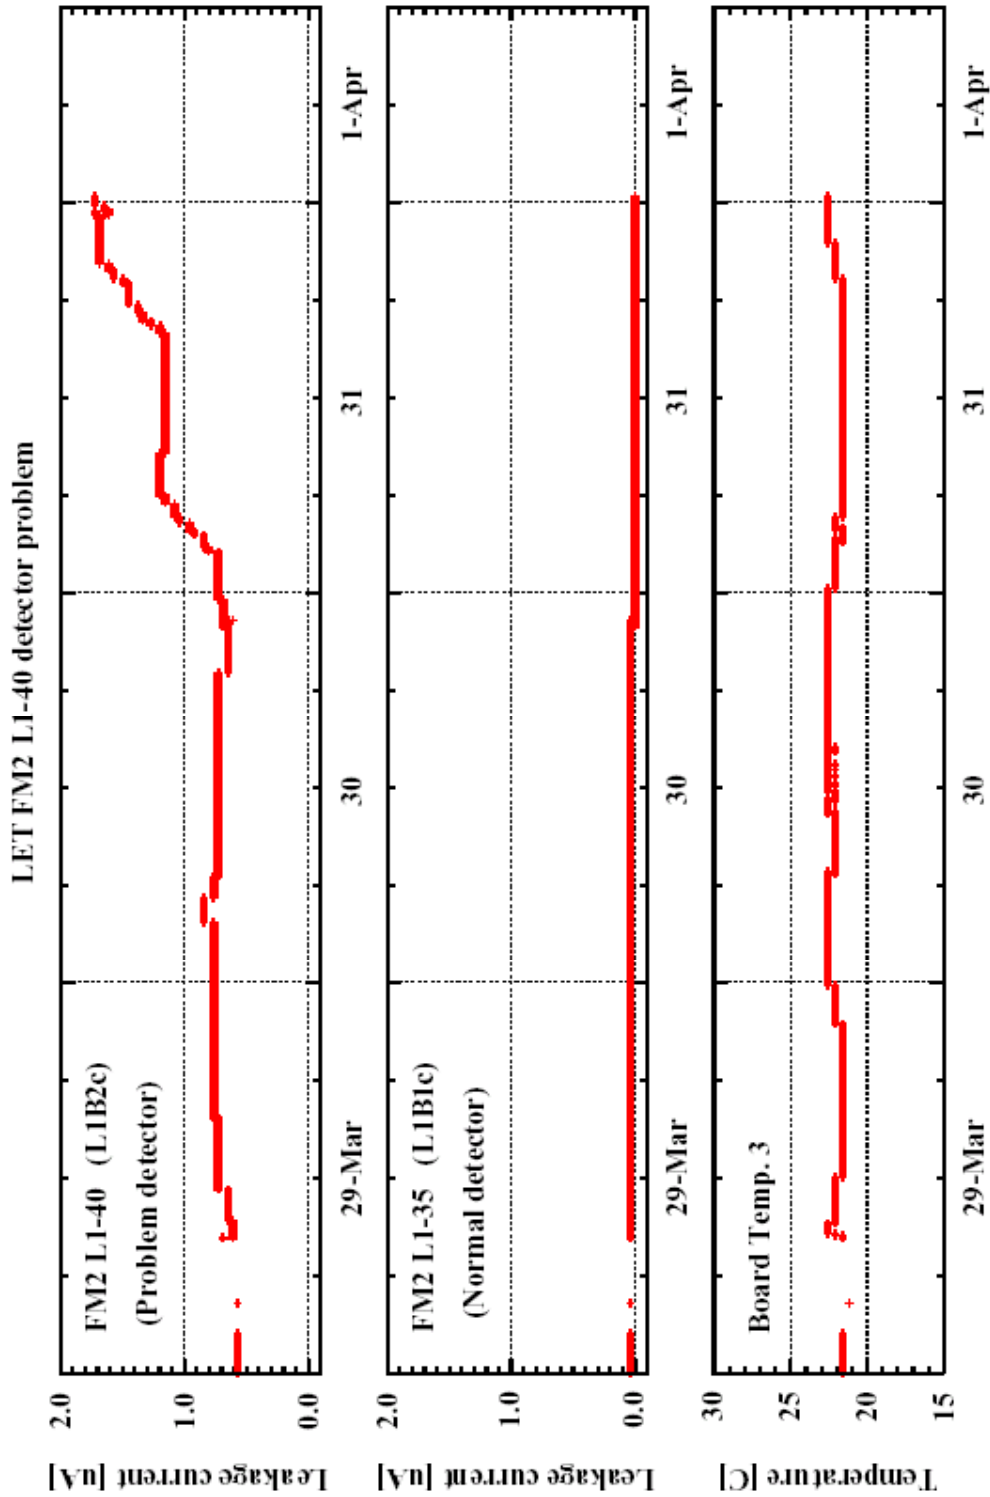
The L1-40 detector in the FM2 LET instrument (L1B2) has been displaying a high and growing leakage current over time.

See data plots attached.

Replaced the L1B2 in LET FM1 from S/N L1-40 to S/N L1-37 prior to the start of environmental testing. Functional testing of the unit was successfully and all of the detector leakage currents continue to be trended throughout the entire test program. The leakage current trended throughout acoustic and vibe testing remains nominal.

No additional retesting on the assembly is required due to this change.
