STEREO IMPACT

PROBLEM REPORT

PR-3001

Failure Analysis Report

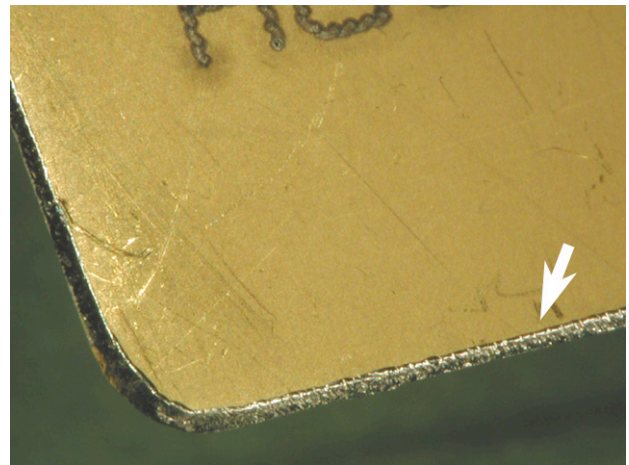
Figure 4. The arrow points to stitch welding which secures the lid to the body. Leak testing indicated a small leak in the package at an unknown location, possibly the frit glass, as some crazing was noted.

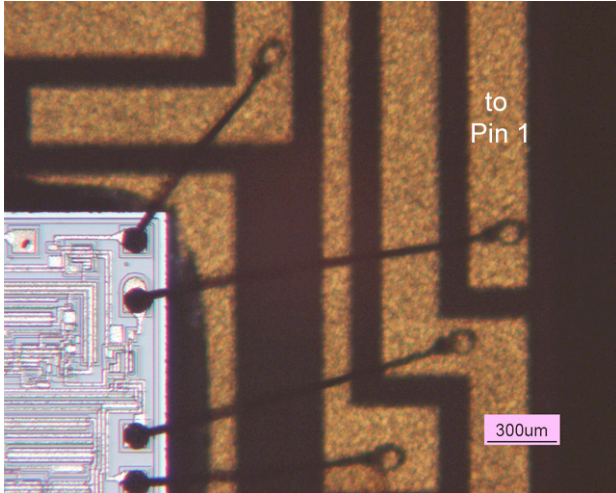
Figure 5. This view shows the corner of Die 1. The second bond wire from the top goes to the gold trace, which leads to Pin 1 of the hybrid.

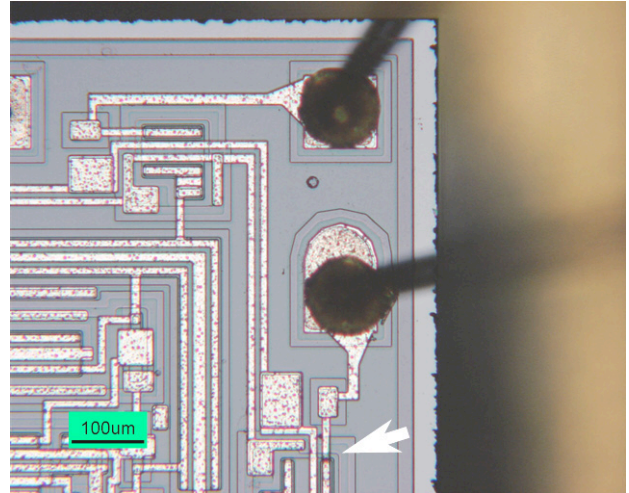
second largest microcircuit in the hybrid (labeled Die 1 for this analysis). The defect area was traced to a nearby gold pin (without input protection) and, from there, along the gold metallization of the hybrid to Pin 1—the input pin connected to the gate of the Peak Hold Detector. Inspection found that the void on Die 1 occurred where metal stepped across what appeared to be the base region of a bipolar transistor.

Figure 6. An anomaly was found on Die 1 at the arrow. The second bond wire from the top leads to Pin 1, and is connected to the defect site. No input protection is seen at this bond pad.

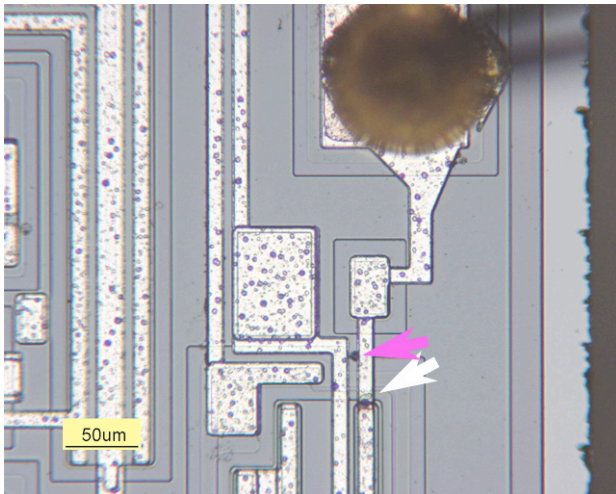
Figure 7. The defect resolves into two anomalies at higher magnification. The white arrow points to an apparent void in the metallization, seen through the transparent glass. The pink arrow points to an unusual feature noted adjacent to the wire.

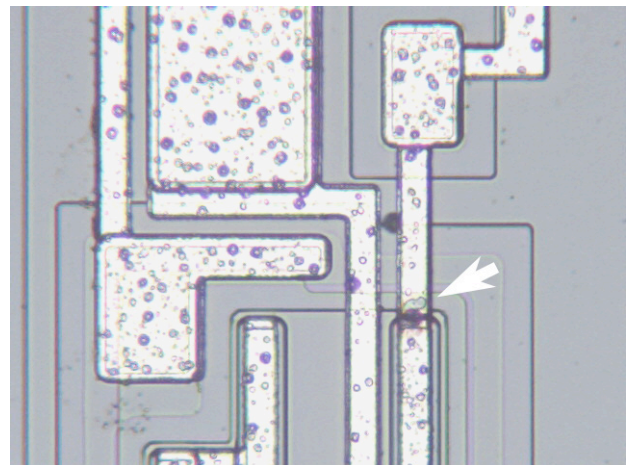
Figure 8. A zoom view of the metallization anomaly clearly shows a patch of missing metal at the arrow.

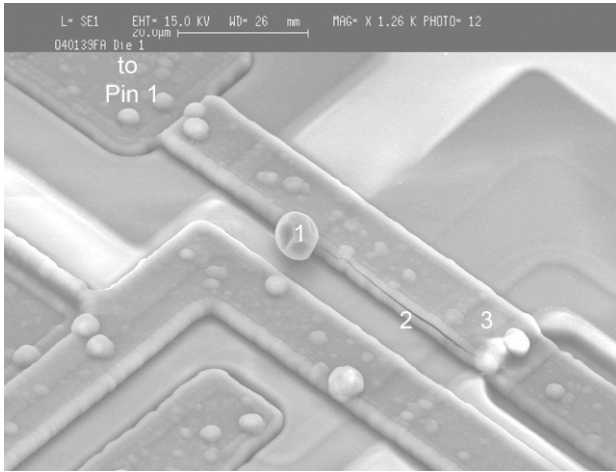
SEM inspection was conducted. Glassivation obscured the metal void. However a long crack was observed in the glassivation on one side of the aluminum trace. The crack extended approximately 50 microns from the location of the void, terminating near a roughly spherical mass of aluminum 7-microns in diameter, which appeared to have extruded from the crack.

Figure 9. This labeled image shows the area of the defect.: (1) indicates a sphere at the end of a (2) crack, which terminates at, (3) the location of the void. The void is still covered by glassivation in this image.

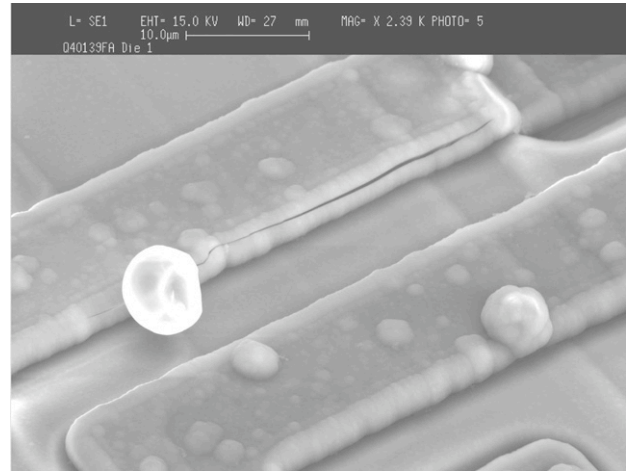
Figure 10. A different view of the defect area, clearly showing the cracked glassivation.

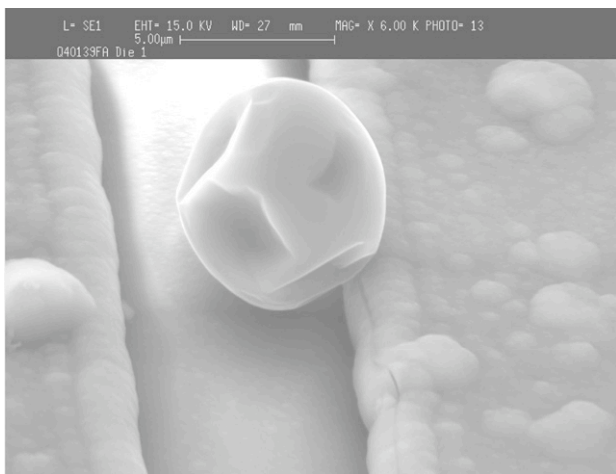
The remote location of the melted aluminum ball from the void site argues that the aluminum trace between the void and the ball was in a molten state, or at an elevated temperature near melting. This fact further suggests that this failure was caused by electrical overstress (EOS). The cracked glass is explained by thermal expansion during electrical overstress.

Figure 11. A close-up view of the soccer-ball like sphere near the end of the crack. The scale shows the sphere is approximately 7 microns in diameter.

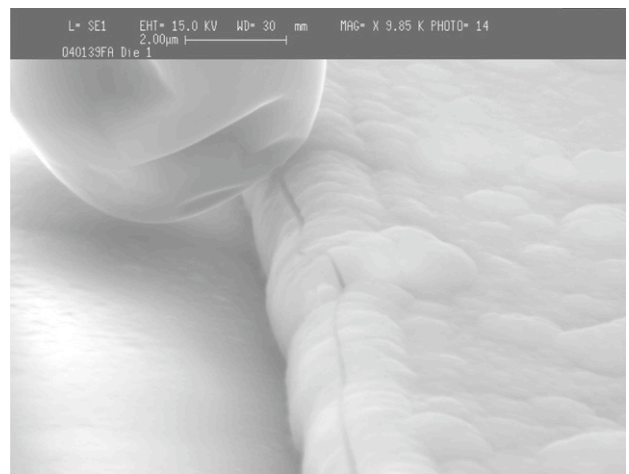
Figure 12. A slightly different angle of view shows that the sphere is connected exactly at the crack.

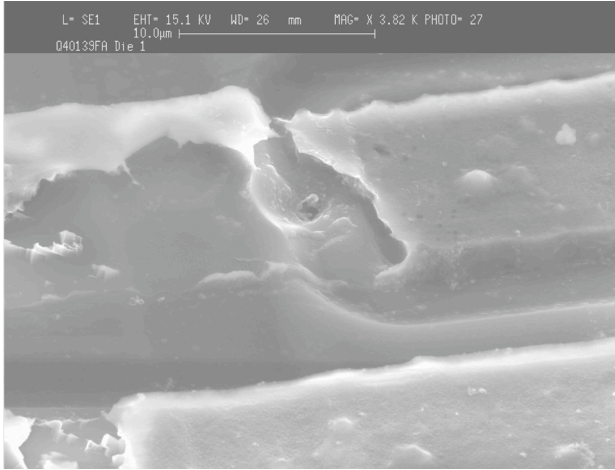
Figure 13. Plasma, chemical, and fluid pressure techniques were used to remove the glassivation. The fluid pressure also removed a wedge-shaped section of the aluminum between the location of the sphere and the metallization void, leading to the suspicion that this section had been thermally weakened.

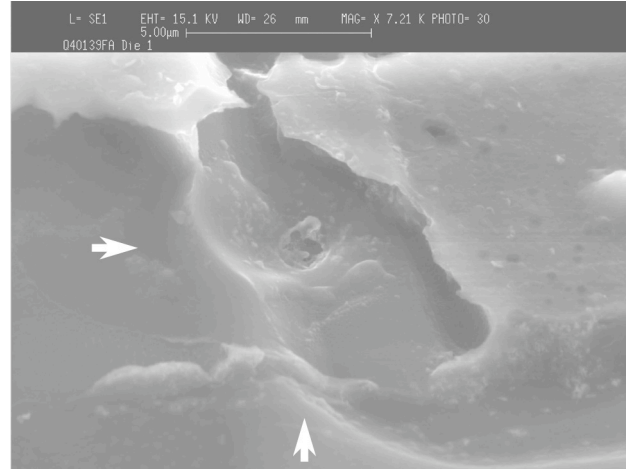
Figure 14. The arrows crosshair on a damage site in the silicon under the area of the void. This defect is seen in Figure 15.

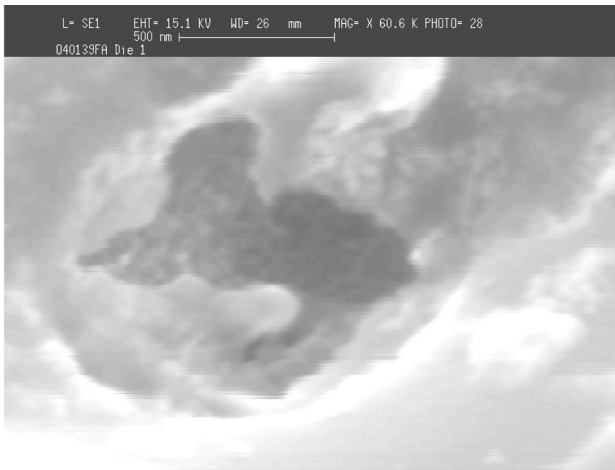
The glassivation was stripped using plasma, chemical, and fluid pressure techniques. At the location of the aluminum void, a 1-micron pit in the silicon was found. SEM zoom and contrast established that the bottom of the pit had a rubble-like appearance, consistent with electrical overstress damage.

Figure 15. A Texas-shaped, but tiny, pit in the silicon is seen at high-magnification. Inspection of its bottom reveals a rubble-like appearance, consistent with electrical overstress damage.
