STEREO IMPACT

PROBLEM REPORT

PR-3017
Reichenthal
7/27/05

Assembly : SIT Instrument	SubAssembly : HVPS
Component/Part Number:	Serial Number: FM1/FM2
Originator: Reichenthal	Organization: UMd
Phone : 301-286-5634	Email : Lillian.S.Reichenthal@nasa.gov

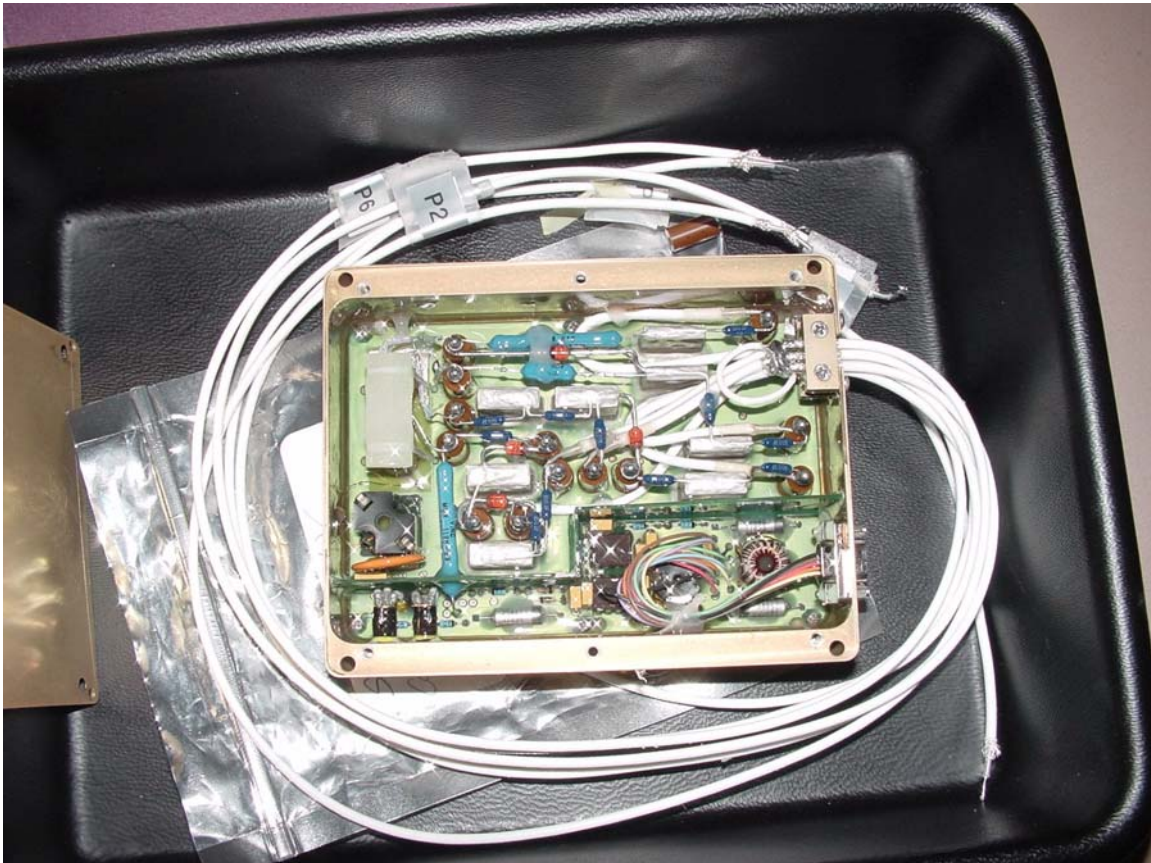
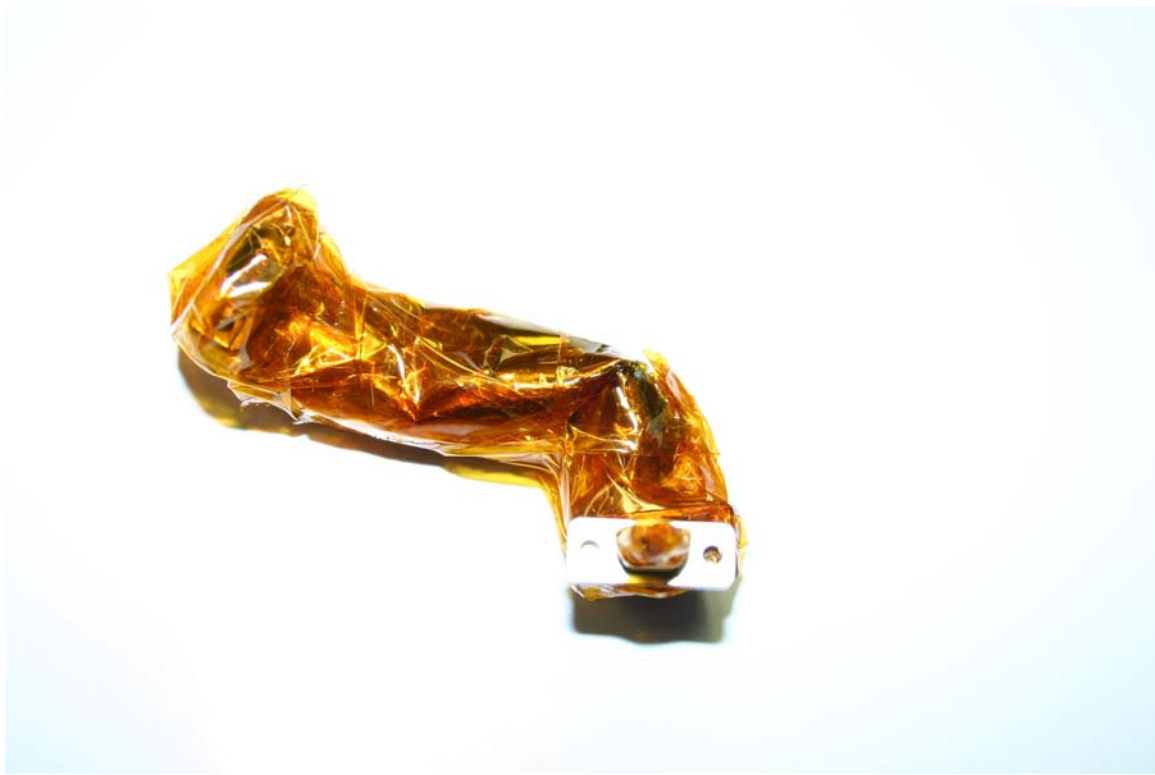
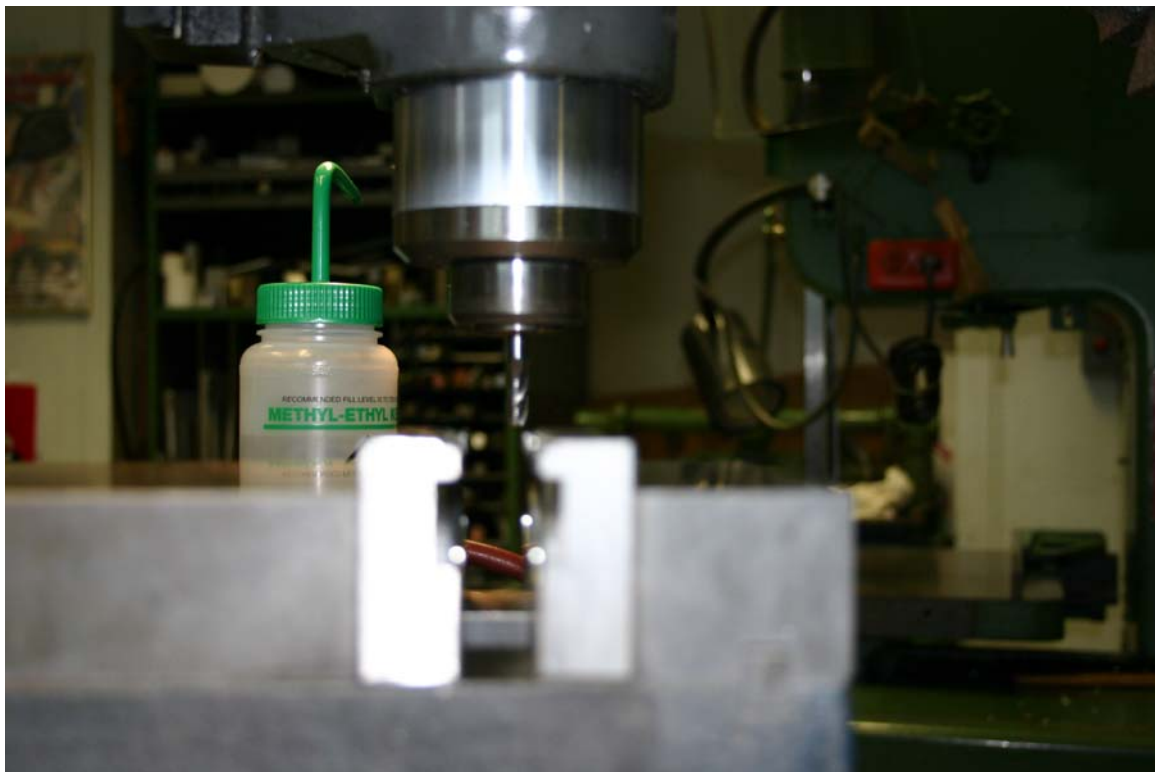
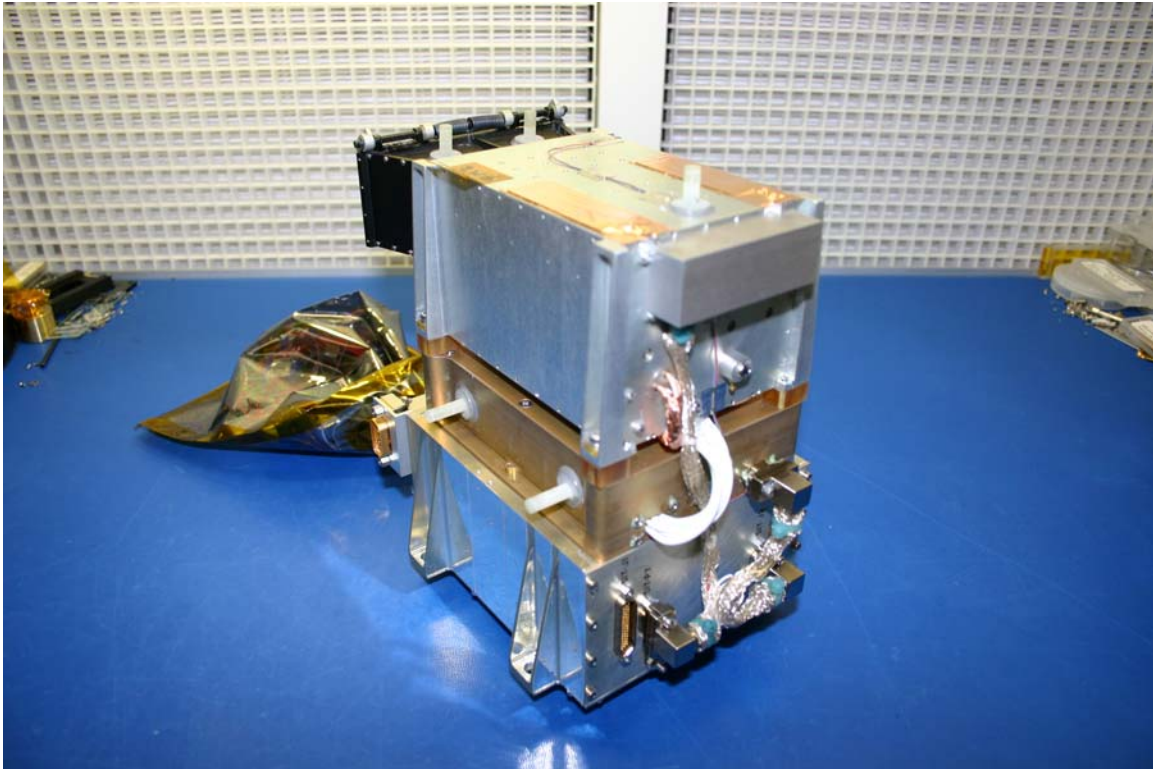
The 9 pin MDM connector on the SIT HVPS is not seated fully. There is approximately a 0.050 gap from a full connector engagement. This is due to the fact that the length of the jack post head protrudes past the connector shell. This problem is seen on both flight units. The jack post cannot easily be replaced because the hardware is terminated with nuts inside of the HVPS box. It would be a major effort to disassemble the SIT unit to disassemble the HVPS box.

Calculations of the worst case pin engagement due to the 0.062 gap is (0.012) worst case and (0.065) best case. In addition, without full connector engagement, the connector becomes more susceptible to humidity. This is not acceptable for flight.

The flange of the MDM connector of the mating harness was modified to allow for the jack post head to not protrude past the connector shell. Removed the clip (0.015") and milled the flange (0.025"). (Prior to milling the flange was 0.090"). The mounting hardware along with the area that was modified on the connector was covered with Uralane 5753. See attached pictures. The connectors on both flight units are now fully engaged.
