STEREO IMPACT

PROBLEM REPORT

PR-4002

FAILURE ANALYSIS REPORT FOR DEVICE TYPE
RT54SX72S-CQ208B
CASE NUMBER 1-6981277

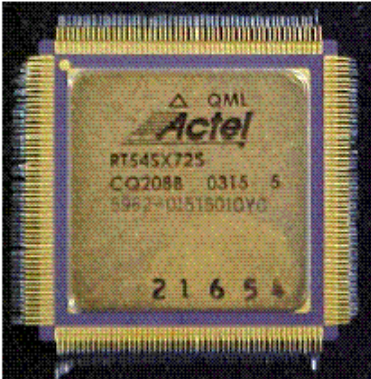
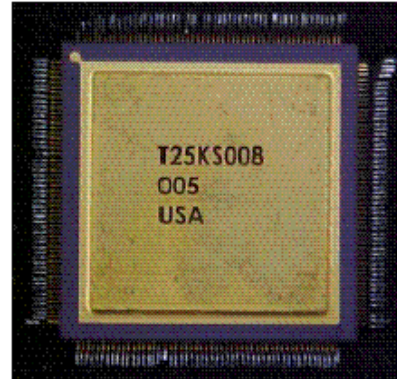
Figure 1: Top View of Returned Unit

Figure 2: Bottom View Of Returned Unit

A detailed visual inspection of the unit showed that all the pins were bent. On April 28, 2004, the returned device was sent to an outside laboratory to have it manually soldered onto a CQ208 lead frame (ceramic quad flat pack with 208 leads) for further testing. On May 4, 2004, Actel received the reworked device ([Figure 3](#) and [Rework Figure 4](#)) in the following physical condition:

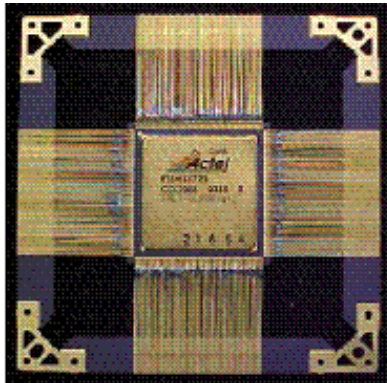
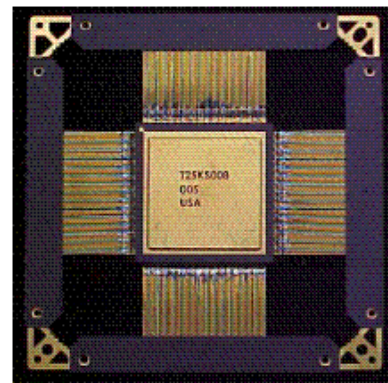
Figure 3: Top View Of Device After Rework

Figure 4: Bottom View Of Device After Rework

A visual inspection of the device following package rework showed that all the leads were properly soldered to the lead frame.

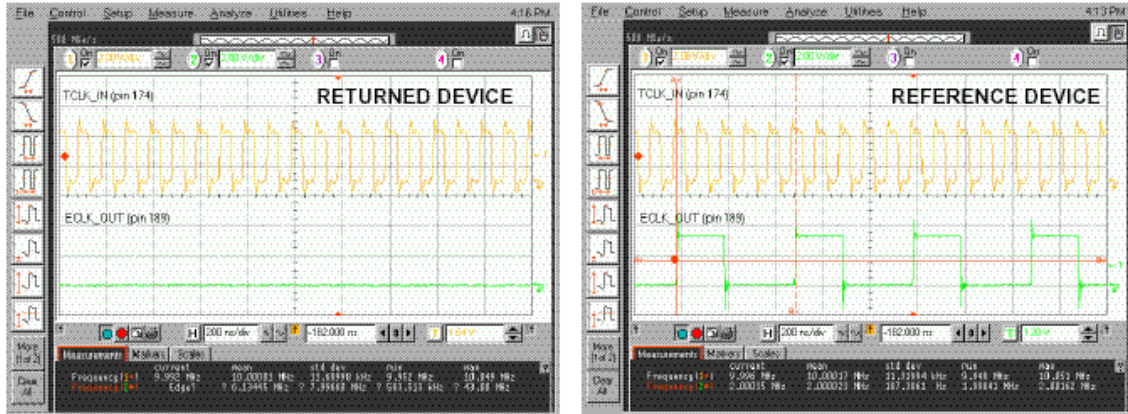
Actel was able to observe the reported failure mode using the Silicon Explorer. The internal nodes of the “Divide By Five” circuit (**Figure 6**) and the output pin #189 showed no activity, while the internal nodes and output pin #189 of the reference device toggled as expected. Output pin #189 of the returned device was verified to be tri-stated using a 10 K pull-up resistor connected to V_{cc} . Shown in **Figure 7** are scope plots of signals on input pin #174 and output pin #189 of the FPGA.

Figure 7: Scope plots of the output signal eclk_out (pin 189) with respect to the input signal

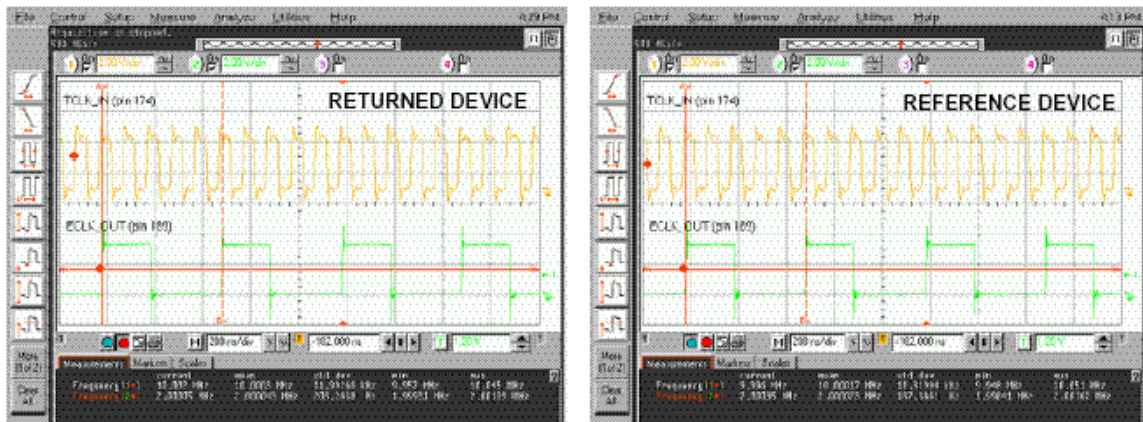
Figure 9: Scope plot of the output signal *eclk_out* (pin 189) of the returned device (LEFT) is identical to that of the reference device (RIGHT) when the charge pump is turned on by the test program

Since the output signal *eclk_out* (pin #189) of the returned device functions correctly when the charge pump is enabled through software this indicates there is a problem in the circuit that controls the charge pump. Analyzing the FPGA transistor circuit, it is found that the charge pump enable (*PMPEN*) signal is controlled by signal *MR22* (Mode Register bit 22) and signal *FUS3*. [Figure 10](#) below shows the simplified circuit generating the *PMPEN* signal.

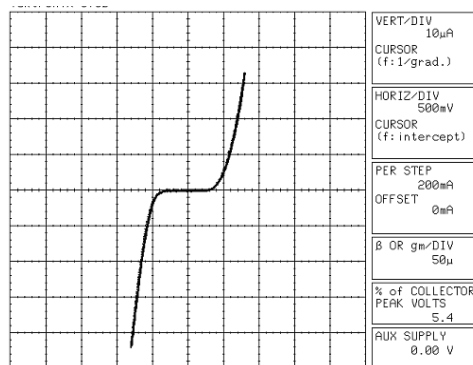
FIB2, FIB3, FIB4, FIB5 were electrically probed and the curve results showed a good I/V characteristic indicating that U3, U2, U6, U7 and U8 were functional. [Figure 14](#) on the left below shows the I/V curve that was performed on these pads. The curve result of [Figure 15](#) however reveals a short between the output of NOR gate U9 and V_{CCA} .

Figure 14: I/V characteristic of FIB2, FIB3, FIB4, FIB5 and FIB6

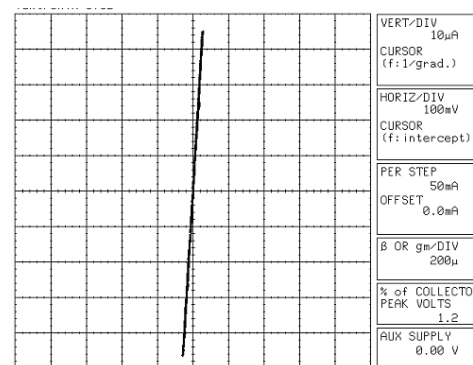
Figure 15: I/V Characteristics of U9 (NOR gate) shorted to V_{CCA}

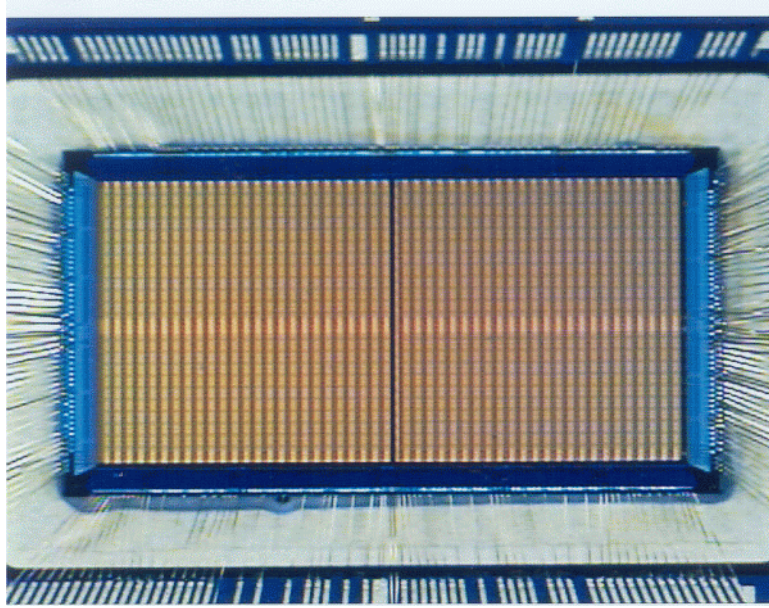
Based on all the observed measurements pointing to a possible short within the *FUS_BLK* circuit, a decision was made to proceed with de-processing in the region of *NOR gates U8, U9* in order to locate the specific fault site and thus determine root cause of the failure. De-processing removes one processed layer at a time followed by optical and SEM imaging for possible regions where there may be a short or any other defect. Additional steps for verification of the fault included application of additional FIB pads with subsequent electrical measurements. A choice of *Riga Analytic Labs* was made for the de-processing activities as this lab has previously demonstrated excellent skills at layer removal without damaging the device under analysis. A first step at Riga is a die examination for any obvious gross level defects. From the photo shown below in [Figure 16](#) the surface does not exhibit any surface scratches or contamination.

Figure 16: NASA unit as Received by Riga Labs

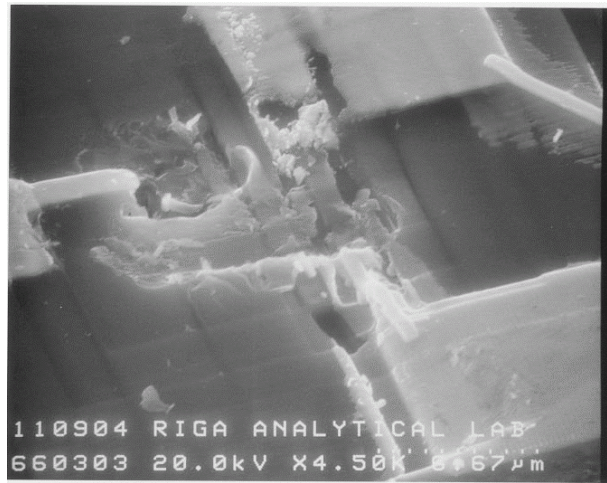
Further examination of the FIB pads on the left side of [Figure 17](#) revealed possible surface damage resulting from the first application of FIB pads and subsequent micro probing. This damage may have resulted in the earlier indication of a short between V_{CCA} and the output of *NOR gate U8*. This possibility was further confirmed in examination of the device layout where it was observed that a V_{CCA} metal layer is present in the FIB area along with a V_{SV} metal interconnect line. Shown magnified below in [Figure 18](#) are FIB Pads 1-3 indicating possible corruption of metal layers. As a result of this observation a decision was made to remove the top metal layer followed by addition of a new FIB pad to determine if the FIB1 to V_{CCA} short was still present.

Figure 18: Possible FIB Pad damage

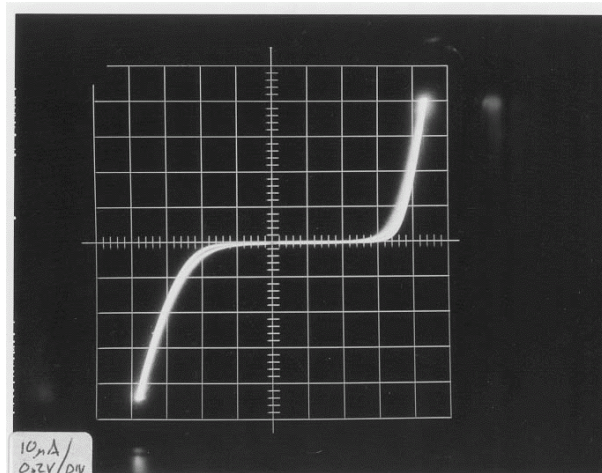
The new FIB pad added by Riga as shown in [Figure 20](#) is electrically the same as the original FIB1 shown in [Figure 13](#) as it is connected to the original FIB1 via a poly silicon line and Metal 1. Subsequent micro probing of this FIB connection to U9 no longer indicated a short to V_{CCA} as indicated in the curve trace photo shown below in [Figure 21](#) thus providing additional evidence that the short originally measured was a FIB related short.

Figure 21: Curve Trace of Secondary FIB1 to V_{CCA}

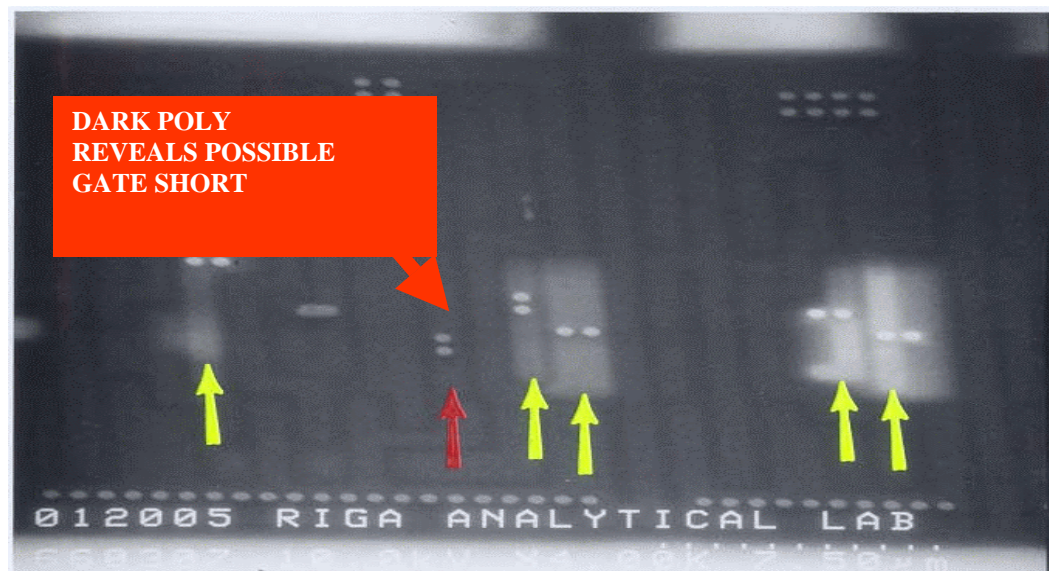
Following secondary micro probing operations, a decision was made to continue de-processing down to metal layer M1. Here the sample was mechanically lapped and at each level the area of interest was inspected for defects or damages and none were found. At the M1 layer, a Passive Voltage Contrast (PVC) test was performed to examine for any poly silicon shorts. This is a test in which low energy electrons are used to image the unit. If the poly-silicon is electrically floating it will charge up with a contrasting bright image display that is a different image from a poly-silicon gate that is shorted to the substrate. During the test the M1 lines that have source/drain contacts appeared dark (grounded). The Metal 1 lines that are connected only to poly gates appeared bright (floating) except for one gate. The dark poly silicon line shown below in [Figure 23](#) is connected to the N-channel gate input of Inverter U4 (FIB “A”) shown in [Figure 13](#). This dark poly silicon indicates a possible leakage to the under laying substrate.

Figure 23: PVC Test Reveals Evidence of Gate Short

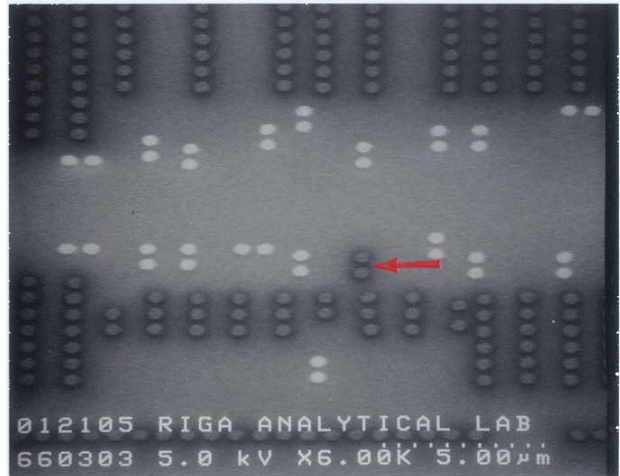
Next the sample was lapped through the M1 layer to the contact level where the PVC test was repeated. At this level contacts to the poly silicon are exposed with all metal layers now removed. Close examination as shown in [Figure 24](#) revealed two poly contacts to the N-Channel gate input of Inverter U4 that were dark.

Figure 24: Anomalous Poly Contacts to U4 Inverter

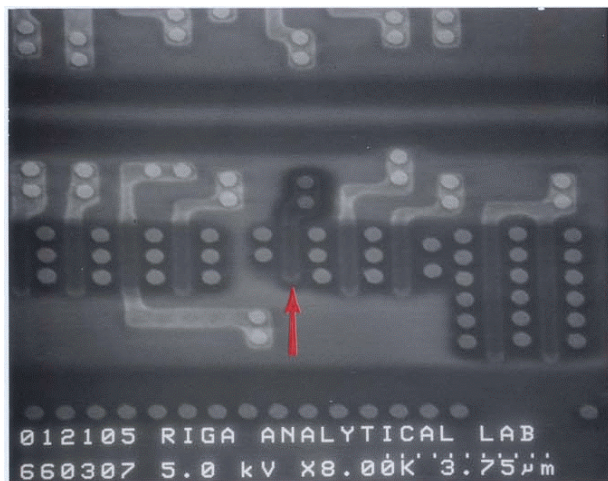
De-processing continued with the failed unit sample mechanically lapped to the poly level and a final voltage contrast test was performed at this level. As shown in [Figure 25](#) the gate corresponding to the dark contacts, as observed in previous PVC tests, appeared dark. This indicates that the gate has leakage or is shorted to the substrate.

Figure 25: Detailed View of N-channel Gate to U4

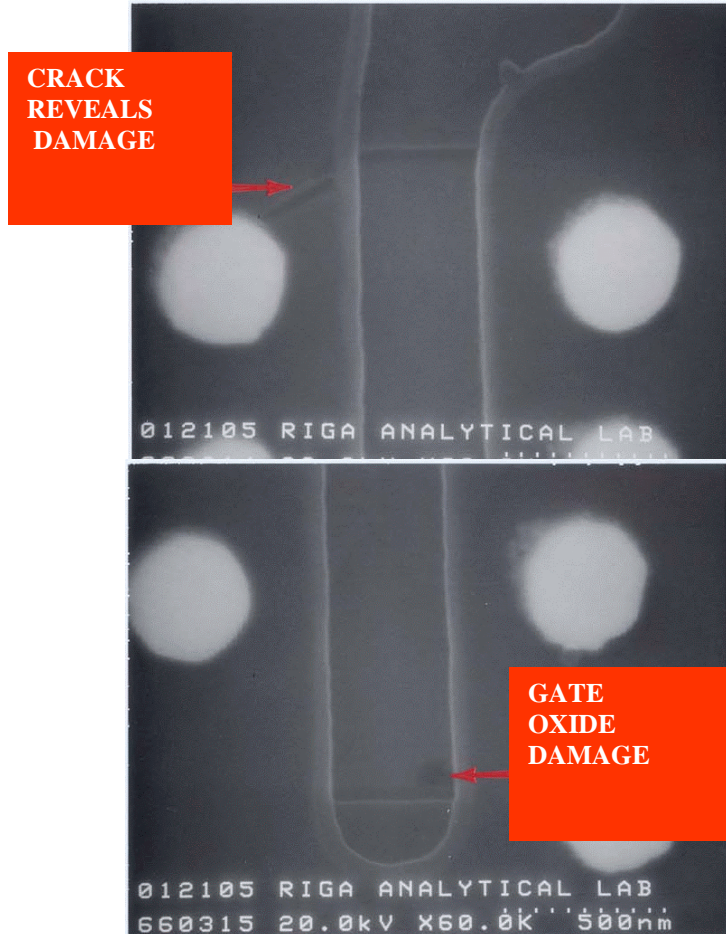
Following removal of the poly level an inspection of the region where the anomalous gate was observed revealed a crack in the field oxide region between a source/drain contact and the poly sidewall. In addition, gate oxide damage was observed near the lower edge of the gate. These transistor damages are shown in the photos of [Figure 26](#) and [Figure 27](#).

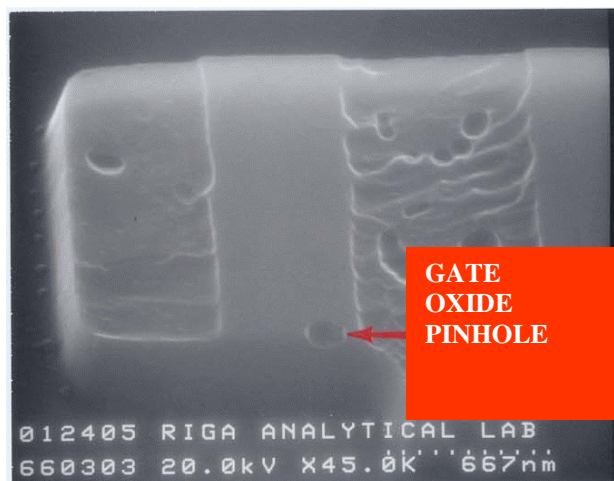
Final De-processing stripped all oxide to the silicon level. As shown below in [figure 28](#) a small pinhole at the poly edge of the N-channel transistor of Inverter U4 exhibits a small pinhole.

Figure 28: N-Channel of U4 Gate Damage

Based on the results of the FA investigation, it is concluded that this unit failed due to an EOS event that damaged the N-channel transistor of Inverter U4. This inverter has as its input, signal *VSVRDET B* that normally would be at logic level High. Thus if this signal is virtually stuck low by the n-channel input gate fault the signal *FUS3* will no longer be at Logic High and the charge pump will turn off.

Because of EOS events of this type, it is recommended that close attention be applied to power supply spikes that may occur during device programming or system operation.

To screen for this type of EOS event if it occurs during Sculptor programming, Actel is to release a revision to the Sculptor software (v4.52.03.89), which is planned for May 24, 2005. The revision will include programming an unused Silicon Signature Bit, (*SSIG2, Bit0*) allowing a test of the *VSVRDET B* signal controlling *FUS3*, which in turn enables the charge pump to be activated. This test will fail if the *VSVRDET B* signal is in a stuck high or low condition and will also fail if the output of logic gate U8 following the path of the PFUS and JFUS signals shown in [Figure 13](#) is stuck high or low. This new test would have discovered an inoperable *VSVRDET B* signal resulting from the EOS event if the EOS event had occurred during Sculptor programming.
