STEREO IMPACT

PROBLEM REPORT
PR-6001
HVPS_thermal
2003-09-15

PFR- 6001 HVPS VMI Multiplier Failure

Failure Analysis Report

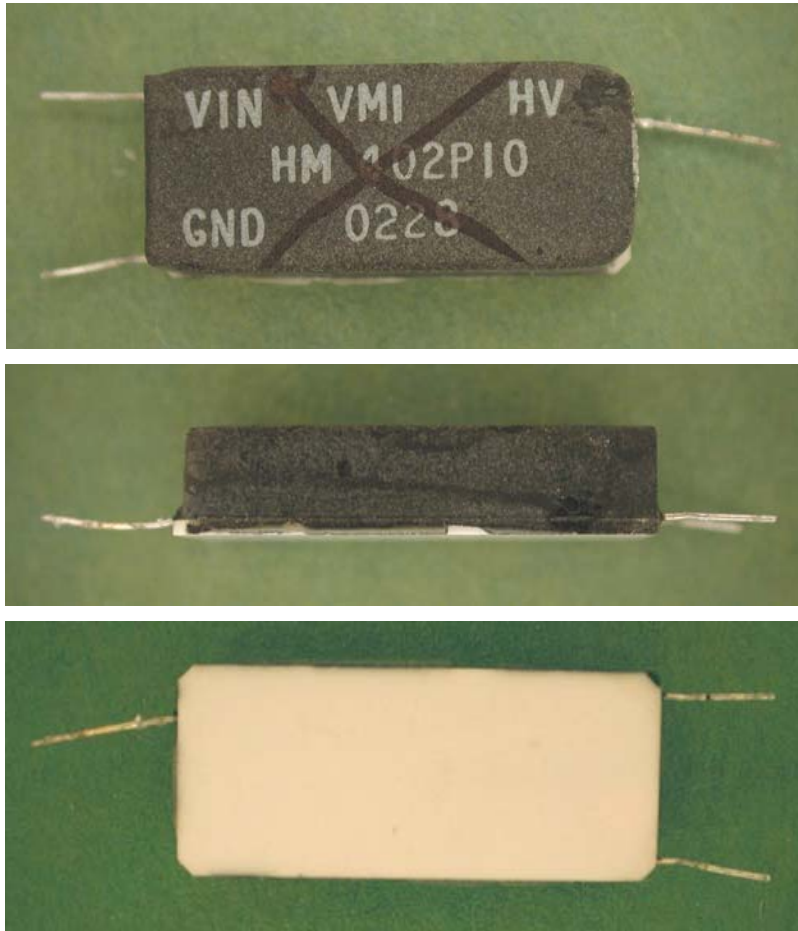
External examination revealed a small round anomaly in the potting material near the VIN lead. This feature was not an artifact or cause of failure. The package had a hand-written “X” marked across the top surface, possibly identifying it as bad. Figures 1 and 2 show external views of the device.

Figure 1. External views of the VMI HM402P10 hybrid voltage multiplier.

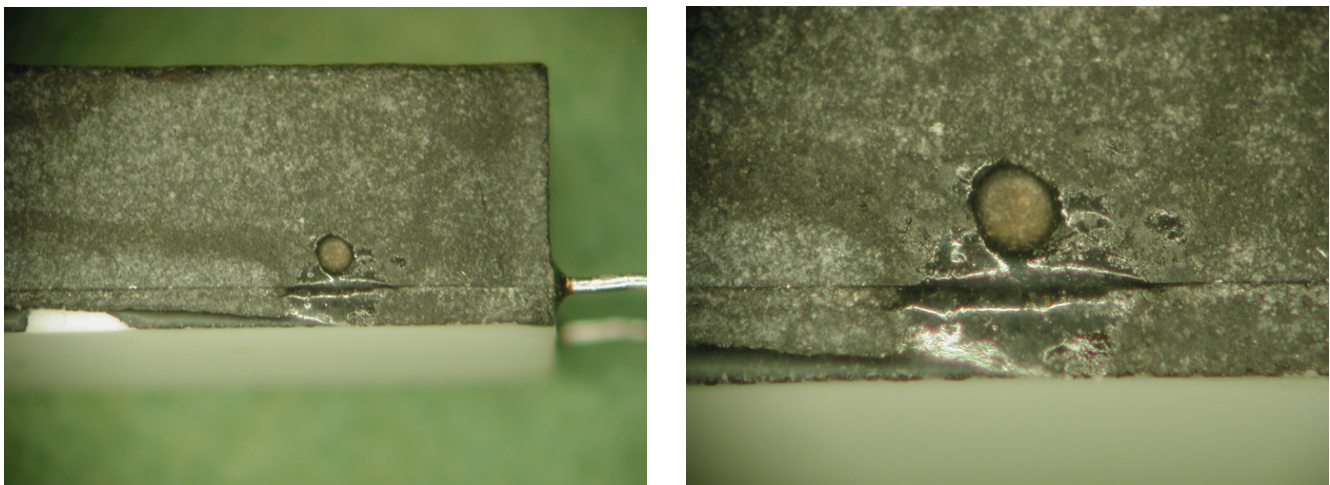
Figure 2. Anomaly in the potting material near the VIN lead.

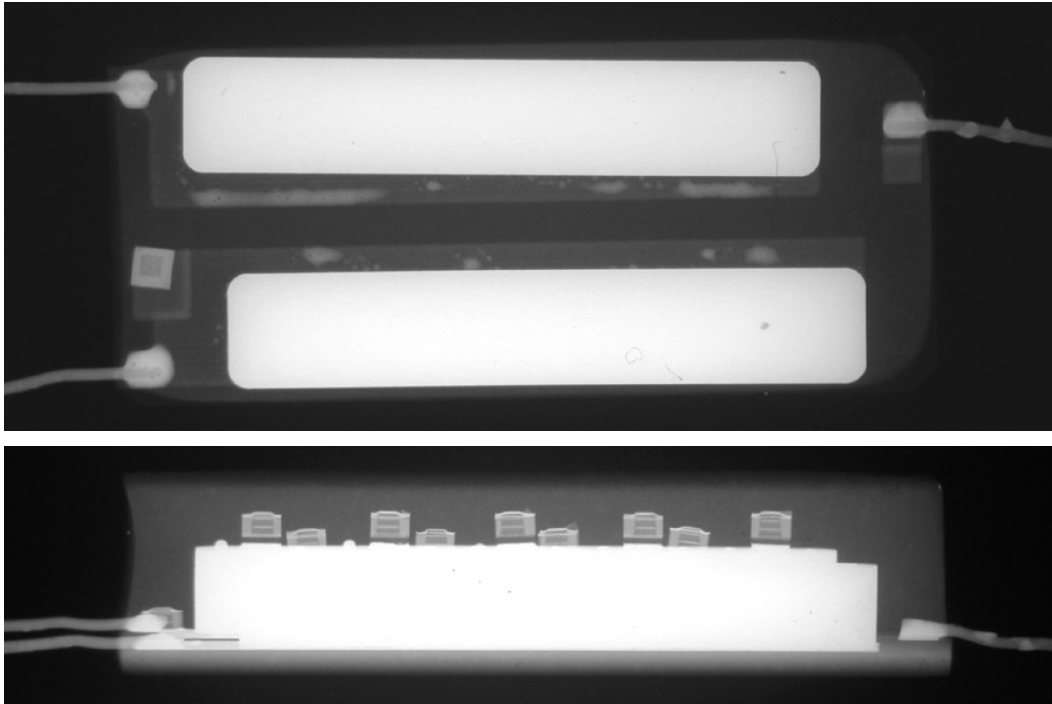
Figure 3. Radiographic images of the HM402P10 device. The large rectangular white objects are two monolithic segmented ceramic capacitors. Nine discrete surface mount diodes are mounted on the capacitors and one is mounted on the substrate near the GND lead.

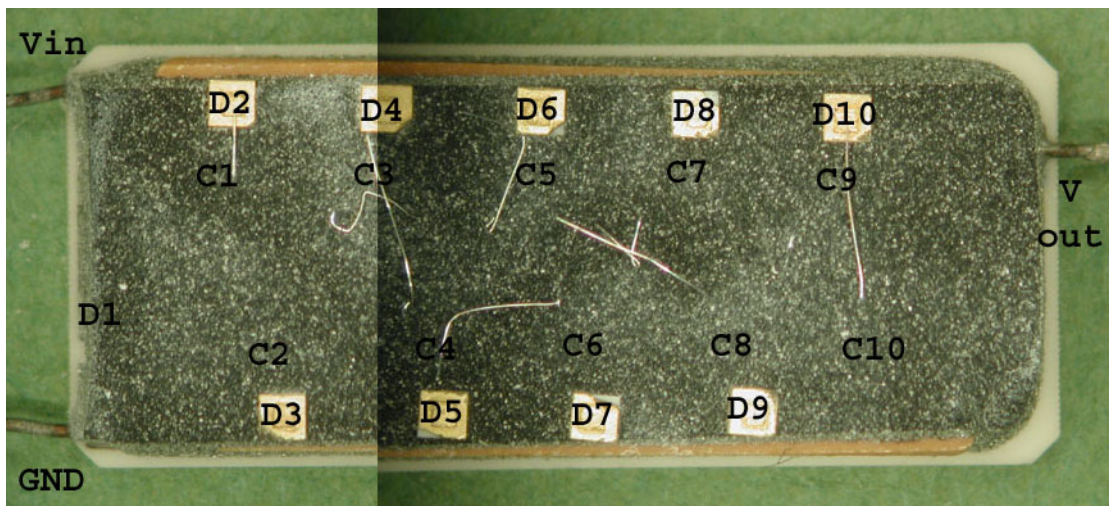
Figure 4. This view shows the device at an intermediate deprocessing stage. The tops of the diodes are revealed (except D1). The aluminum bond wires were inadvertently broken due to the blow-off process necessary for residue removal after oxygen plasma ashing.

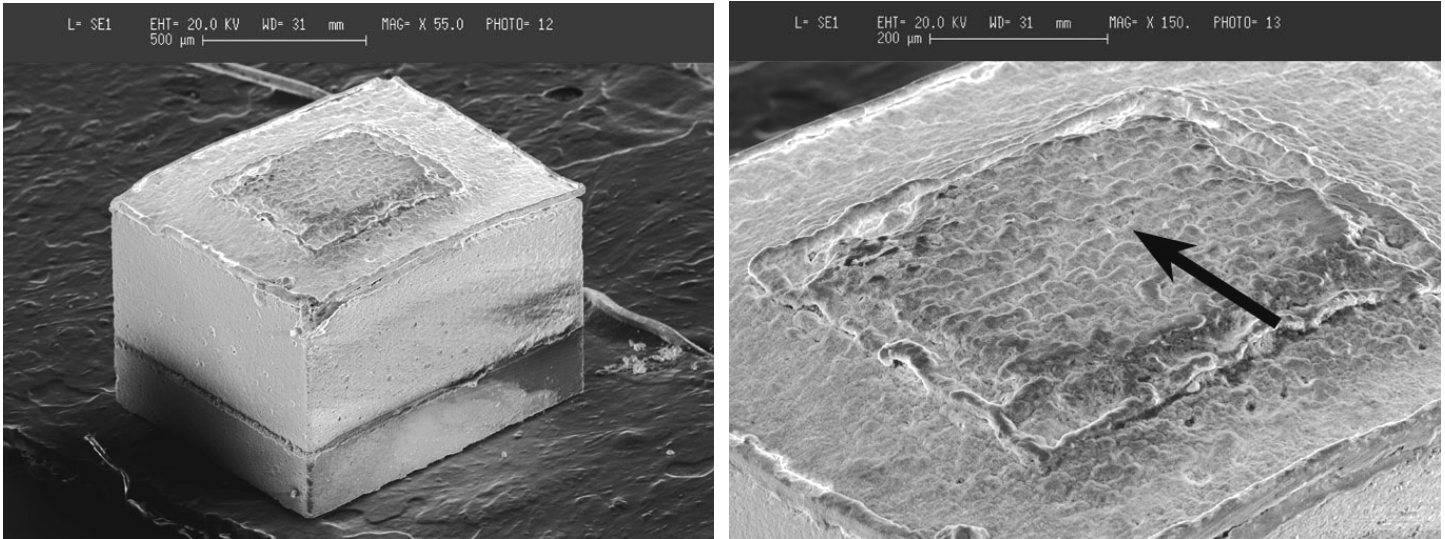
It appears most likely that the cause of intermittent failure of the HM402P10 voltage multiplier observed by the STEREO/IMPACT/SWEA team was the result of a poor wire bond at diode D9 that lifted due to thermal expansion and contraction of the molding material. The wire bond was defective at manufacture, and its subsequent fracture and failure was exacerbated by temperature stress.

Figure 5. SEM views of diode D9 after removal from the assembly. The arrow in the right image points to where the aluminum bond wire was located on the diode.

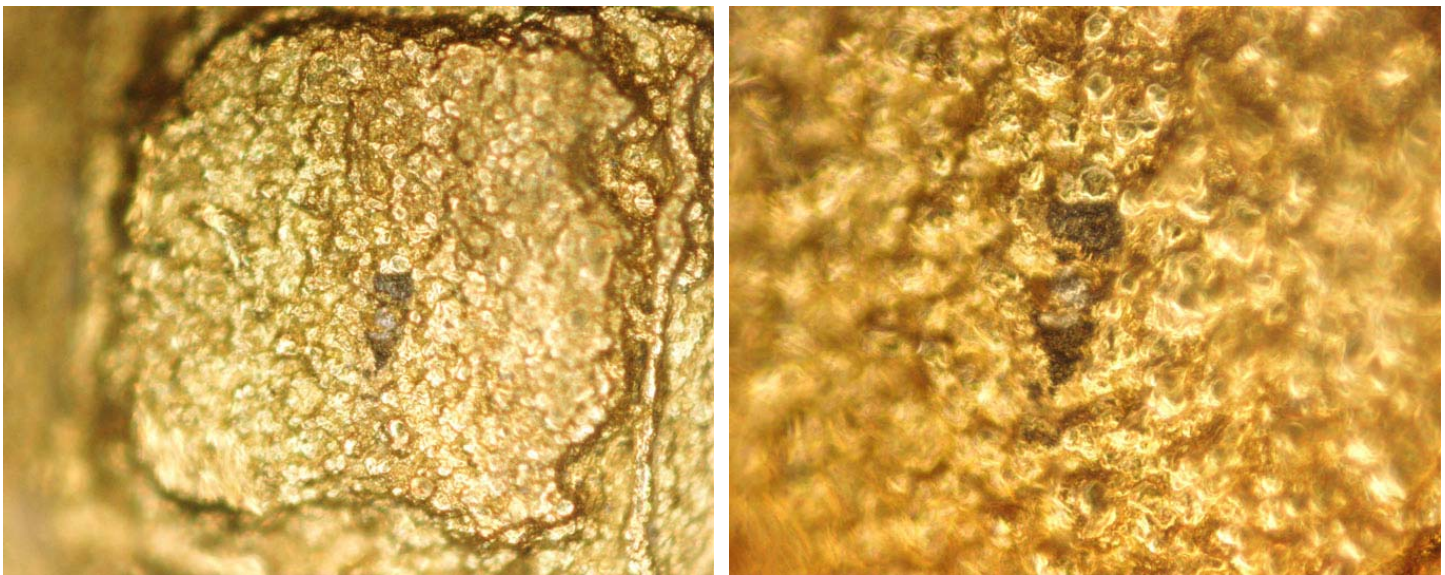
Figure 6. Optical images taken prior to removal of D9 from the assembly show the same area and the remaining wire bond foot-print on the gold plated surface.

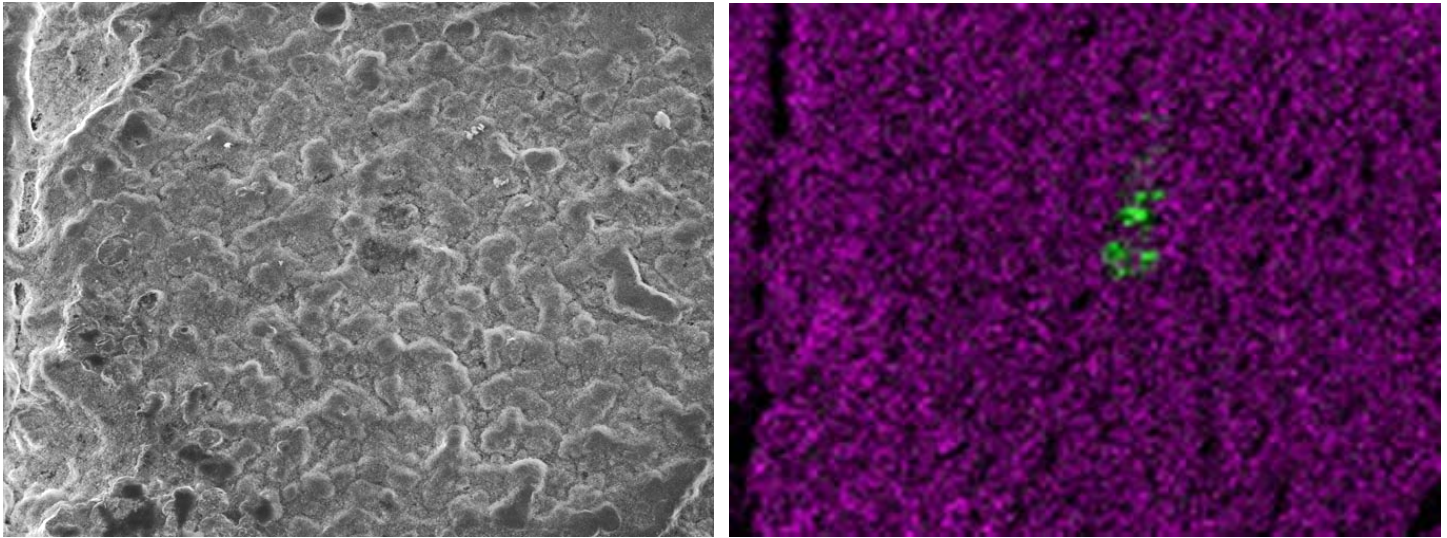
Figure 7. SEM and EDS x-ray dot map images of the diode surface where the aluminum bond wire was attached on D9. In the dot map at right, purple represents the element gold and green represents aluminum.

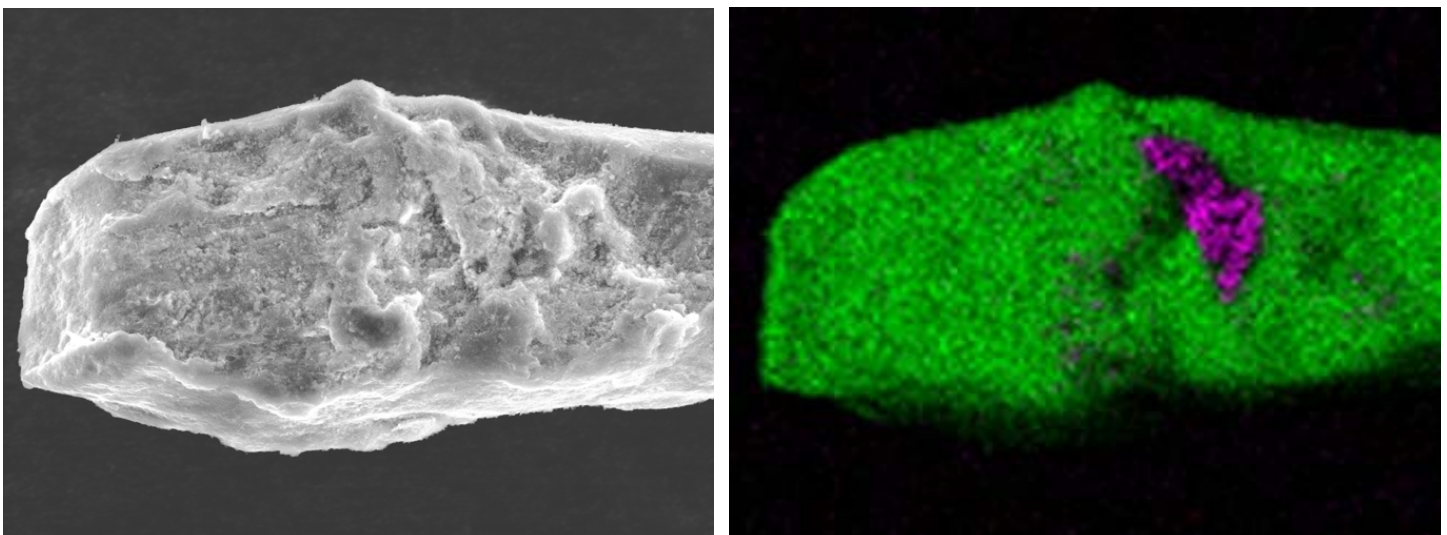
Figure 8. Images of the matching surface of the D9 aluminum bond wire. The surface shows insufficient alloying of aluminum-to-gold and gold-to-aluminum.

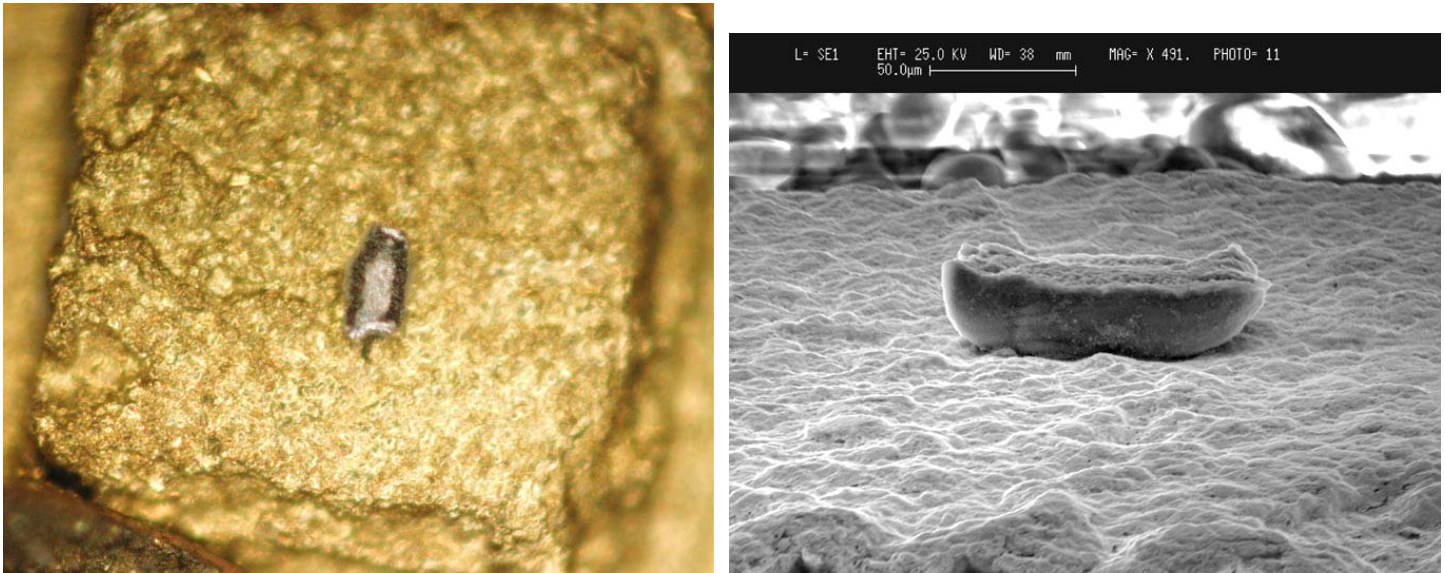
Figure 9. For comparison, optical and SEM images of the wire bond “foot” present on diode D7 are shown above.

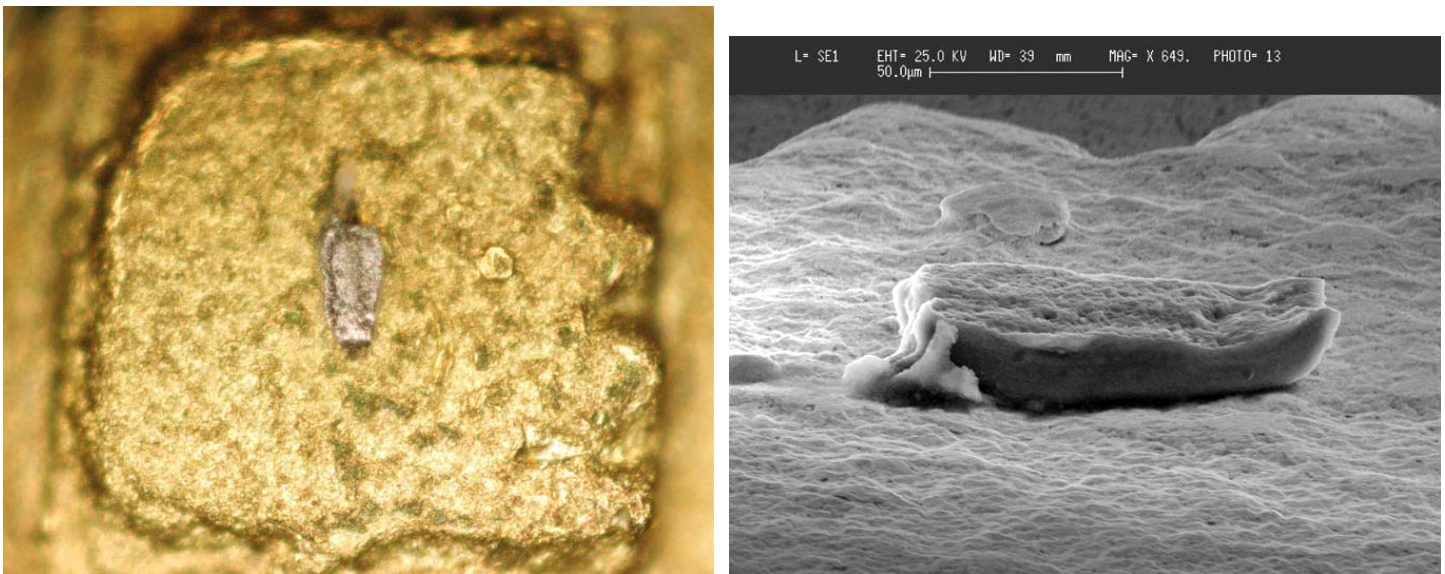
Figure 10. Optical and SEM images of the wire bond “foot” present on diode D8.

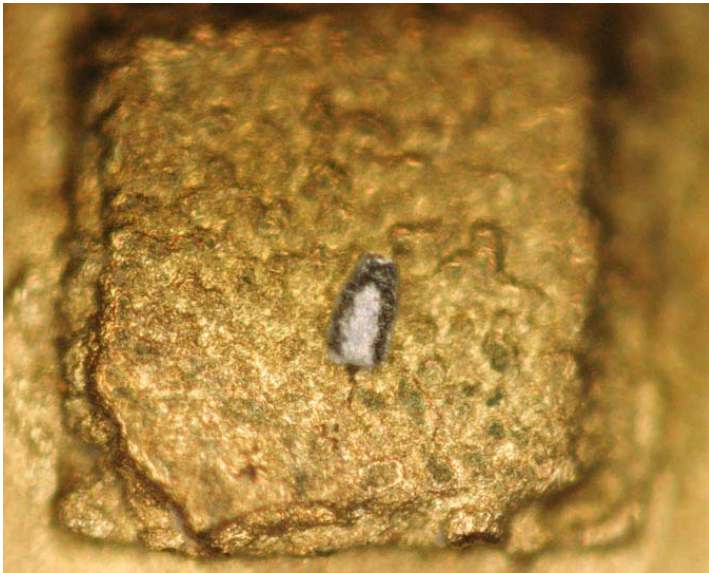
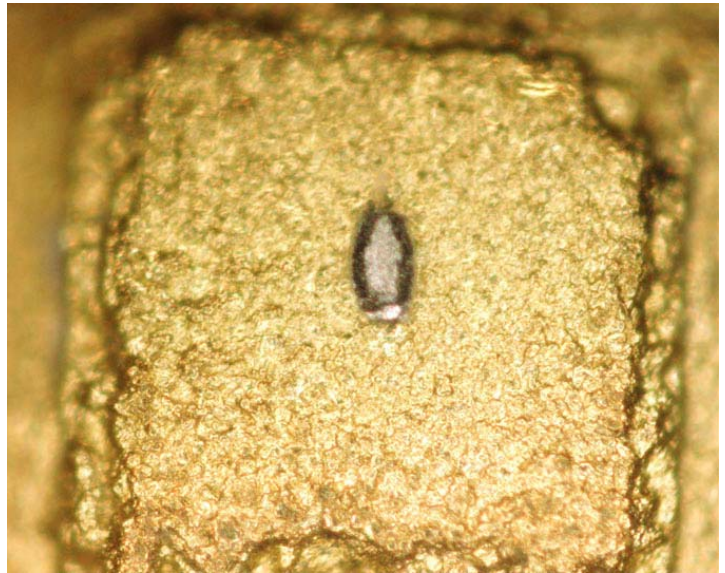
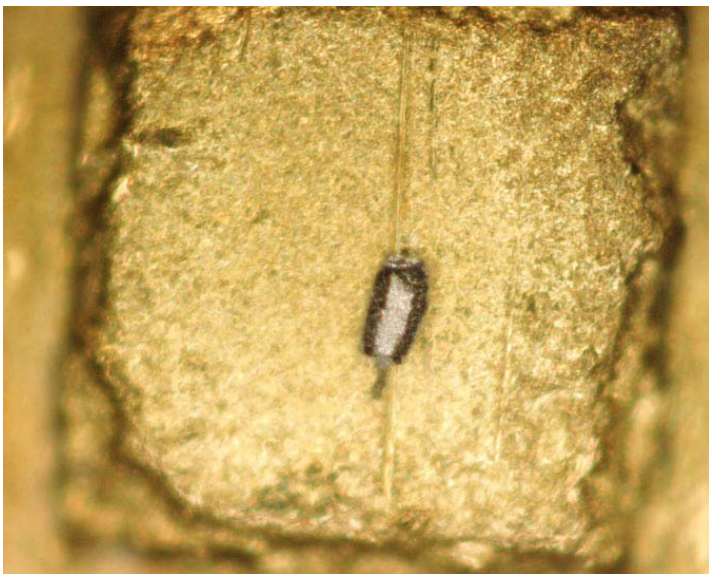
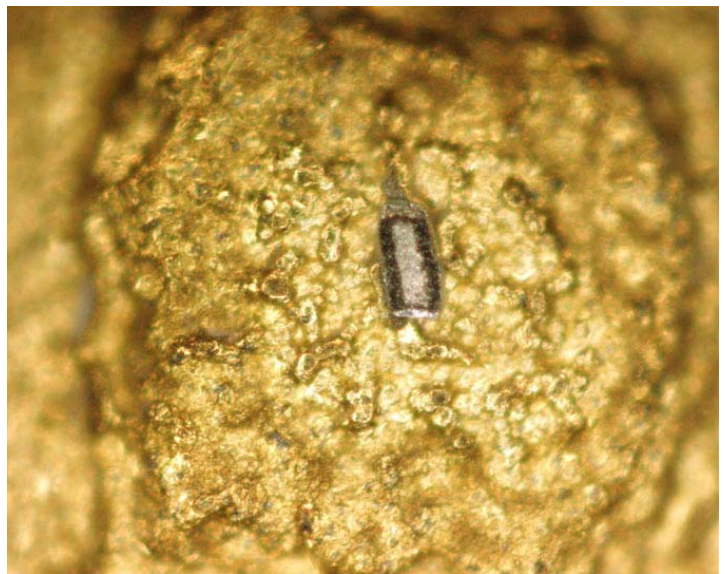
Figure 11. Optical images showing bond “foot” remnants on diodes D3, D4, D5 and D6.

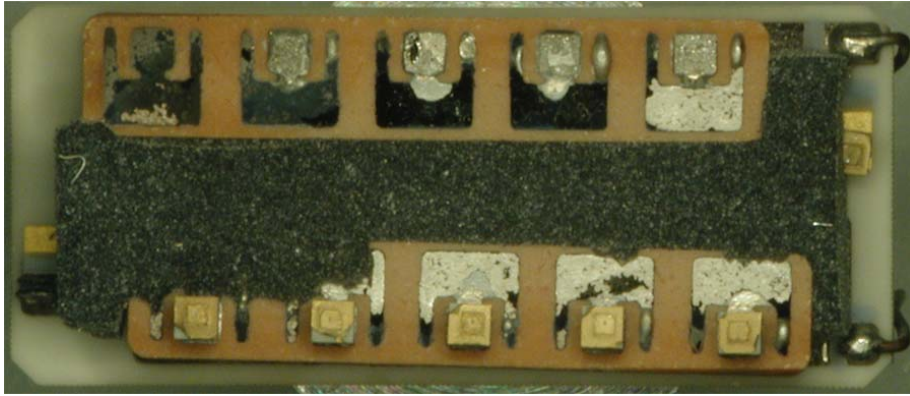
Figures 1 to 3 show internal views of the hybrid and cross-section of the diodes used. X-ray microanalysis indicated that the capacitor pads, which were used also for wire bonding, were plated with silver, thus indicating that aluminum-to-silver wire bonds were used at the bottom of the diodes.

Figure 1 Overall view of the part showing silver plated capacitor pads. Wire bonds connected diodes and silver capacitor metallization.

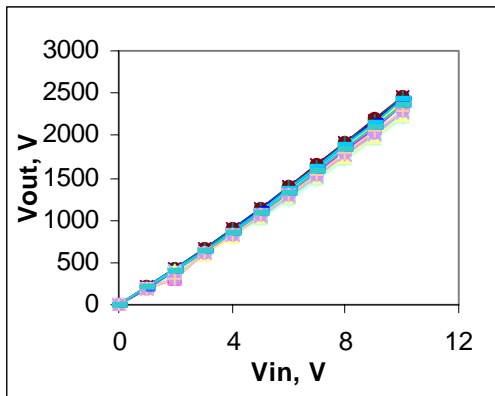
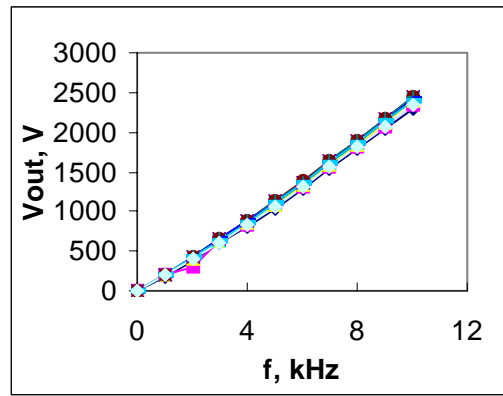
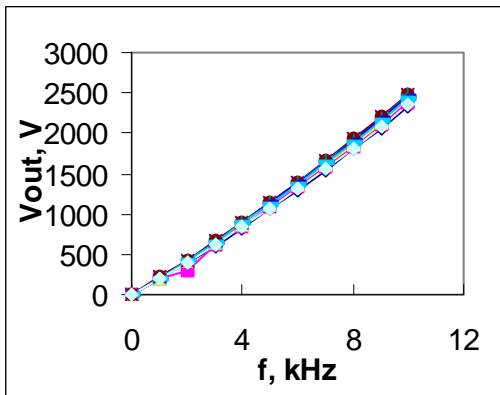
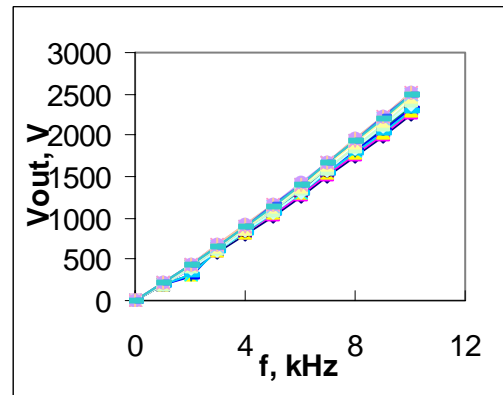
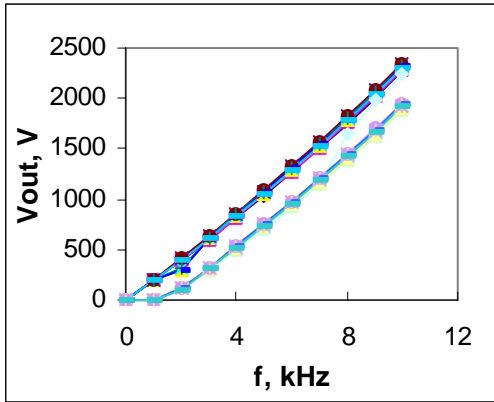
Evolution of the transfer characteristics measured at -55, -40, -20, 0, 20, 40, 60, 80, and 100 during stress testing of the two flight parts are shown in Figure 4. Some degradation of characteristics was observed in SN2 only after HAST. Figure 5 shows an anomaly in the temperature dependence of the output voltage in SN2 after HAST, when the output voltage, which was initially ~400 V below normal recovered after the 80 °C measurement, thus indicating possibly intermittent contact in the part.

Figure 4. Transfer characteristics of the two parts at 100 kHz and temperatures varying from -55 to $+100$ °C.

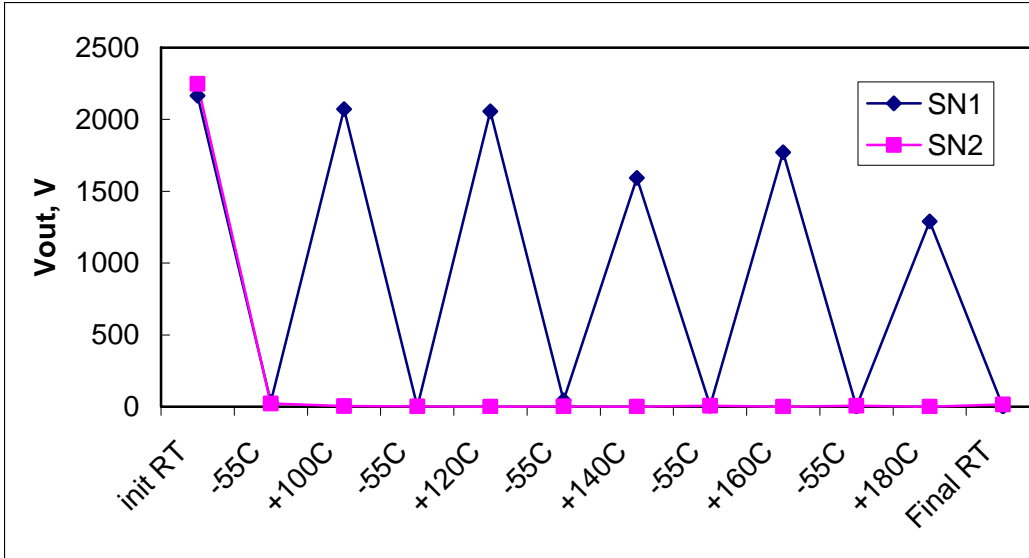
After HAST the parts were baked for 15 hrs at 150 °C to remove moisture from the potting compound and then were subjected to five monitored temperature cycles from -55 to high temperatures, which incrementally increased from 100 to 180 °C in 20 °C increments. Results of these measurements are shown in Figure 6 and indicate a catastrophic failure of SN2 after the first cycle to -55 °C and intermittent failure of SN1 when the output dropped to a few volts each time at -55 °C and then recovered at high temperatures.

Figure 6. Monitored temperature cycle testing of the two flight parts after HAST followed by 15 hrs bake at 150 °C showing a catastrophic failure in SN2 and intermittent failure in SN1.

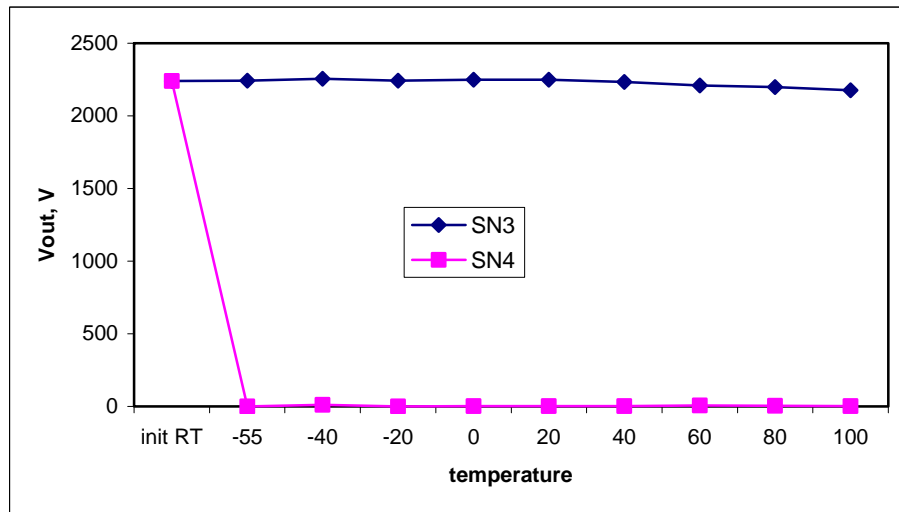
Similar to what was observed on the two flight samples, one part, SN4, failed at the first low temperature measurement after HAST (see Figure 10).

Figure 10. Temperature dependence of V_{out} after HAST for two samples.

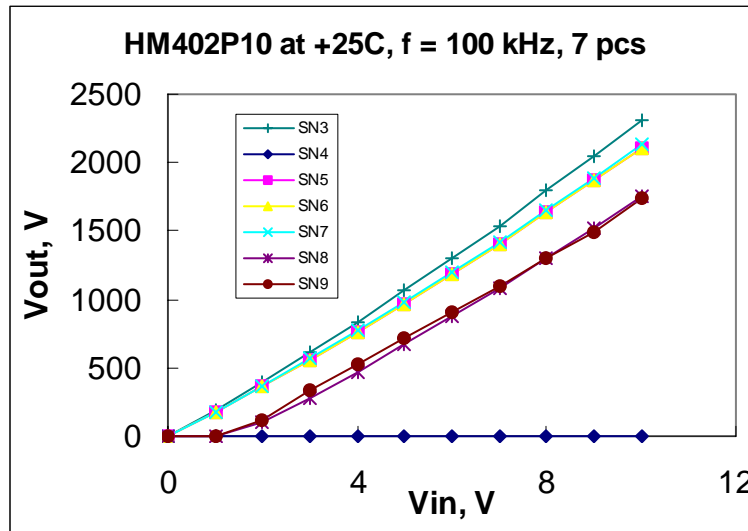
Transfer characteristics for all seven parts measured after 15-hour bake at 150 °C (following HAST) are shown in Figure 11. In addition to SN4, which failed after HAST, two more samples, SN8 and SN9, exhibited degraded characteristics.

Figure 11. Transfer characteristics of the parts after stress testing.

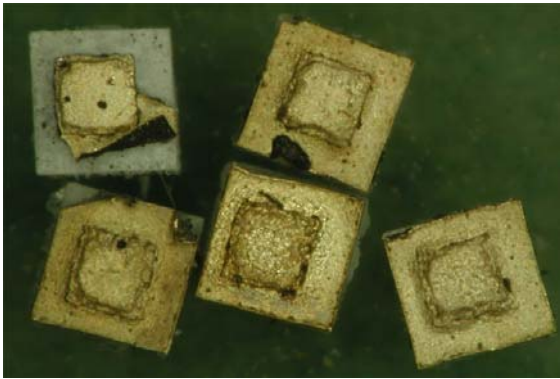
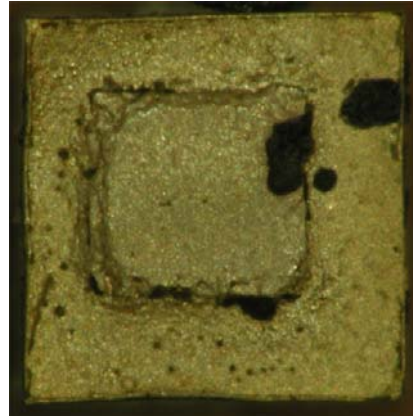
In parts, which had not been stress-tested, the decapsulation revealed remnants of alumina wires still attached to the gold or silver-plated surfaces in most wire bond areas of the assembly. However, most of the diodes in the stress-tested parts had no evidence of wire bonding as shown in Figure 12. This indicates that the performed stress testing degraded the bonds to the point where they could be easily lifted from the surface. Typically, after lifting of the degraded bonds, gold/aluminum intermetallics can be observed. High power optical examination did not reveal similar intermetallics in our case. This is due most likely to a poor initial bonding, which resulted in few microwelding spots only.

Figure 12. Top gold plating on the diodes removed from the failed part, SN2 (a) and from the functional part, SN1 (b) after stress testing.

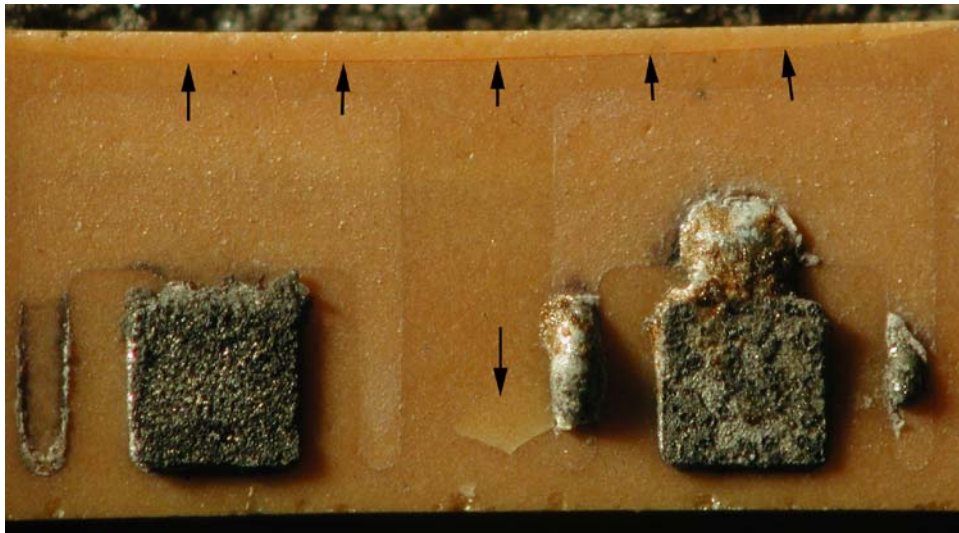
Cracking in the ceramic block used to form capacitors was found in the failed sample, SN2, (see Figure 13). These cracks are most likely not related to the observed failure and could possibly exist in the part before the stress-testing. Note, that no cracks were observed on the failed flight part.

Figure 13. Cracks in ceramic in the failed part, SN2.
