STEREO IMPACT

PROBLEM REPORT

PR-7009

SEPT-NS Bracket

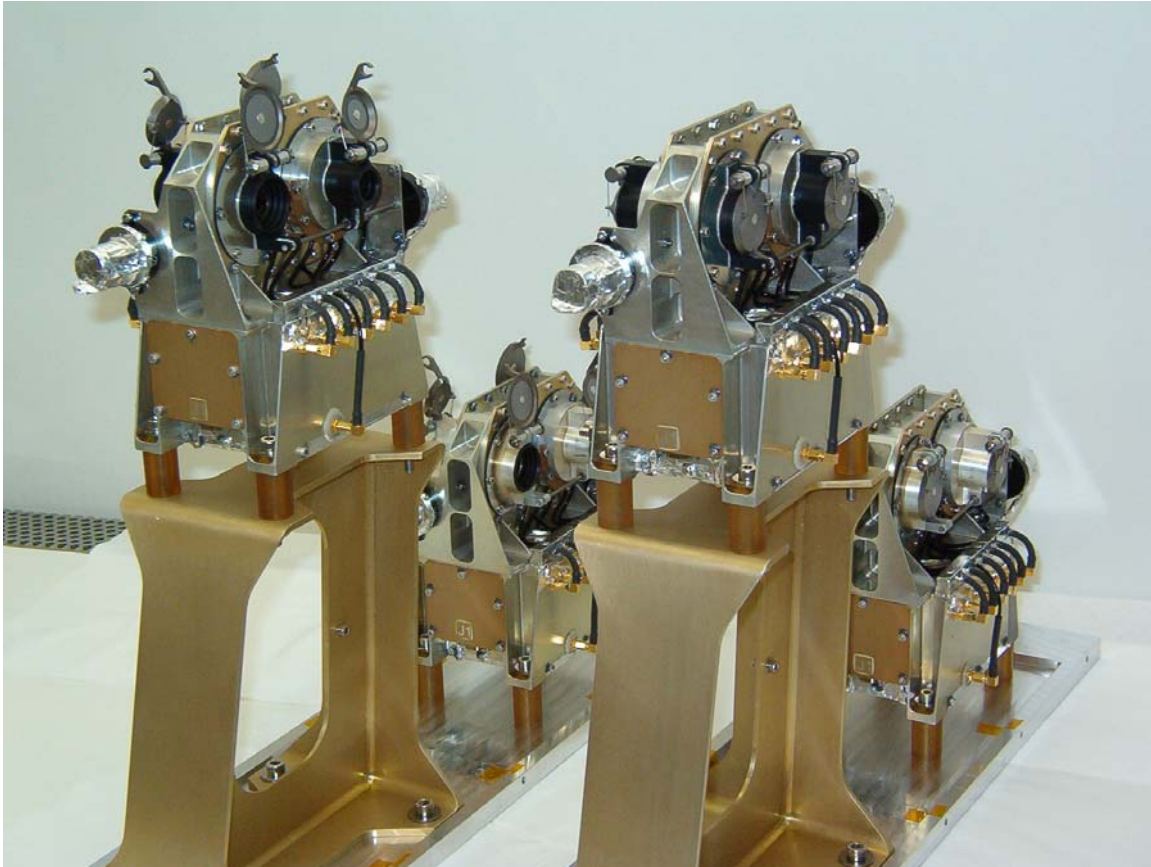
PROBLEM REPORT
PR-7009
SEPT-NS Bracket
2005-7-27

The mounting bolts that mount the SEPT-NS instrument to the bracket have only 0.12" of thread engagement into the tapped bracket. Typically, 1.5D of thread engagement (approximately 0.246") is used.

The flight units were visually examined. The inspection found that less than 1D of thread engagement and slightly fewer than four threads were in the tapped bracket section. At the torque values used, the internal aluminum threads may have been damaged (yielded).

Examined the design to determine whether a #8-32 bolt and lock nut thru a clearance hole could be used in place of the M4 screw and tapped hole. There was room for the holes to be opened up and for nuts on the underside of the bracket.

1. Removed the instrument from the bracket.
2. Opened up the mounting holes in the bracket for a #8 clearance hole (0.18"). Spot iridite finish was applied to the newly drilled-out holes.
3. Replaced the M4 mounting bolt with a #8-32 socket head cap screw (titanium, 1.44" long) and locking nut to mount the instrument.
4. Applied a torque of 16 in-lb to each bolt. The torque applied was ~16 in-lb (plus running torque). This torque applies roughly 700 lb per bolt, well within the capability of the Ultem and high enough to prevent gapping. After blanketing the bolt torques were adjusted for creep due to the Ultem.
