GODDARD SPACE FLIGHT CENTER

Failure Analysis Report

Voltage Multiplier, Hybrid, Positive Output

P/N: HM402P10

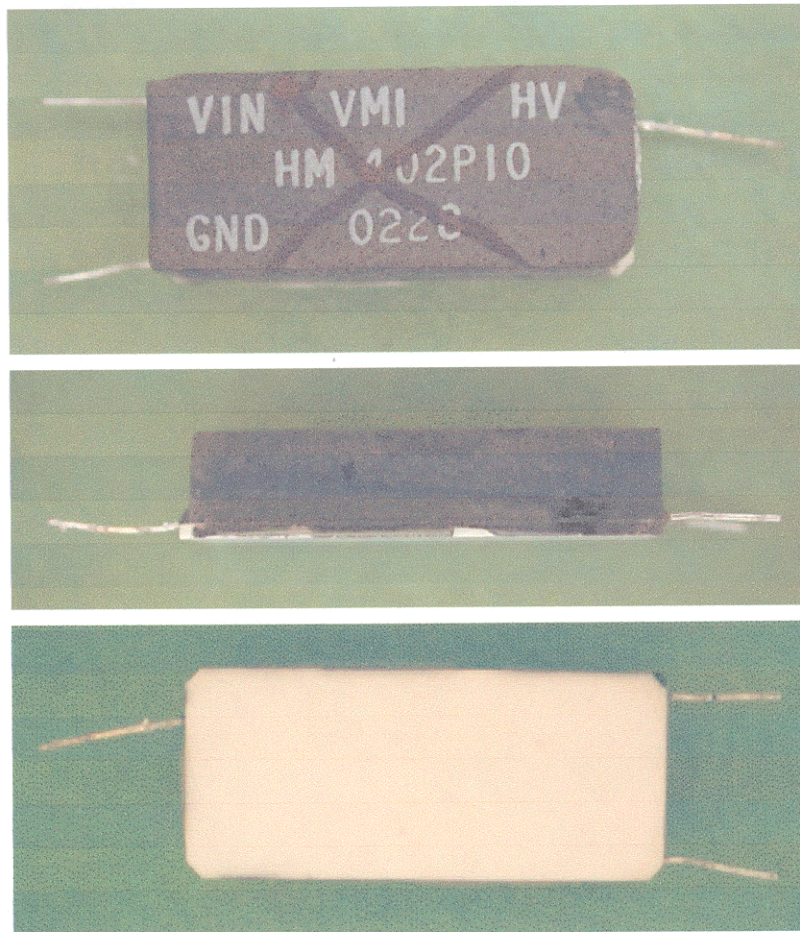
External examination revealed a small round anomaly in the potting material near the VIN lead. This feature was not an artifact or cause of failure. The package had a hand-written "X" marked across the top surface, possibly identifying it as bad. Figures 1 and 2 show external views of the device.

Figure 1. External views of the VMI HM402P10 hybrid voltage multiplier.

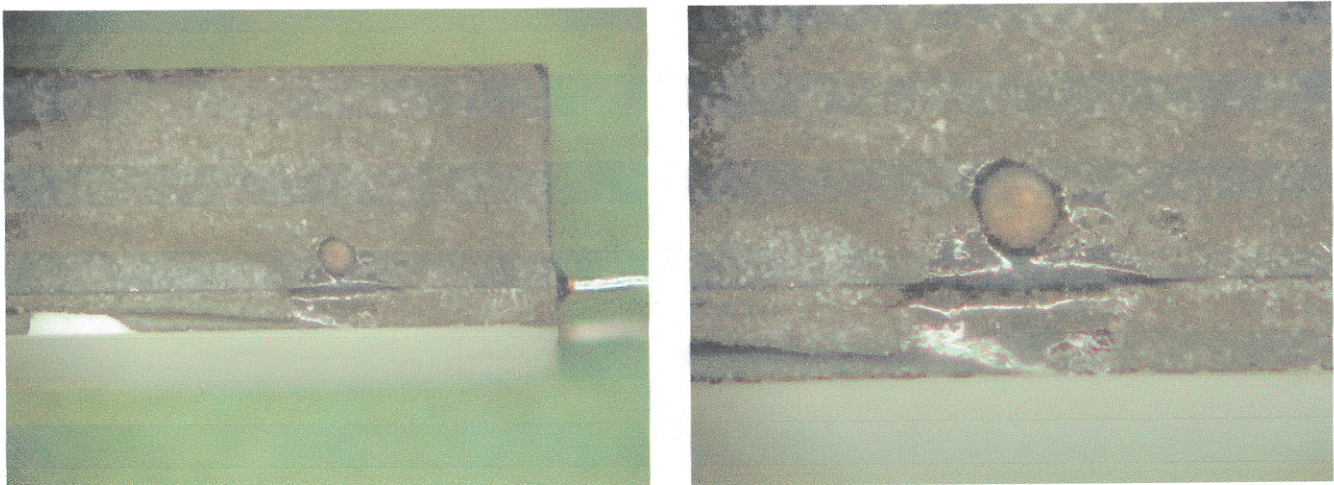
Figure 2. Anomaly in the potting material near the VIN lead.

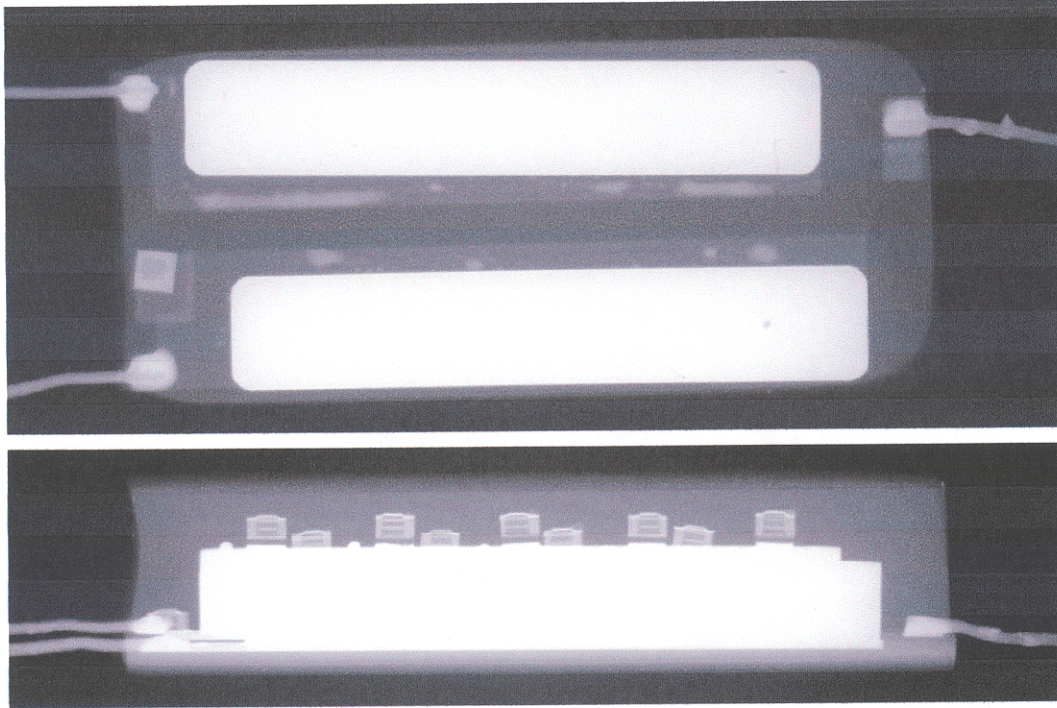
Radiographic inspection revealed no anomalies but did reveal many construction features previously described. As expected, the aluminum interconnect wires were not visible in radiographic inspection. Figure 3 shows top and side view radiographic images of the device.

Figure 3. Radiographic images of the HM402P10 device. The large rectangular white objects are two monolithic segmented ceramic capacitors. Nine discrete surface mount diodes are mounted on the capacitors and one is mounted on the substrate near the GND lead.

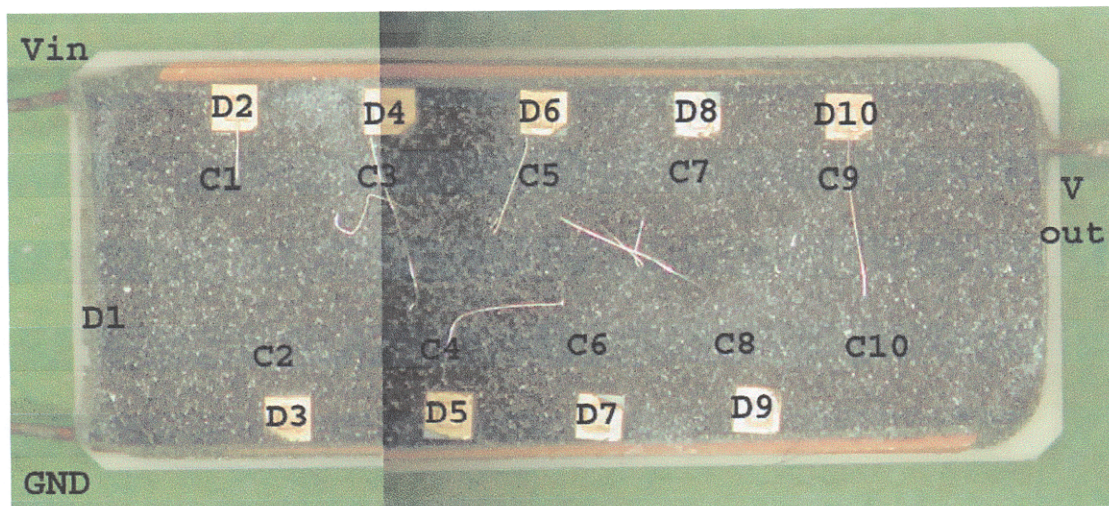
The potting material was removed until the tops of the diodes were visible. At this point, compressed air necessary to remove the ash inadvertently broke several wires bonded to the diodes. Figure 4 shows the device at this stage of deprocessing.

Figure 4. This view shows the device at an intermediate deprocessing stage. The tops of the diodes are revealed (except D1). The aluminum bond wires were inadvertently broken due to the blow-off process necessary for residue removal after oxygen plasma ashing.

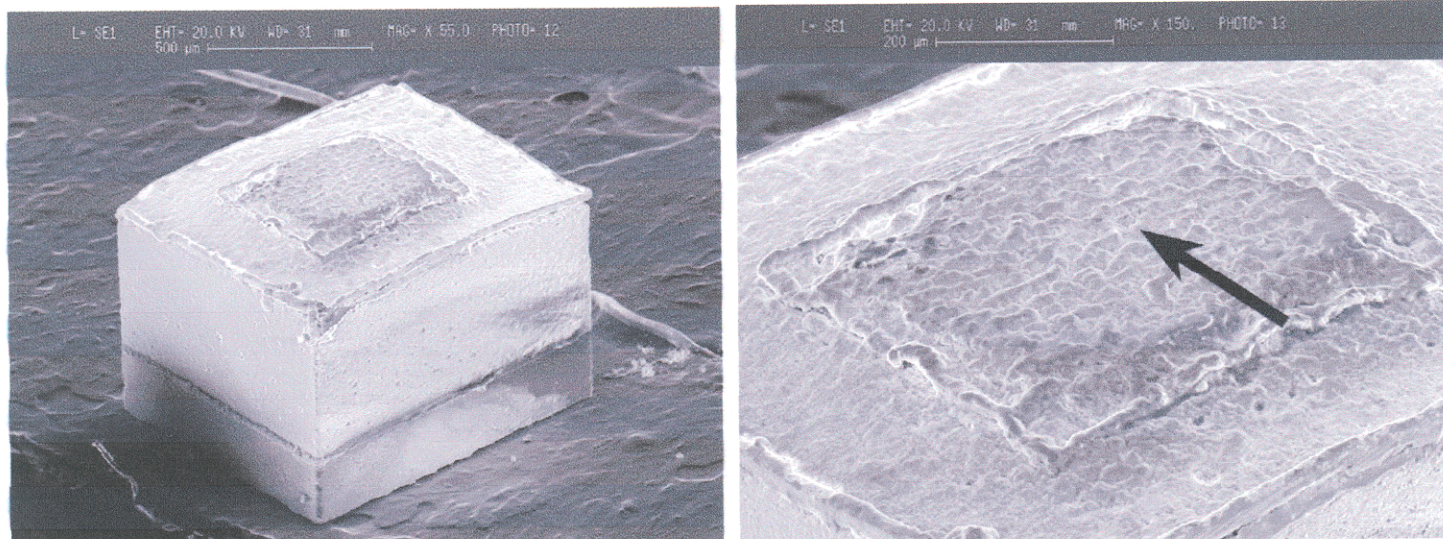
Importantly, optical inspection showed that the aluminum bond wire at diode D9 had lifted from the bonding surface instead of breaking at the neck-down region, as expected for adequately-bonded wires. Figures 5 and 6 show these results. The wire and diode were examined using energy dispersive spectroscopy (EDS). **This technique revealed very little alloying of the aluminum and gold, indicating that a poor bond existed at this location.** Figures 7 and 8 show the x-ray dot maps of gold and aluminum for these interface surfaces.

It appears most likely that the cause of intermittent failure of the HM402P10 voltage multiplier observed by the STEREO/IMPACT/SWEA team **was the result of a poor wire bond at diode D9 that lifted due to thermal expansion and contraction of the molding material.** The wire bond was defective at manufacture, and its subsequent fracture and failure was exacerbated by temperature stress.

Figure 5. SEM views of diode D9 after removal from the assembly. The arrow in the right image points to where the aluminum bond wire was located on the diode.

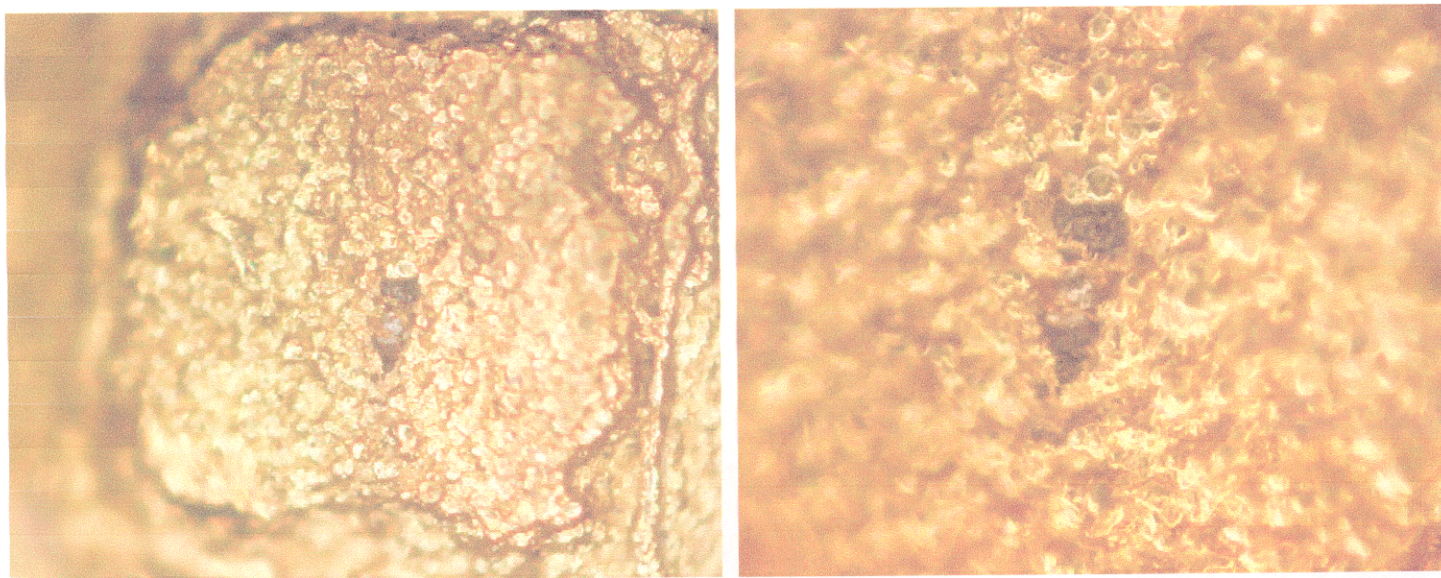
Figure 6. Optical images taken prior to removal of D9 from the assembly show the same area and the remaining wire bond foot-print on the gold plated surface.

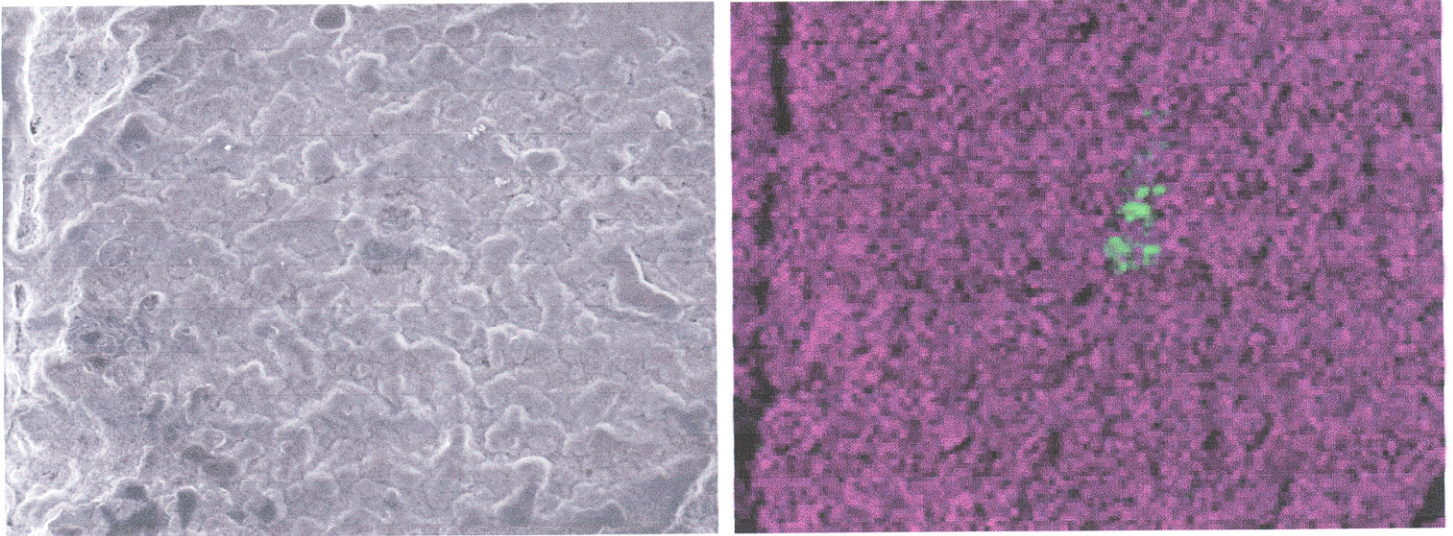
Figure 7. SEM and EDS x-ray dot map images of the diode surface where the aluminum bond wire was attached on D9. In the dot map at right, purple represents the element gold and green represents aluminum.

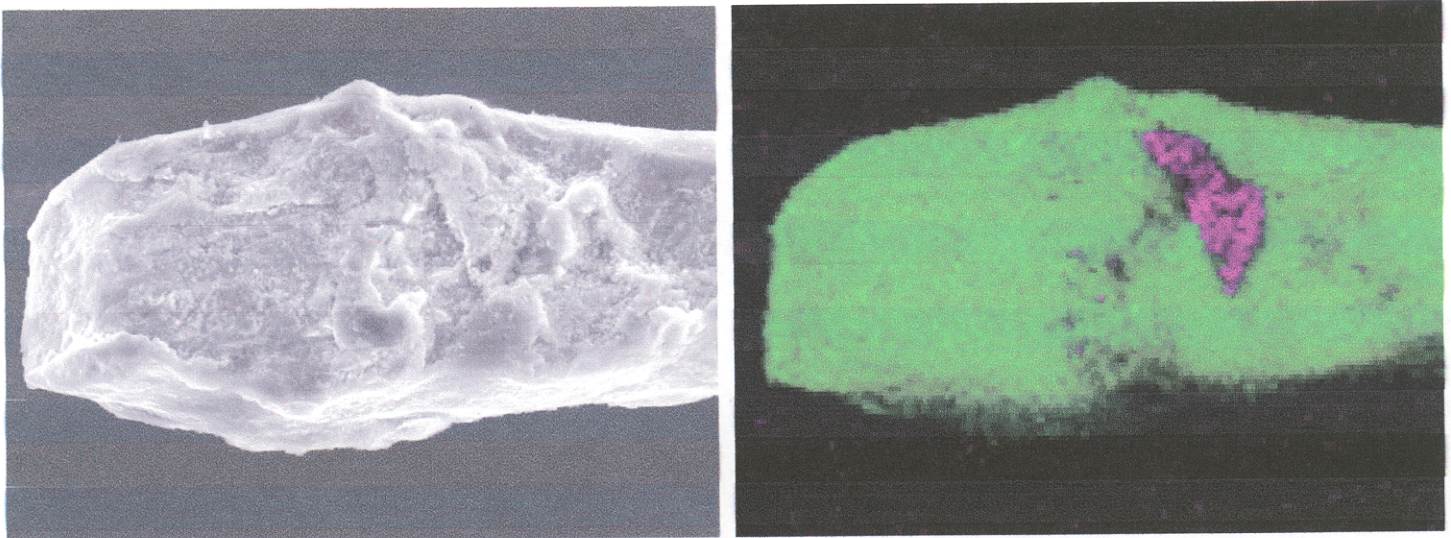
Figure 8. Images of the matching surface of the D9 aluminum bond wire. The surface shows insufficient alloying of aluminum-to-gold and gold-to-aluminum.

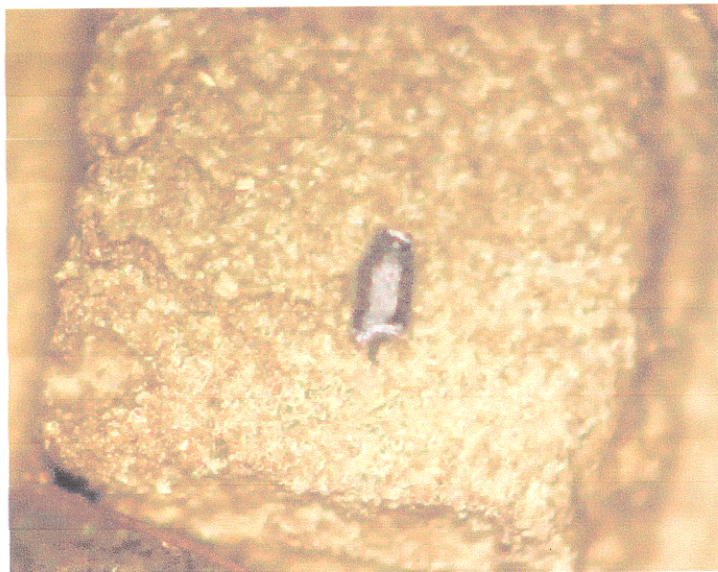
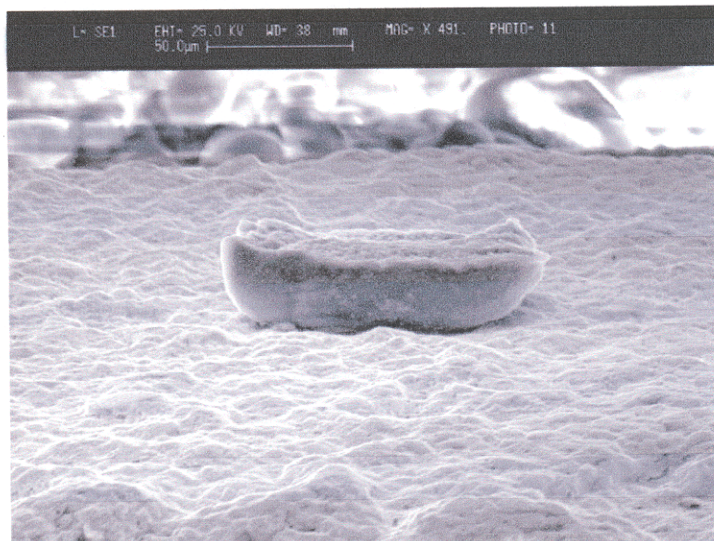
As previously mentioned, all the other wires that broke during deprocessing broke at the wire neck-down and left a bond wire "foot" present at the diode. Figures 9 through 11 show several examples of this expected result.

Figure 9. For comparison, optical and SEM images of the wire bond “foot” present on diode D7 are shown above.

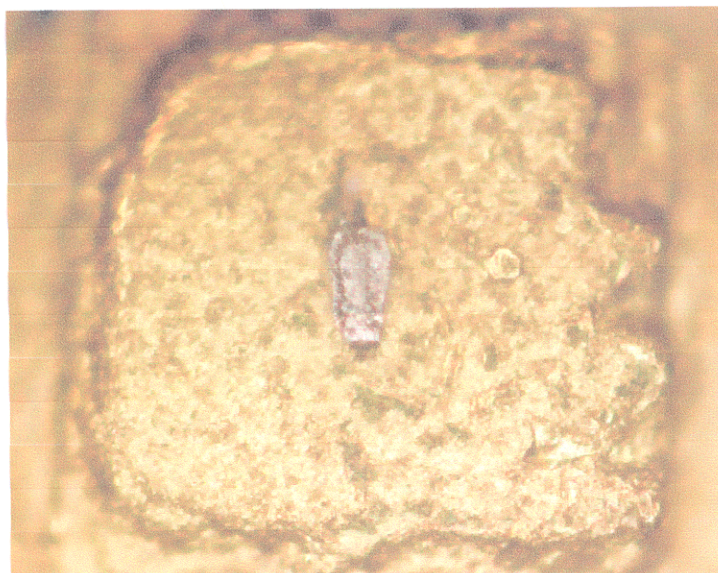
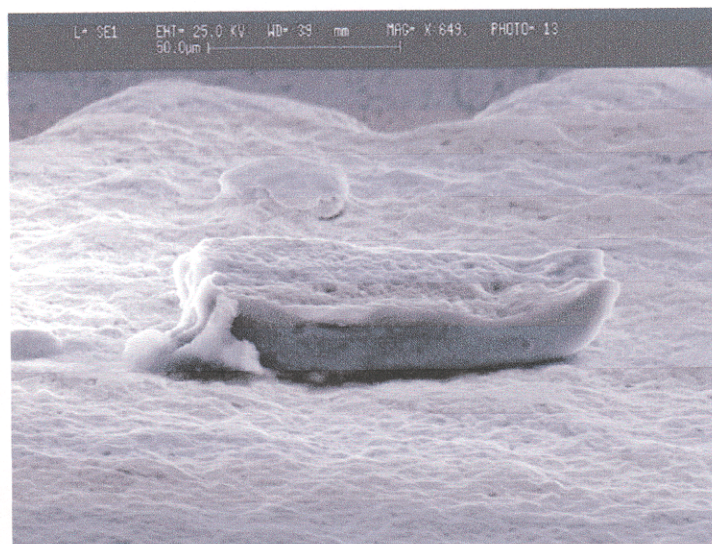
Figure 10. Optical and SEM images of the wire bond “foot” present on diode D8.

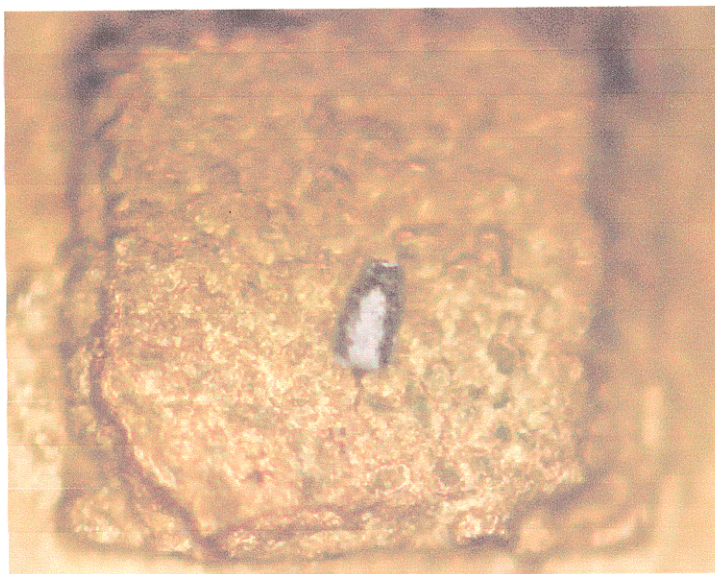
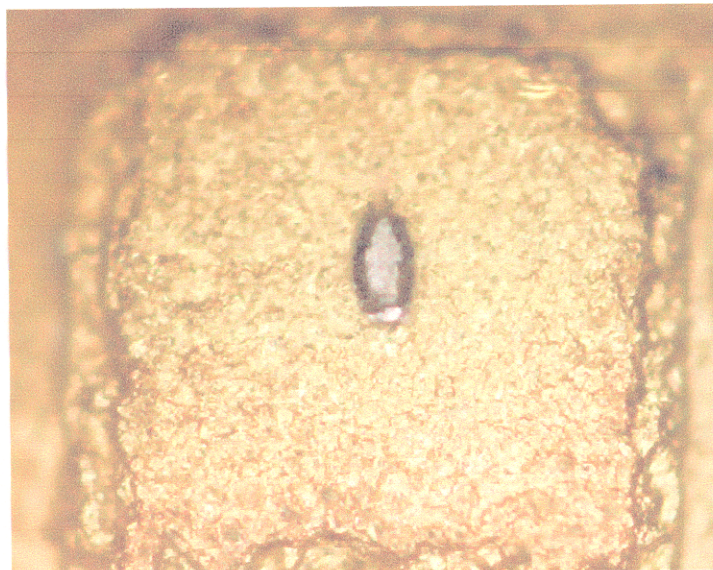
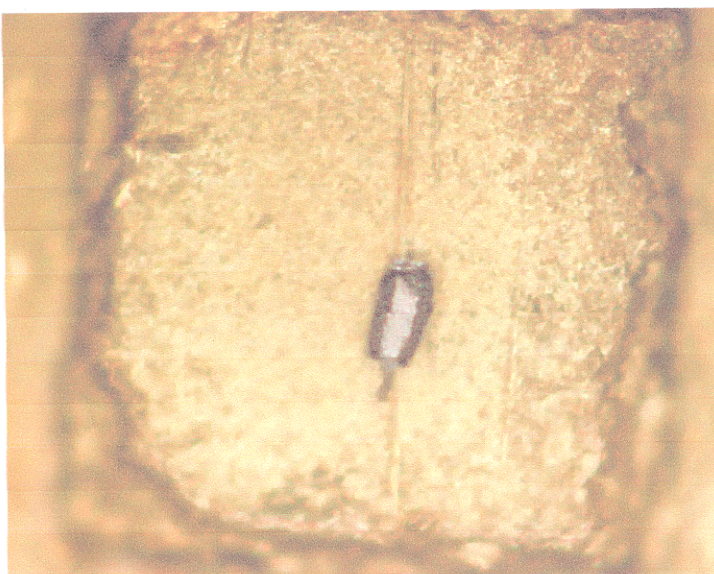
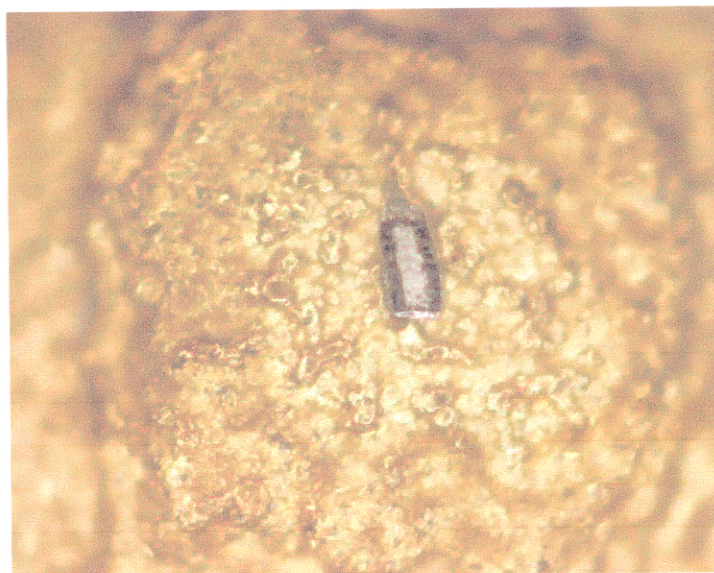
D3
D4

Figure 11. Optical images showing bond “foot” remnants on diodes D3, D4, D5 and D6.
