# **SEPT Thermal Vacuum Test Report Preliminary**

**Doc. No.: STEREO-ETKI-012**

**March 2004**

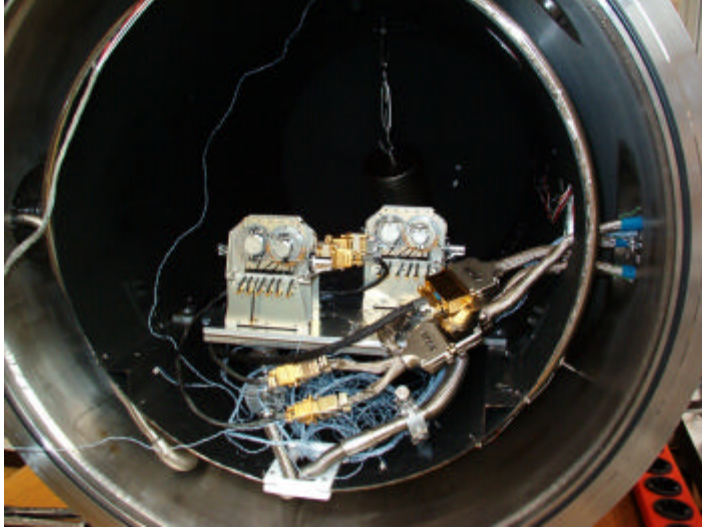
Figure 2: Configuration of the FM1 units (left: SEPT-NS rear view, right: SEPT-E front view)

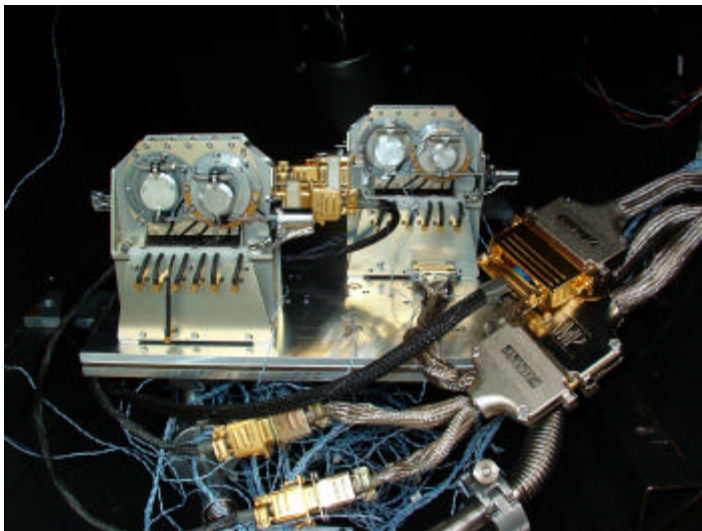
Figure 3: Note locations of the SEPT-E sensor thermocouple TC1 outside the detector housing and the cold plate thermocouple TC6 between SEPT-E and -NS.

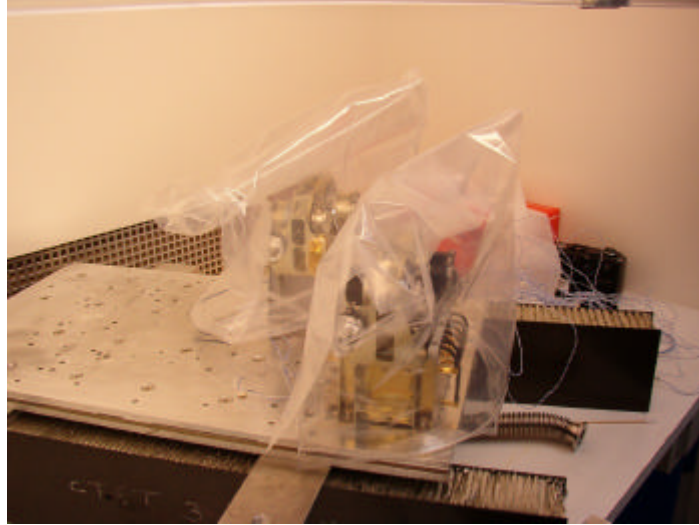
Figure 4: FM1 on cold plate with protection bag during transfer
