# STEREO IMPACT Technical Progress Report

Subject: IMPACT Monthly Technical Progress Report, Contract NAS5-00133

Enclosed is the monthly technical progress report for the STEREO IMPACT project for the month of July 2004.

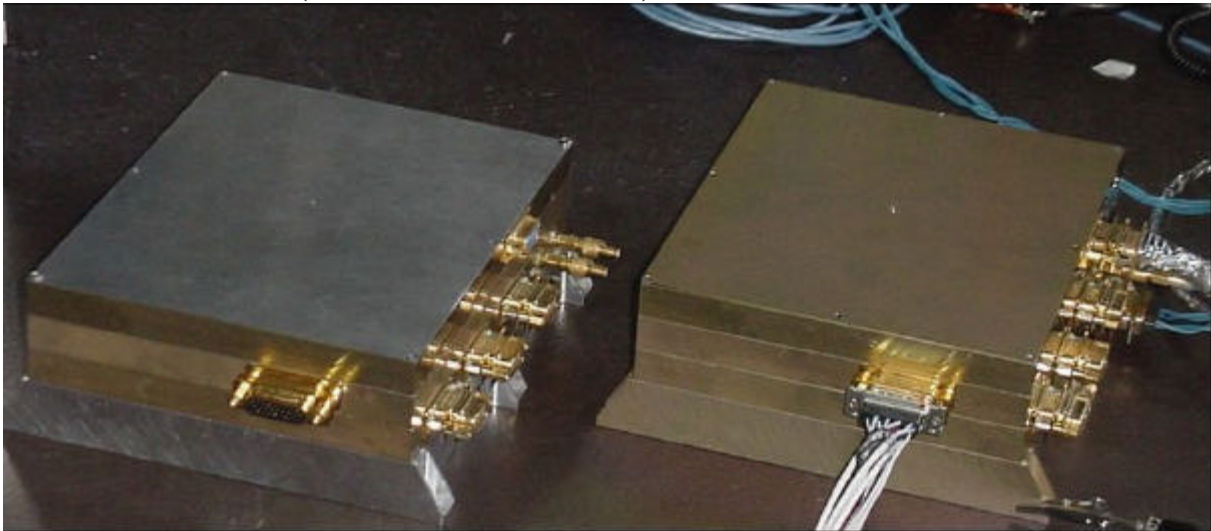
### **FM1 and FM2 IDPU (FM2 has the ETU LVPS).**

- FM1 IDPU complete, FM2 waiting for its power supply
  - LTC1877 parts still need to be replaced in both power supplies
  - FM1 DCB Actel has been replaced with one programmed with the new algorithm; FM2 still needs that done
