IMPACT Boom (Stowed)

IMPACT FM1 SWEA/STE-D

IMPACT FM1 STE-U

IMPACT FM1 BOOM

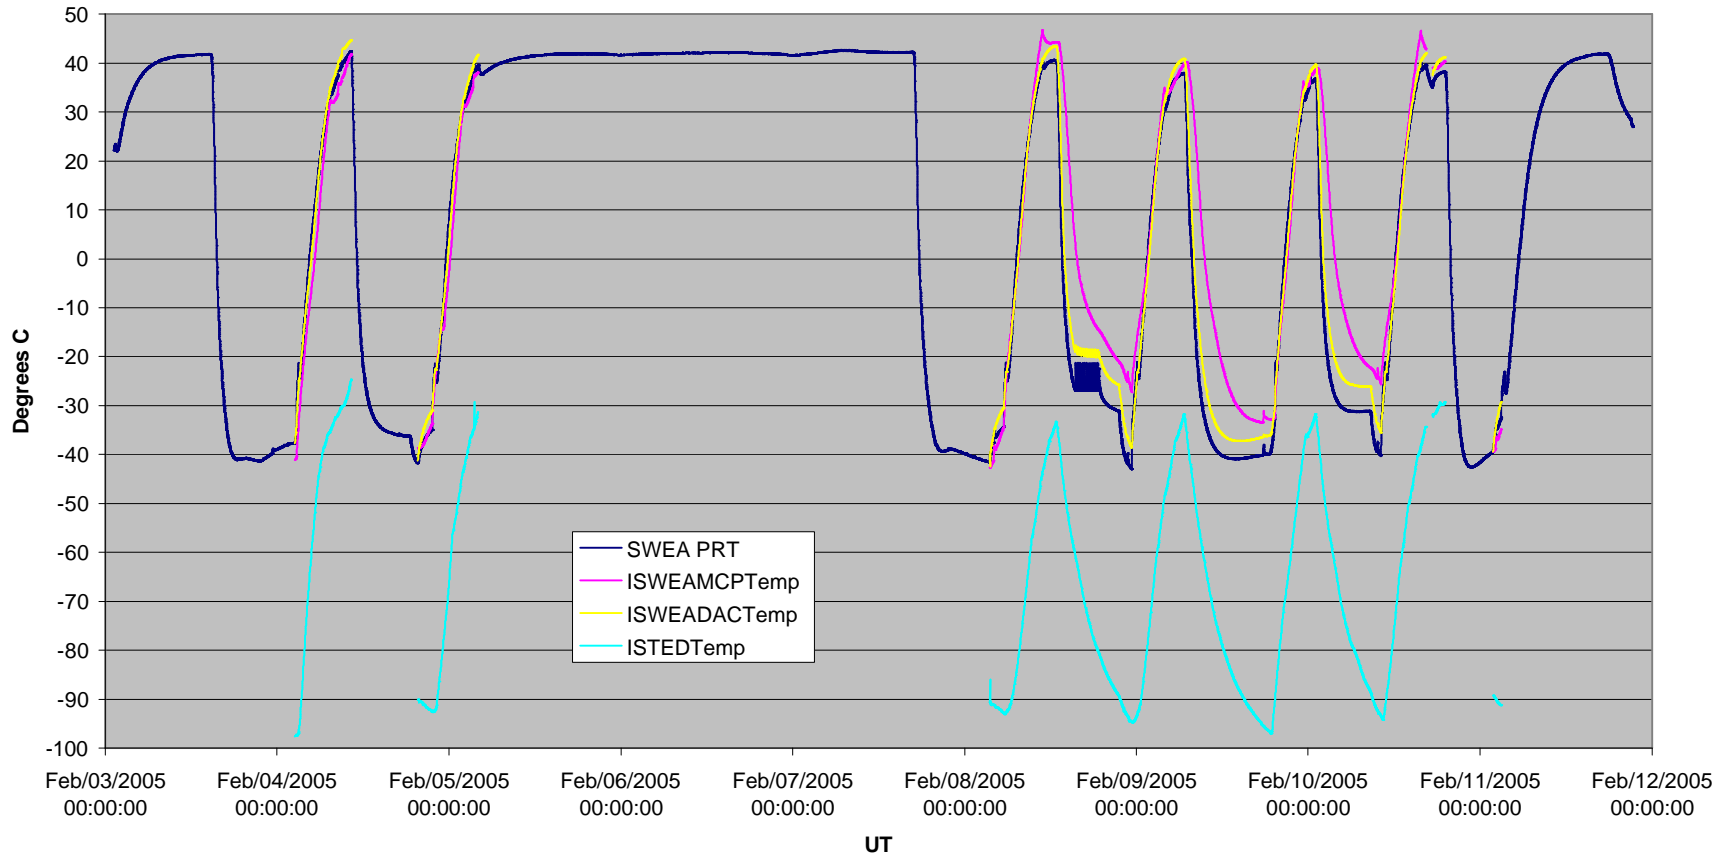
STEREO IMPACT FM1 SWEA/STE-D Thermal Vac

- **There were no problems encountered**
- **Temperatures were controlled with Thermocouples attached to the outside of the instrument**
 - **Internal temperature sensors ran ~10C warmer than the outside when SWEA/STE-D was operational**
 - **STE-D temperature set using internal temperature sensor**
- **No significant trends or adverse temperature dependencies were seen**

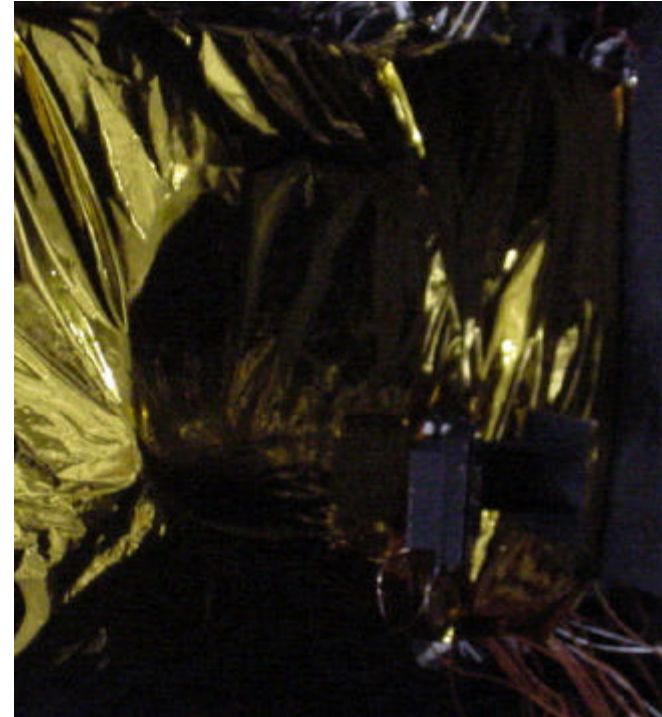
FM1 STE-U Thermal Balance Test

- **Thermal Balance at UCB**
 - STE-U mounted to baseplate to simulate boom mounting, Shrouds run cold
 - ETU Thermal Blankets provided by APL
- **Test passed**
 - Good correlation to thermal model
 - No problems

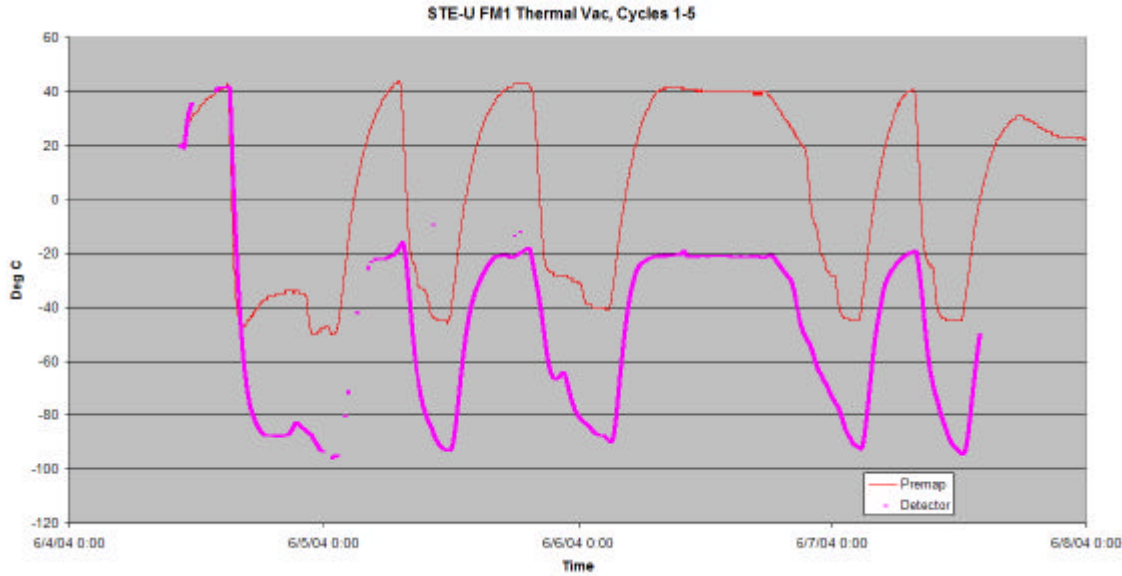
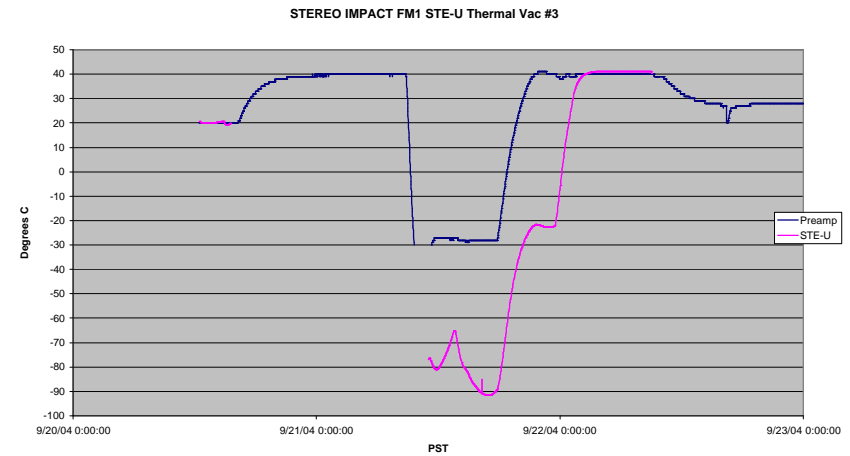
FM1 STE-U Thermal Vac

- **During pre-test checkout it was found that the chamber feed-through was mis-wired (PFR1006)**
 - Potentially stresses parts replaced
- **During first cold soak, STE-U door failed (PFR1008)**
 - Part out of tolerance; repaired, restart tvac
- **Occasional noise observed on STE-U detectors when warm**
 - Correlated with chamber operations
 - Caused by preamp oscillation, exacerbated by chamber noise, long thermal vac harness
 - Break chamber and fix preamp compensation between cycles 5 & 6
 - No problem in final cycles
- **No significant trends or adverse temperature dependencies were seen**

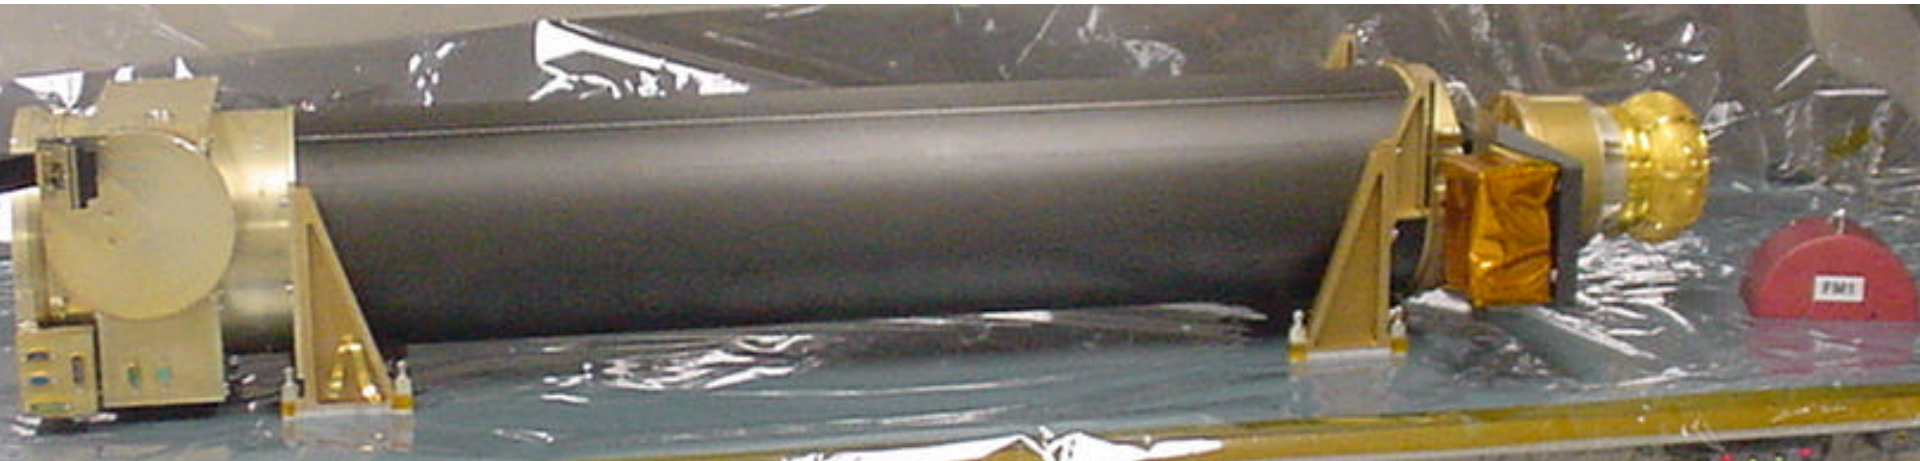
- **09 Jan 2004 Assembly Begins.**
- **14 Jun 2004 Assembly Completed.**
- **June 2004 Magnetometer and STE-U Installed.**
- **28 Jun 2004 Vibration Test. Completed. Loose Pin found (PFR-1010)**
- **30 Jun 2004 STE-U Uninstalled.**
- **1-16 Jul 2004 Thermal Vacuum Test. Completed.**
- **16 Jul 2004 Bakeout Qualification. Completed.**
- **Oct 2004 STE-U Installed.**
- **18 Oct 2004 – 1 Nov 2004**
 - **EMC test with the full IMPACT Suite. Completed.**
- **EMC test exceedances have been accepted by the EMC committee; the official waiver is in process.**
- **03 Mar 2005 SWEA Harness Failure (PFR-1038).**
- **17 Mar 2005 SWEA Final Integration. Boom Complete.**

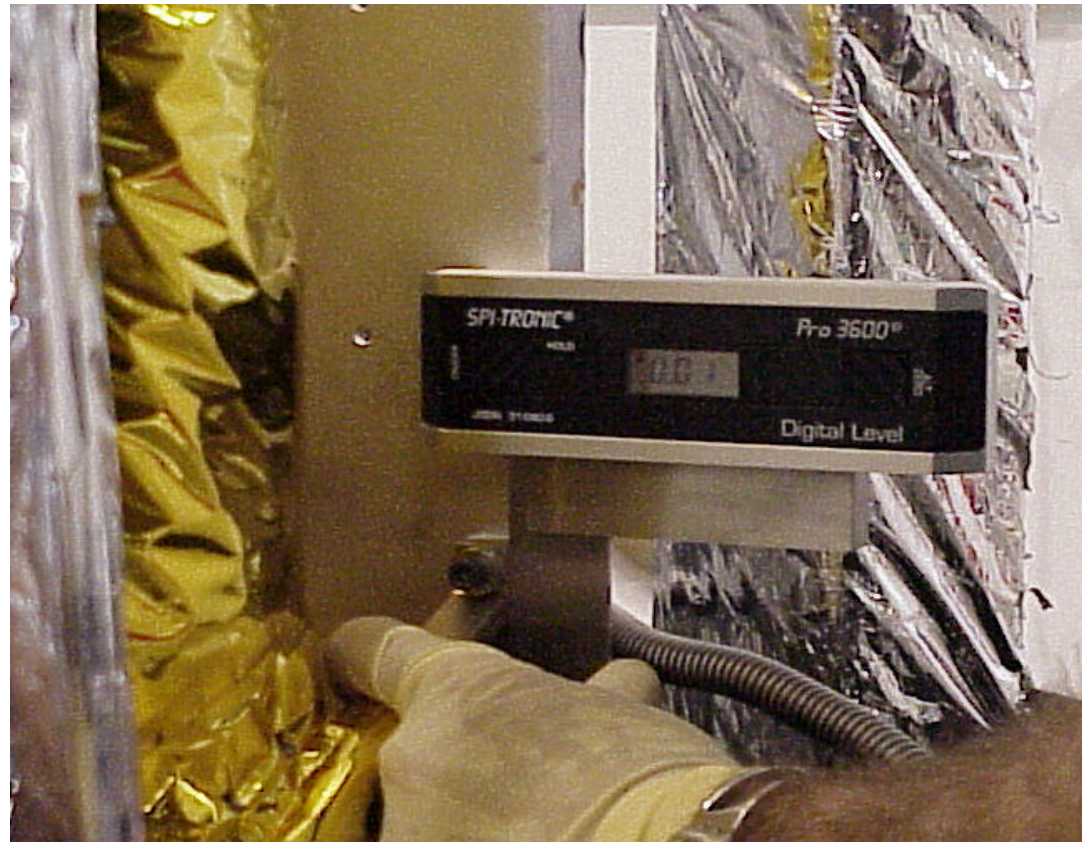
Boom Alignment Test

- Alignment
 - Alignment was verified on Flight Model Booms after each deployment using a digital inclinometer with resolution of 0.01 degree
 - Requirement: 52.5 arcmin
 - FM1 maximum: 11.8 arcmin

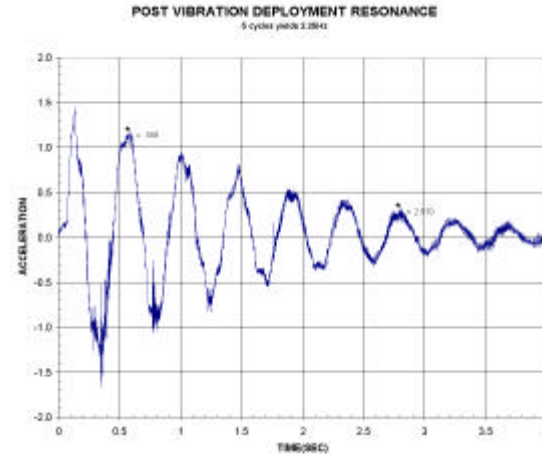
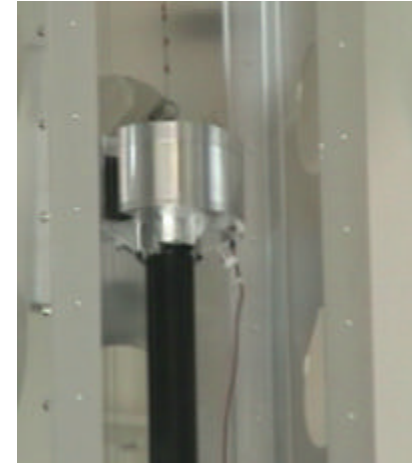
Boom Stiffness Test

- **Stiffness**
 - Stiffness was verified for each Flight Model Boom.
 - Requirement: > 0.5 Hz and not coincident with another device (i.e., solar cells, SWAVES antennas)
 - **Fundamental Frequency: ~1.9 Hertz**

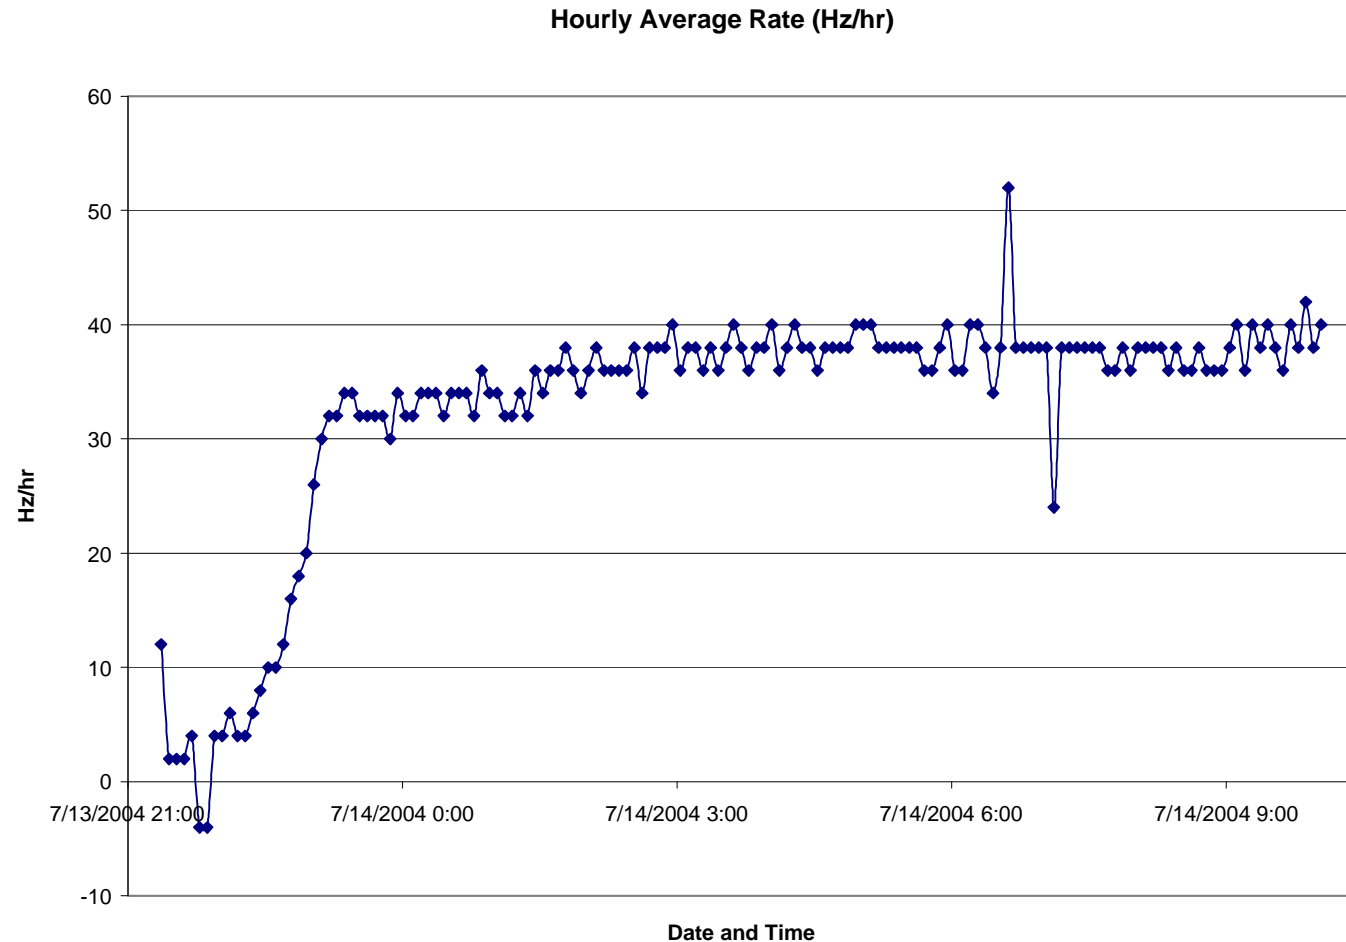
Boom Qualification Bake-out Test

TQCM data taken for 8
consecutive hours
with the chamber at
40C and the TQCM at -
20C
Final Rate: 40 Hz/hr

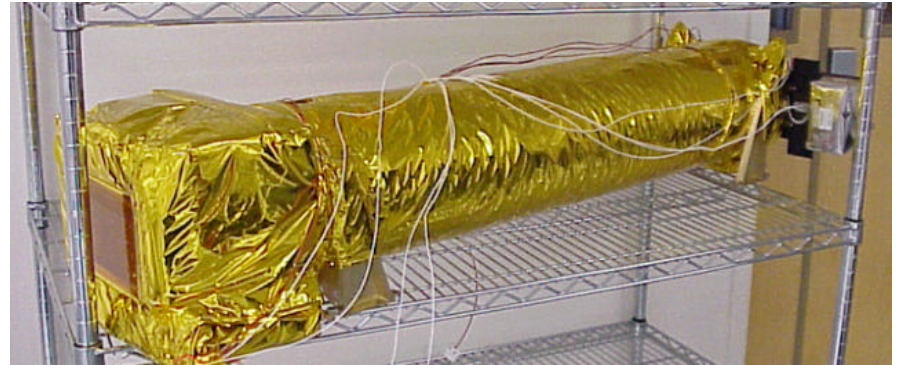
Other Boom Environmental Tests

- **Thermal Balance**
 - Thermal balance was completed for Protoflight and was not repeated for the Flight Models (Waiver submitted)
- **EMC with the suite**
 - Described in SWEA section
- **Acoustic Testing**
 - No foils or other acoustic sensitivities
 - Built into the vibration spec (APL 9003)
