# IMPACT Protoflight Boom Test Results Meeting

Protoflight Boom Test Results Meeting  
August 21, 2003

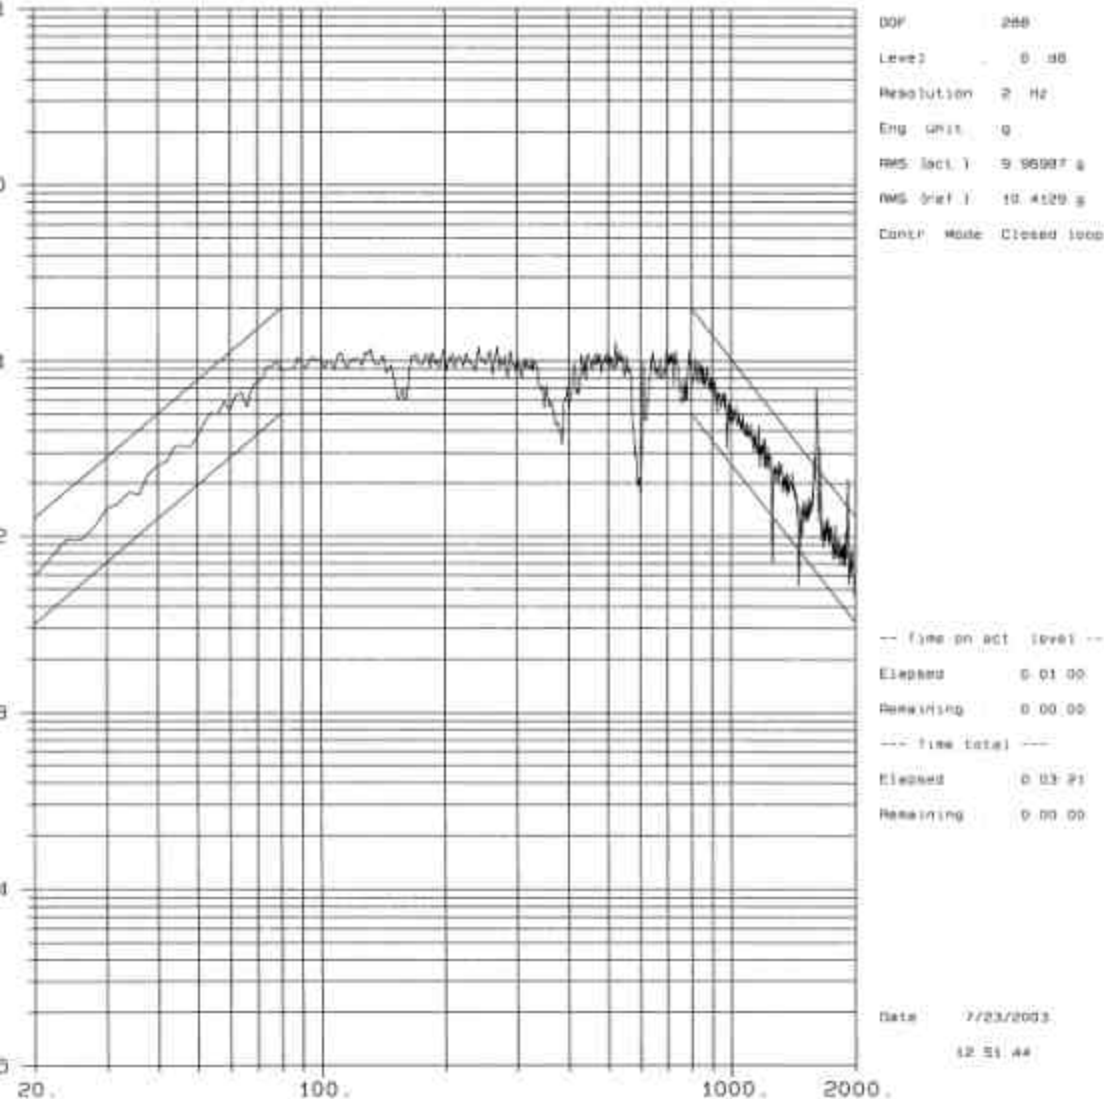
**Y AXIS 0dB RANDOM**

**AVG. OF C1&C2**

**FORCE LIMITED INPUT**

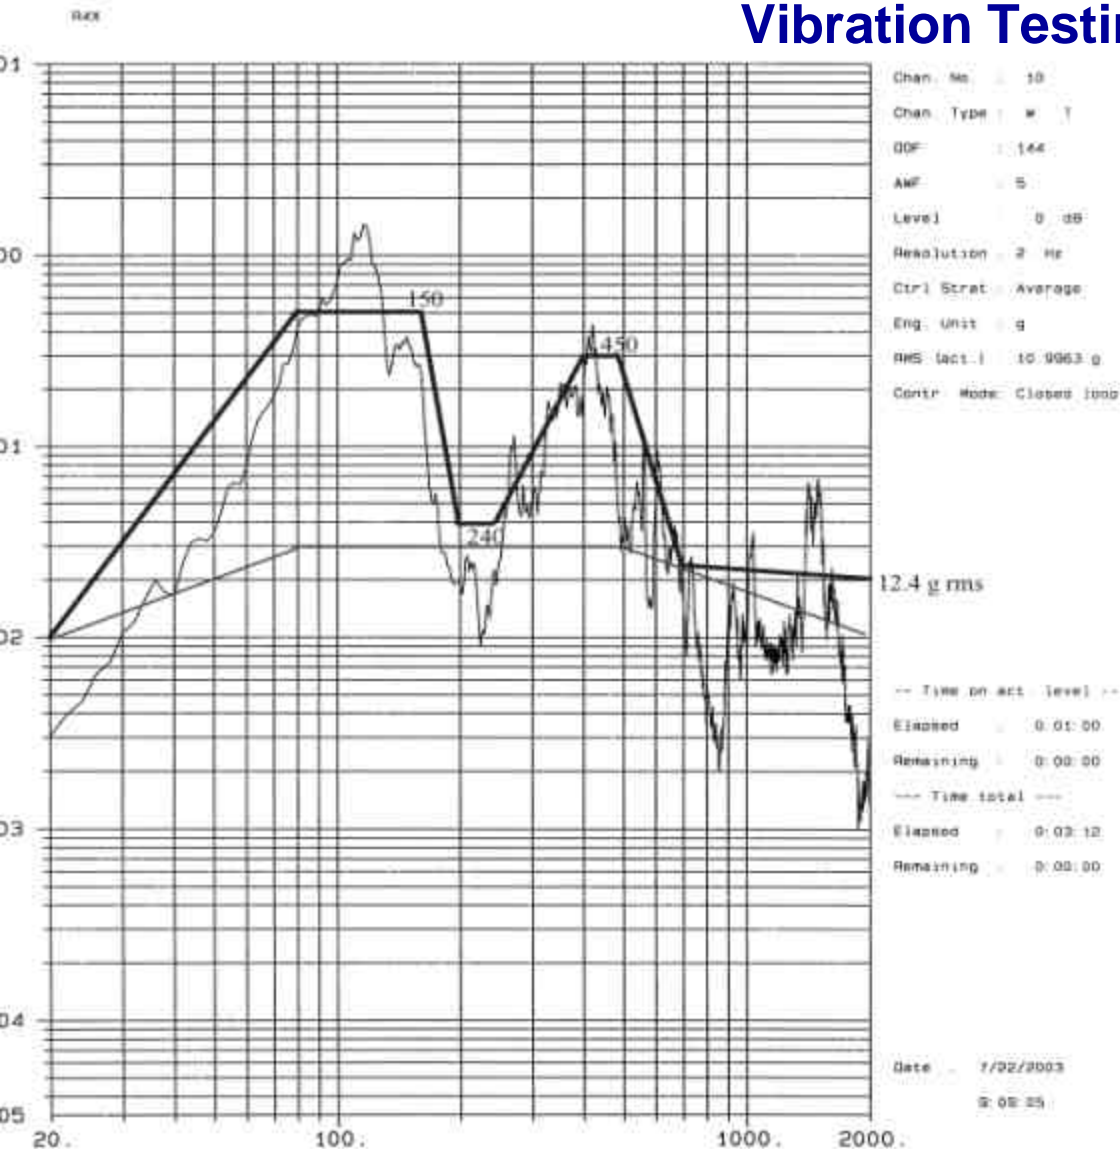
**R4X**

**X AXIS 0dB RANDOM**

**Magnetometer X-axis and  
Envelope for instrument vibration**

**Envelope: 12.4 g rms**

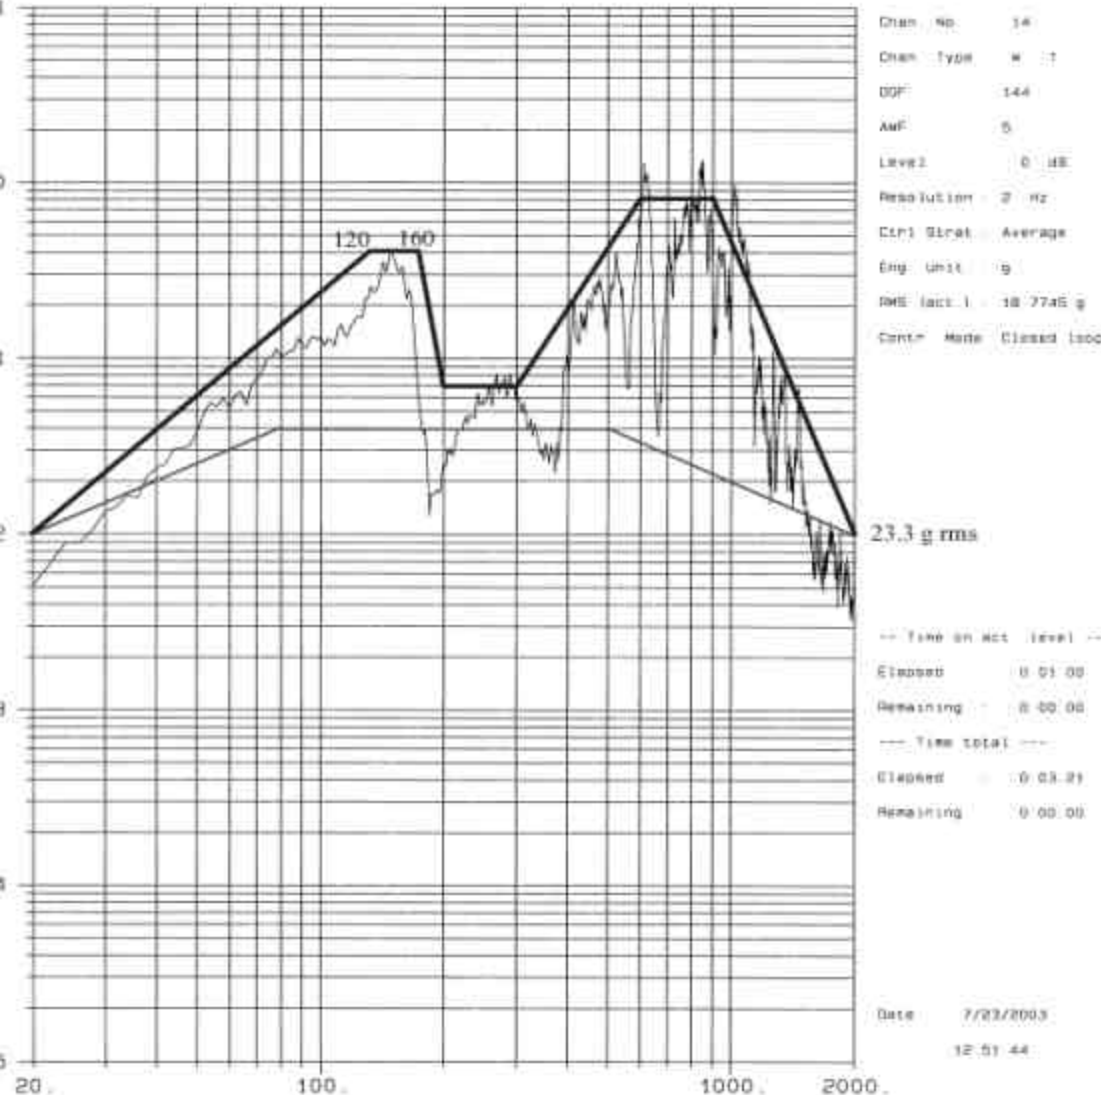
**R5Y**

**Y AXIS 0dB RANDOM**

**STE-U Y-axis and  
Envelope for instrument vibration**

**Envelope: 23.3 g rms**

- Created from The FEMCI Book – Creating a Random Vibration Component Test Specification
- This value is unreasonably high and will be lowered by redesigning the mounting feet for the STE-U. Change is possible due to new thermal constraints.
- STE-U instruments will be tested on flight Booms.

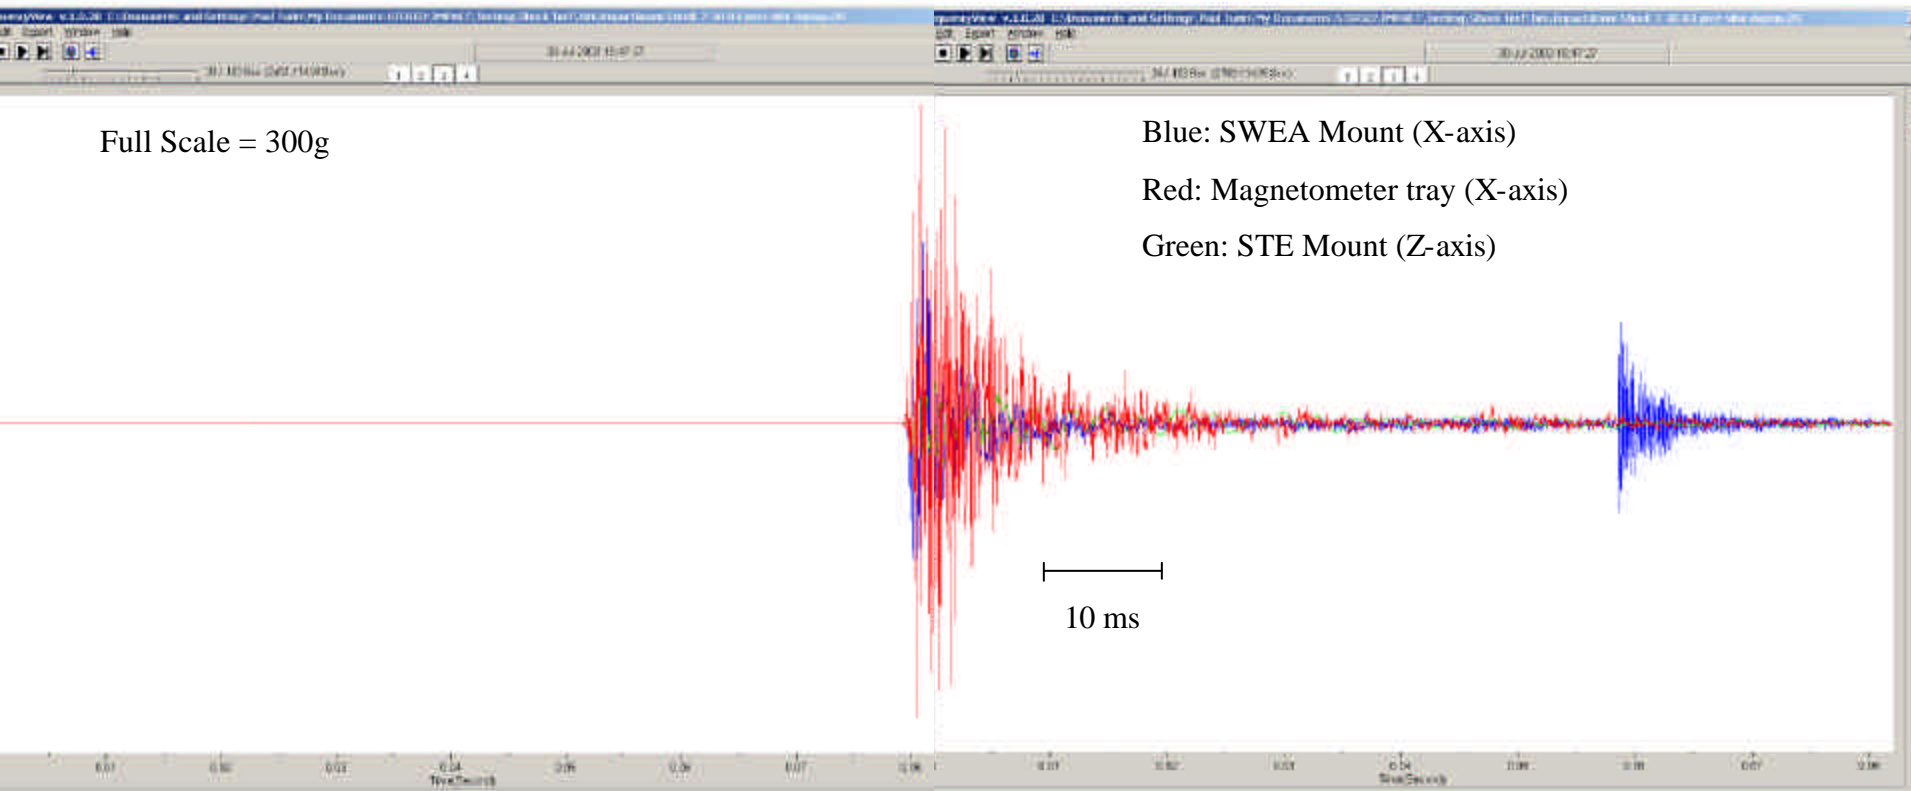
The largest shock occurred at the pinpuller firing was on the order of 290g's, but of very high frequency and so of little concern. The low freq. components appear to be more on the order of 30g's, but further analysis would be required to verify this.

- **The largest shock occurred at the pinpuller firing and was on the order of 290g’s, but of very short duration and so of little concern.**
- **The “pogo shock” reached ~25g at ~140Hz at both the SWEA and Mag mounts. The Mag saw the highest low-freq. shock at the latch up of the 90mm tube of ~50g at~100Hz. We should consider adding these to the instrument qualification tests.**

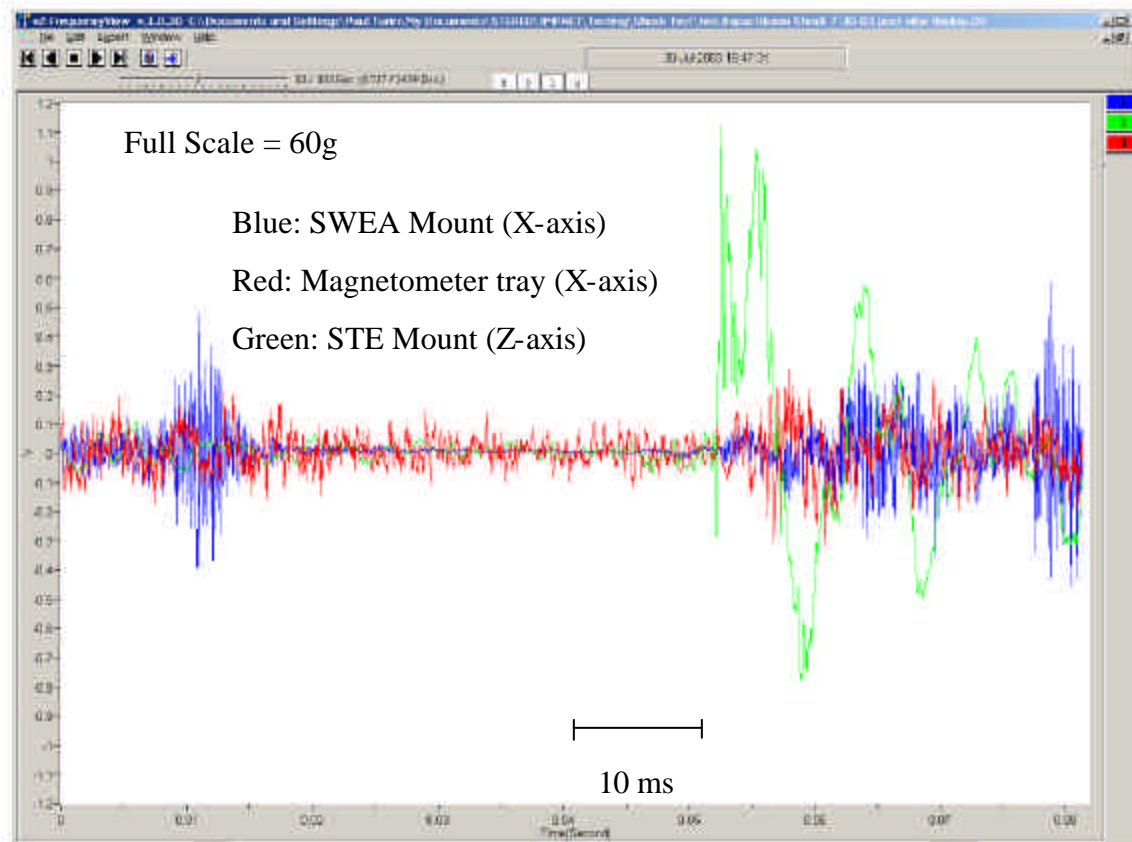
The Highest low freq. Shock on the Mag occurred when the 90mm tube latched with a magnitude of ~50g's.

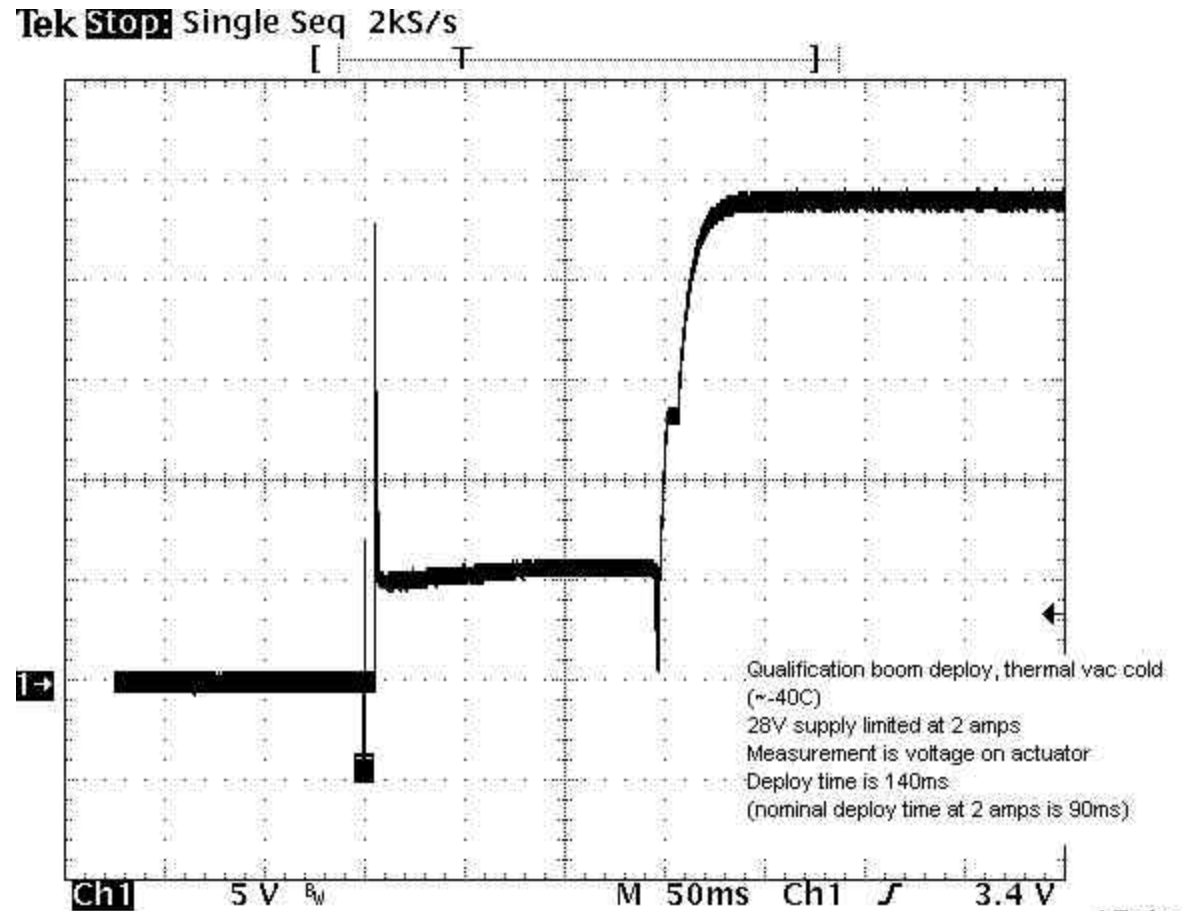
### SMAR Pinpuller Release Data

O'scope data taken from first cold deploy SMAR pinpuller release.

- 28 VDC supply
- 2.0A maximum current
- -40 °C
- Full preload
- Deployment time: 140ms

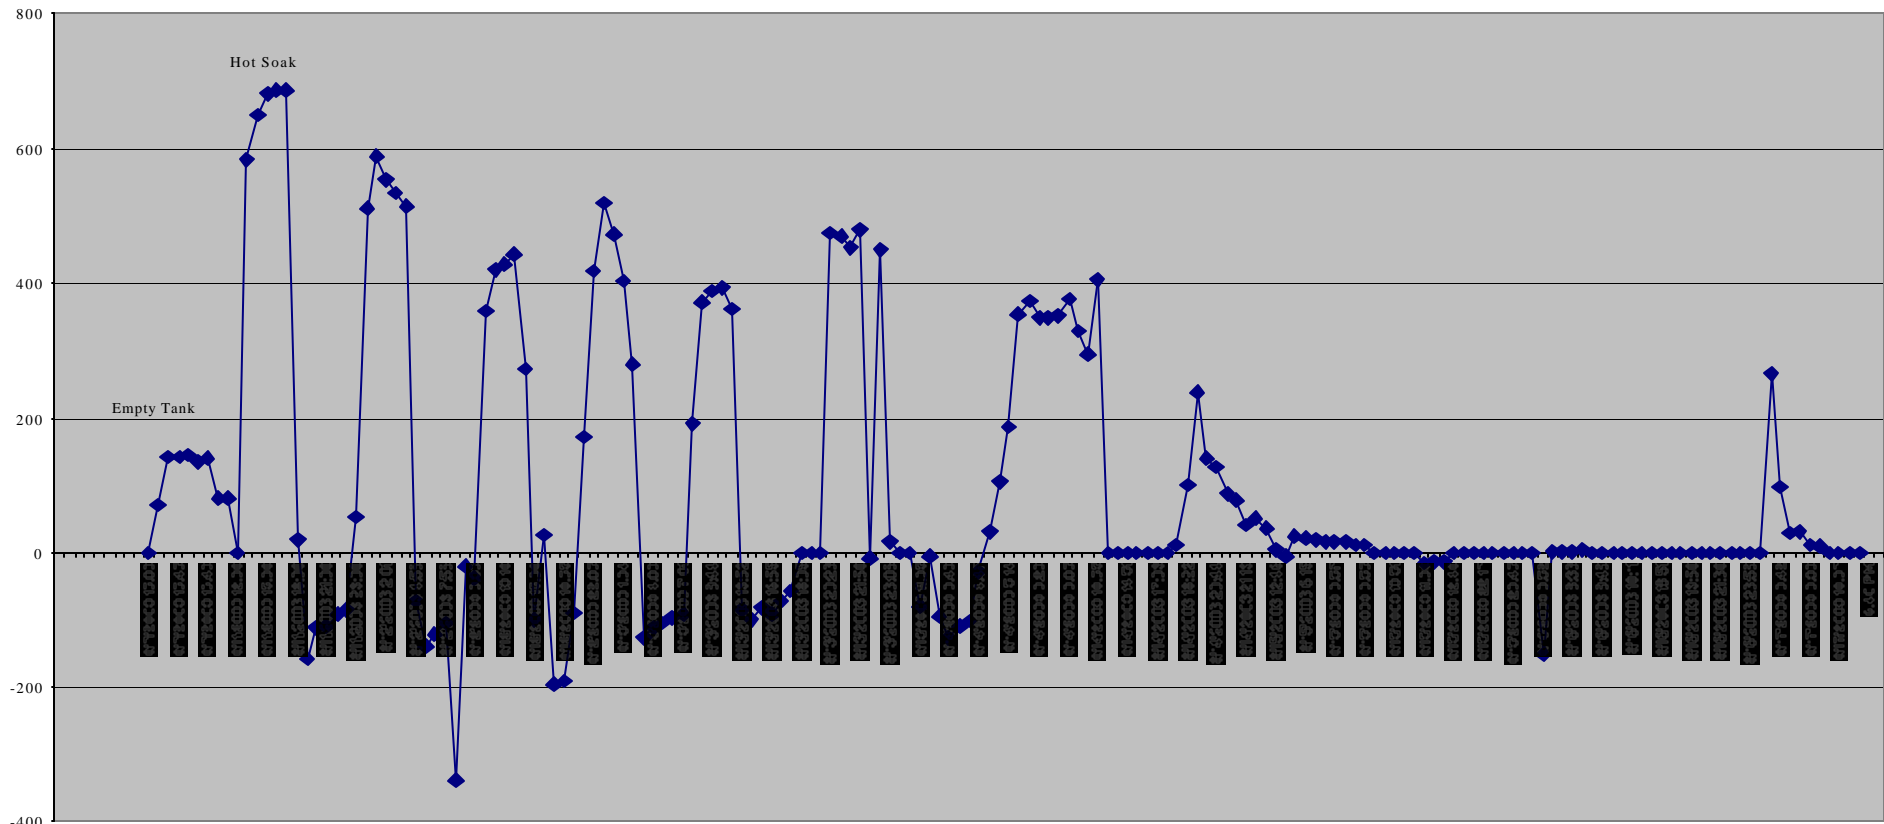
TQCM data from Thermal Vacuum testing of the Impact proto-flight Boom

- When chamber set cold, TQCM temp exceeded chamber temp., thus the chamber served as a 'getter' for the TQCM.
- Hot values continued to drop as chamber was baked out. Final hot value at end of hot cycle # 7 is ~250 Hz/hr
