STEREO IMPACT

PR-1030

FM1 SWEA Too Cold

**SWEA/STE-D Thermal Balance Test Report
IMPACT Boom Instruments**

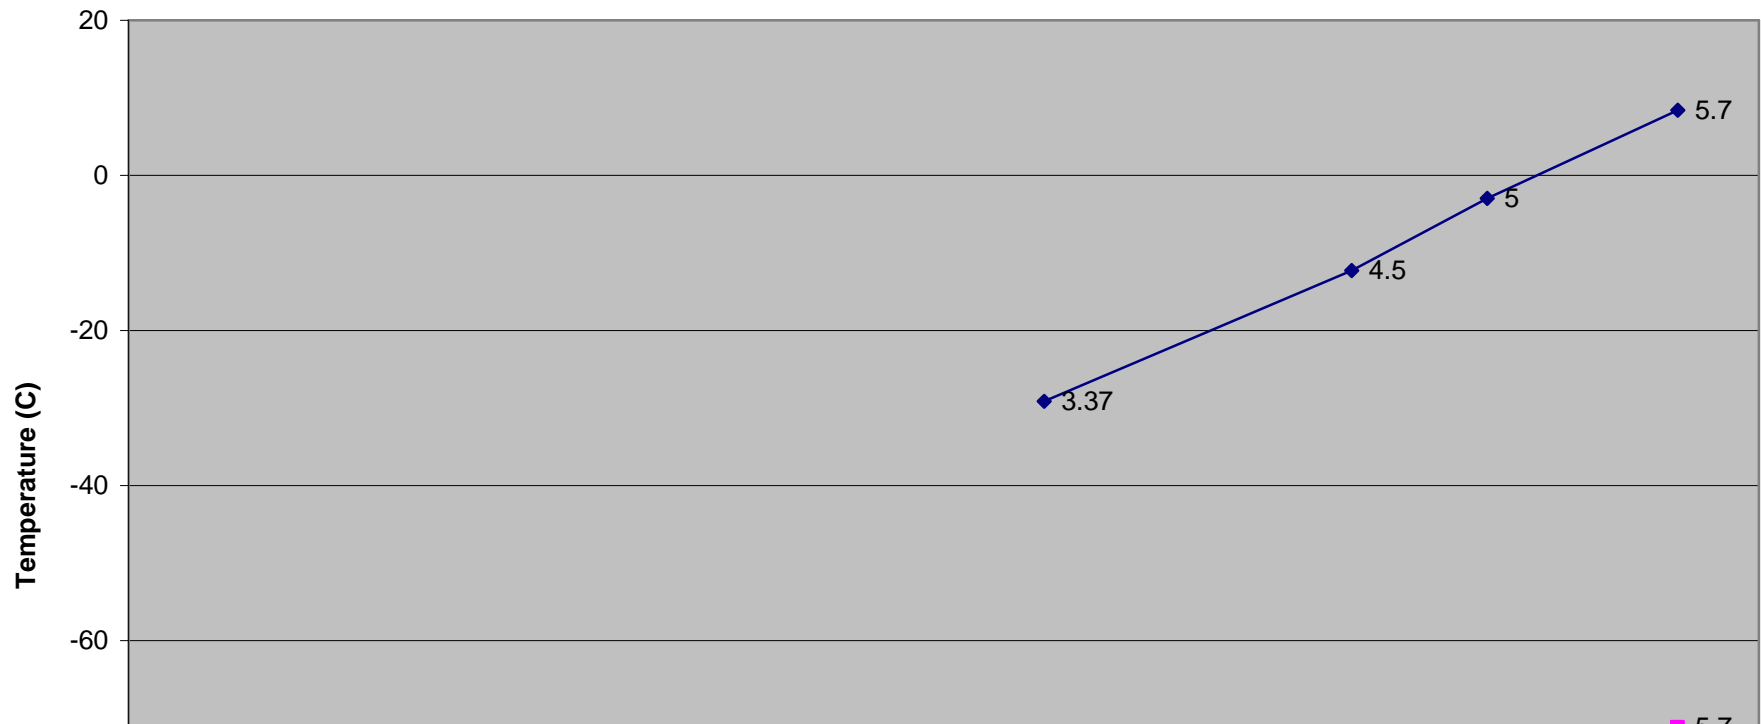
Figure 1: SWEA and STE-D Correlated Model Flight Predictions

SWEA and STE-D test temperatures versus thermal analytical model predictions are provided in Table 1 for the two equilibrium cases. Results show close correlation after implementing the model changes listed above. All internal (flight) sensors match predictions within 5°C for both test cases. All externally mounted thermocouples are reading colder than model predictions. It is surmised that these taped thermocouples may not have maintained intimate surface contact introducing an error in the readout. However, all TCs still match predictions within 10°C except for the Pedestal Base TC and one of the TCs on the 50-mm tube near the base. These two sensors were reading significantly colder than considered possible based on their location and heat flow calculations. Updated flight predictions using the correlated model are provided in Table 2 for several heater power settings. A plot of these predictions is provided in Figure 5.

- Using the SWEA PRT located on the Pedestal Chassis as control, the model predicts that the SWEA will need operational power of 3.67 watts plus 0.5 watts of heater power to maintain the SWEA above -20°C . If the operational heater were to fail, the temperature of the Pedestal Chassis is predicted to reach the -29°C level.
