STEREO Impact Boom FM2 Thermal Cycling Report

Document # IMP-591-DOC

Date: September 29, 2004

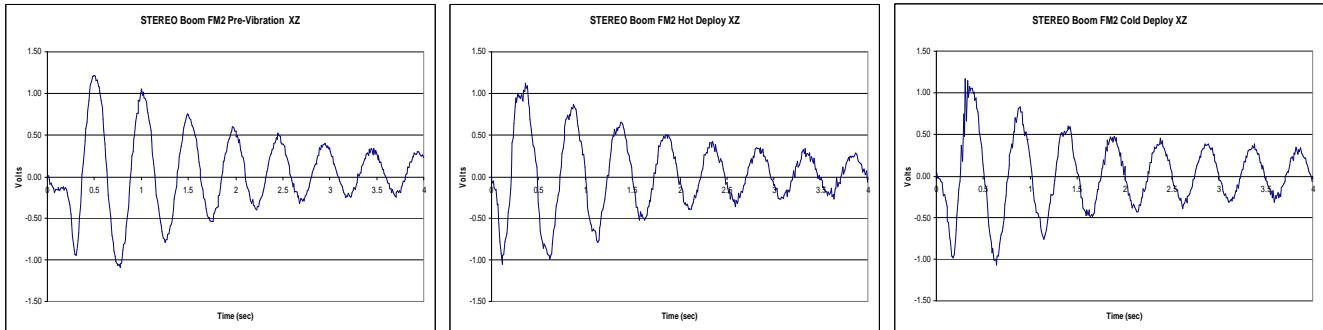
Resonance testing was done to verify that the Boom was fully deployed with all pins locked and to verify that the Boom structural response was similar regardless of deployment temperature. Resonance was measured using an Endevco 61-A500 Isotron Accelerometer through a Model 133 signal conditioner into DAQView. The resultant plots are shown below as is a plot from a room temperature test prior to vibration and thermal vacuum testing. For the post-vibration test, averaging 5 cycles gives 2.06Hz with all mass dummies included. For the hot case deployment, averaging 5 cycles gives 2.00Hz with all mass dummies included. For the cold case deployment, averaging 5 cycles gives 2.01Hz with all mass dummies included. The consistency of these numbers is within the accuracy of the calculations. Thus, the devices show that deployment resonance frequencies are unaffected by temperature extremes.
