# STEREO *IMPACT*

FM2 SWEA/STE-D Thermal Vacuum Test Report

IMPACT-SWEA-FM2-TVac-Report.doc  
Version A – 2005-May-19

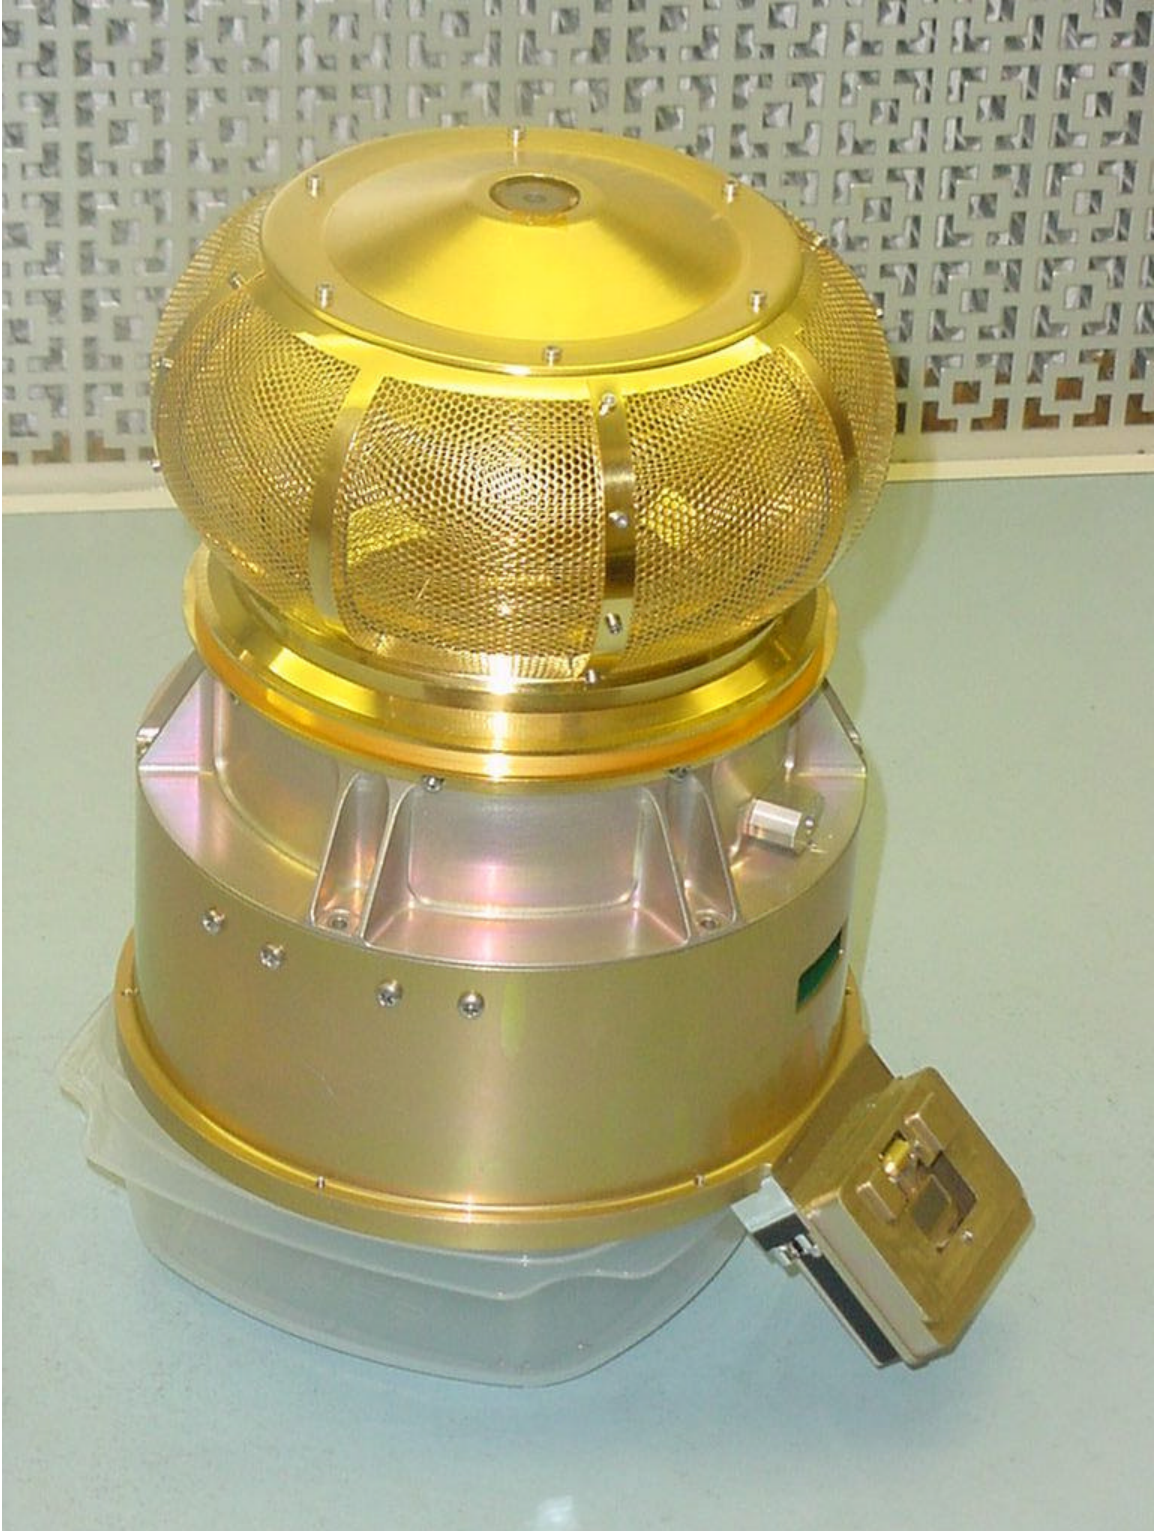
Fig 1. FM1 SWEA/STE-D

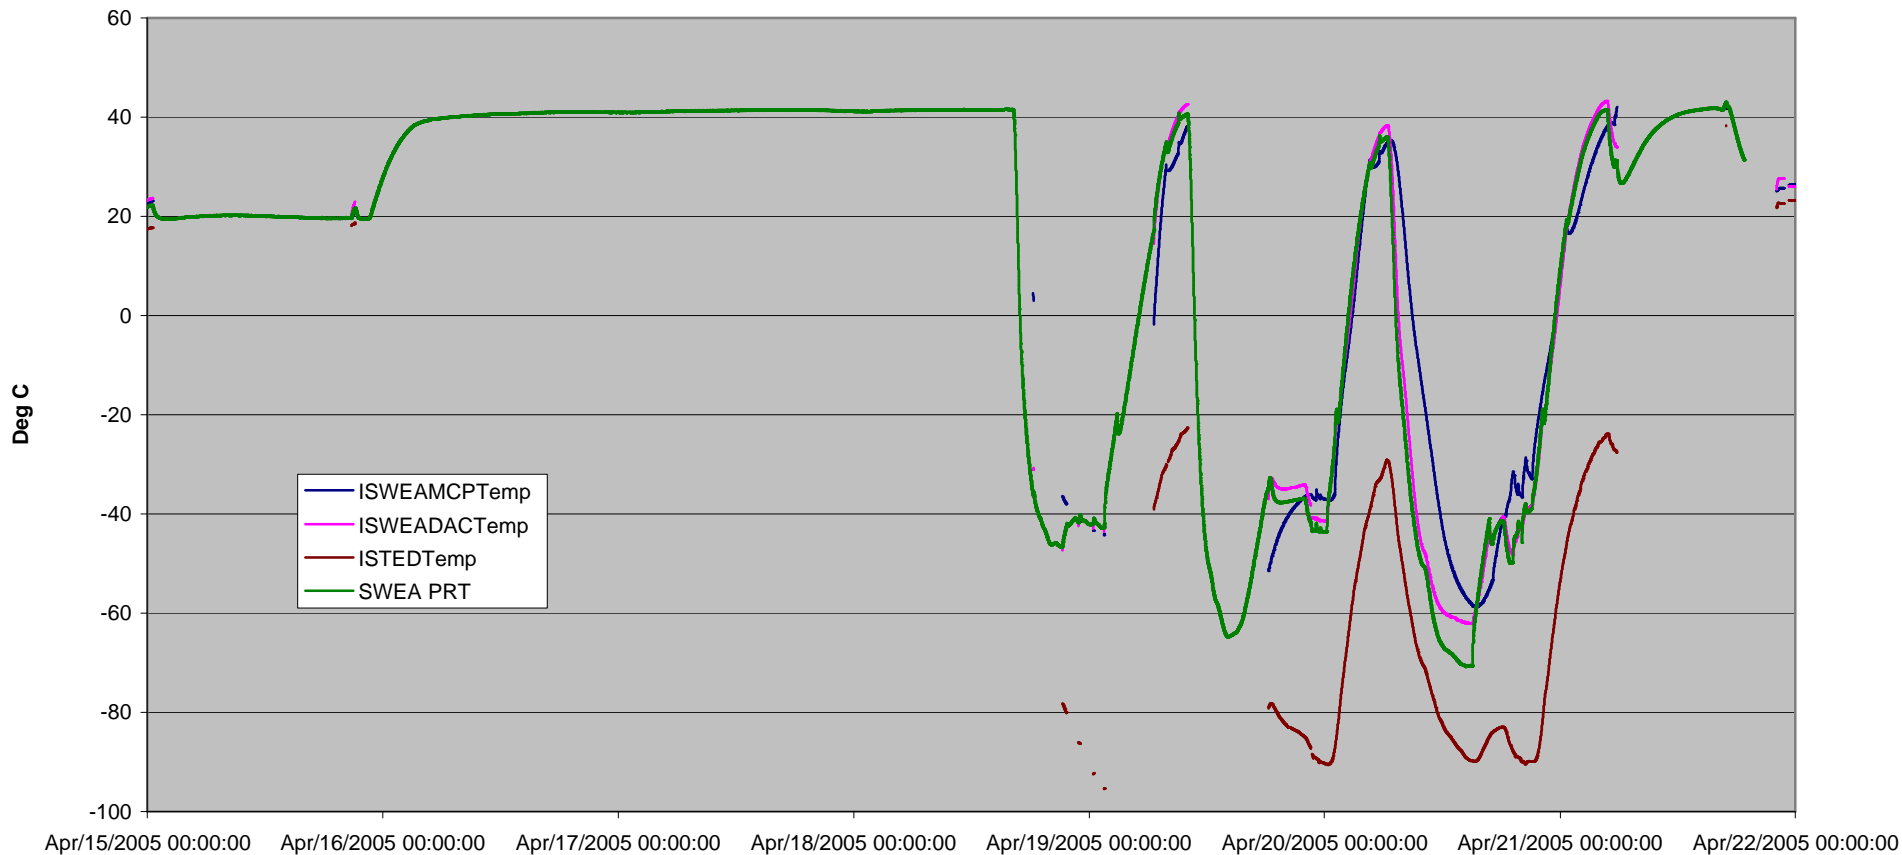
FM2 SWEA/STE-D Thermal Vac Cycles 1-3

SWEA PRT is the spacecraft-monitored temperature sensor attached to the SWEA pedestal (internal). ISWEAMCPTemp is telemetry from a thermistor on the MCP board in the SWEA unit. ISWEADACTemp is telemetry from a thermistor on the DAC board in the SWEA pedestal. ISTEDTemp is telemetry from a PRT in the STE-D unit.

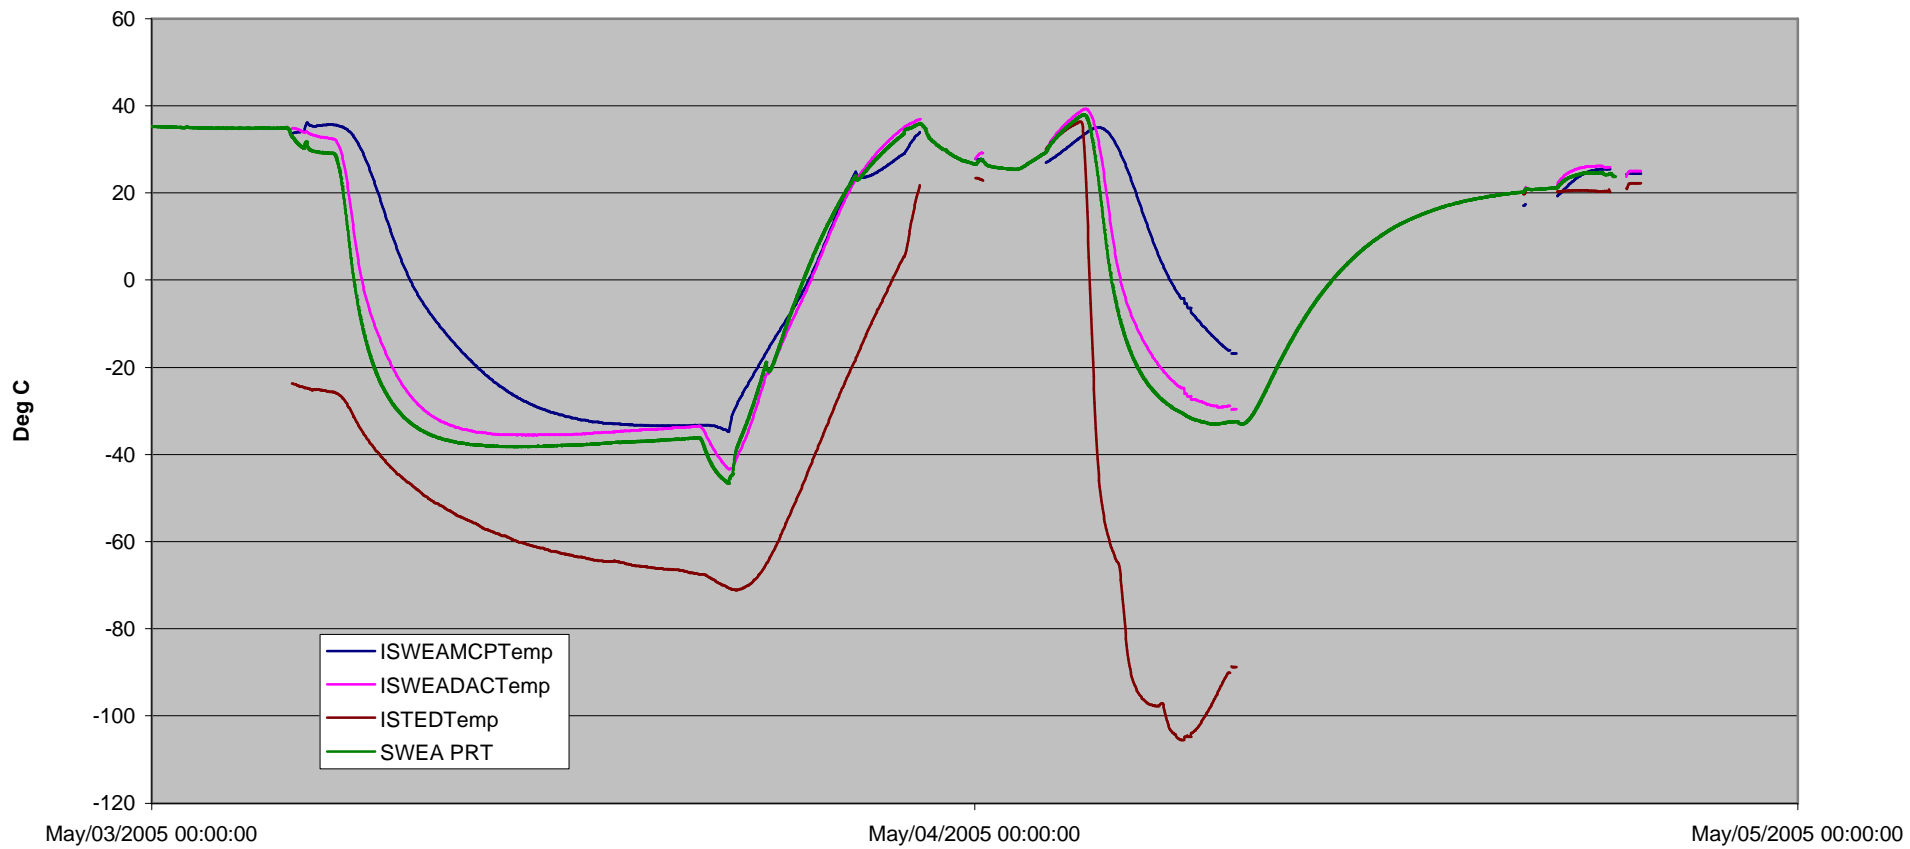
FM2 SWEA/STE-D Thermal Vac Cycle 4

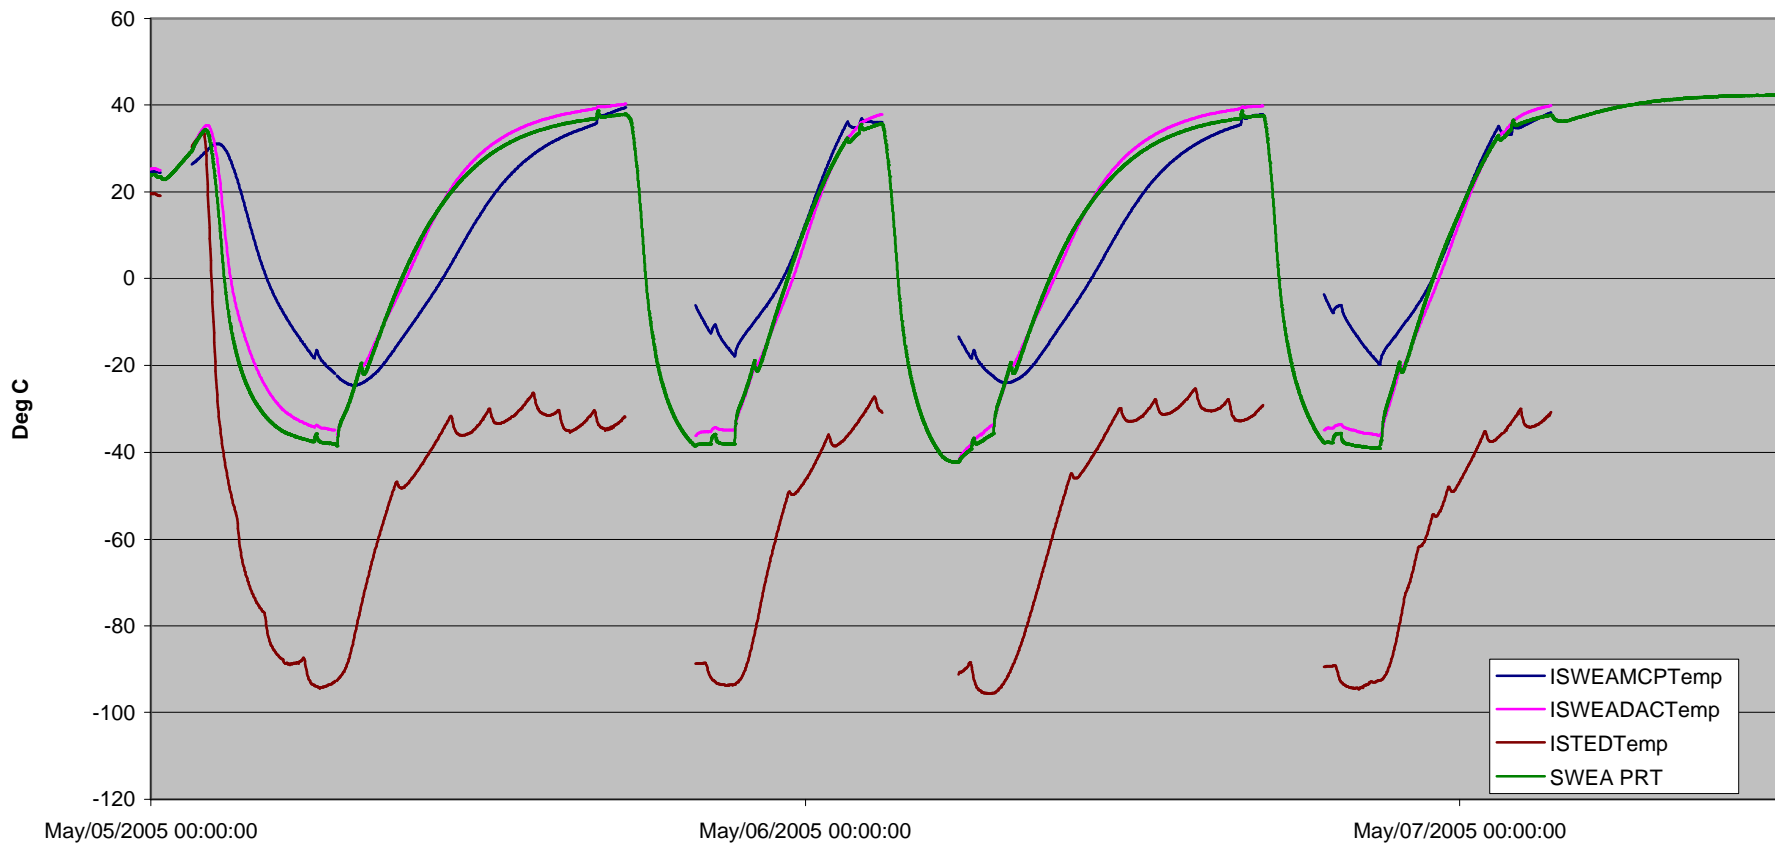
FM2 SWEA/STE-D Thermal Vac Cycles 4-7

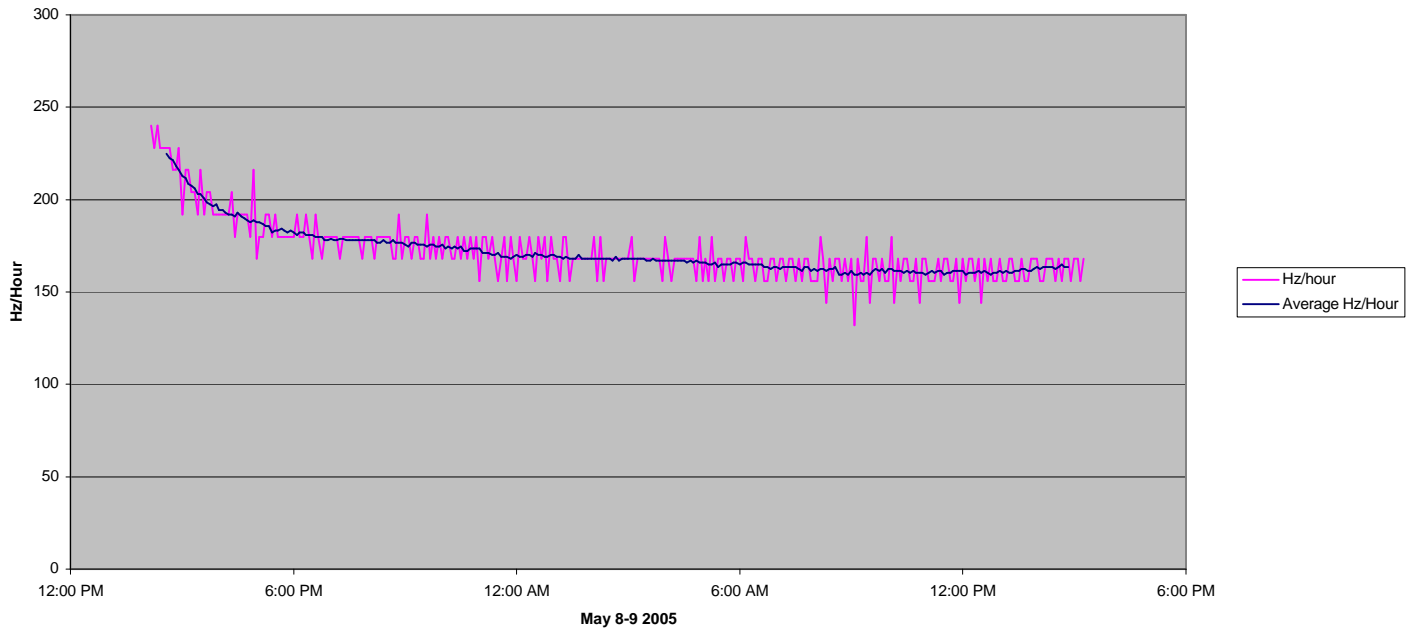
FM2 SWEA/STE-D TQCM without heat strap (22)

A bakeout was added to the end of the thermal vac cycling using a TQCM monitor to verify the outgassing rate meets the requirement ( $2.5E-11$  g/cm<sup>2</sup>/sec). A final outgassing rate of ~160Hz/hour was measured. This is significantly higher than the FM1 rate of ~50Hz/hour (which is close to pre-test chamber background). We re-measured chamber background and got ~150Hz/hour, indicating the chamber has been contaminated (but that the SWEA outgassing rate is low). We have sent a witness foil (collected during the empty chamber run) to GSFC for analysis.

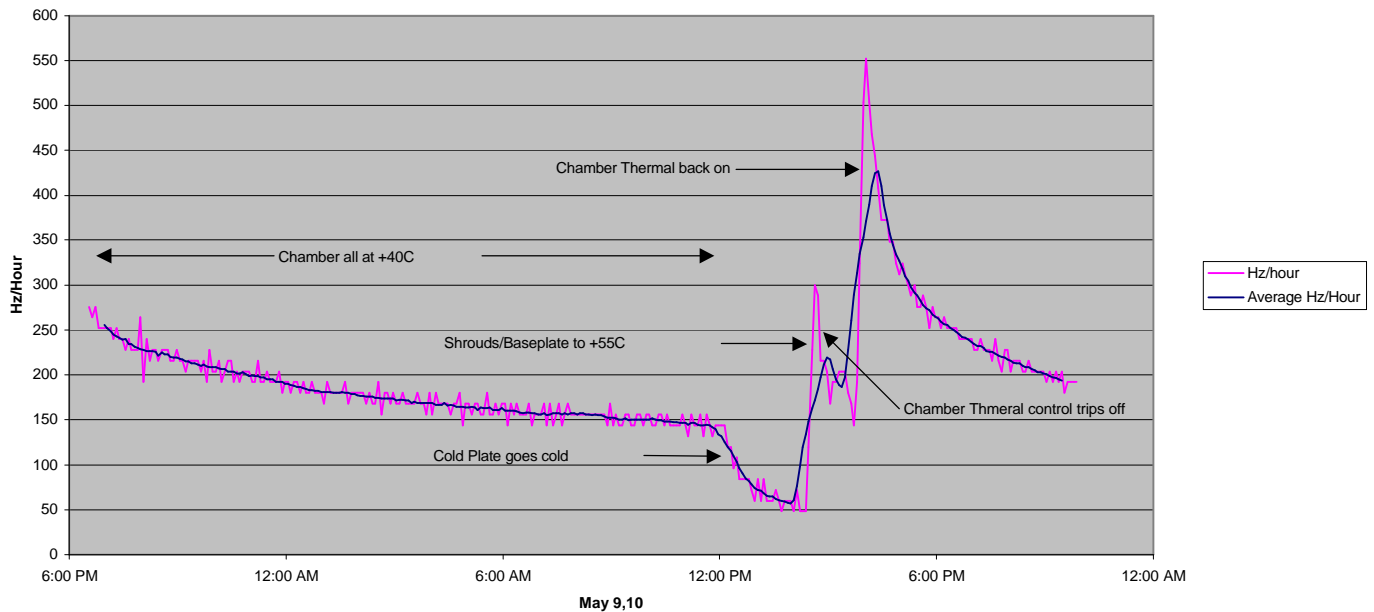
Empty Chamber TQCM (23)
