STEREO IMPACT

PROBLEM REPORT

PR-1037

FM2 SWEA Anode 11

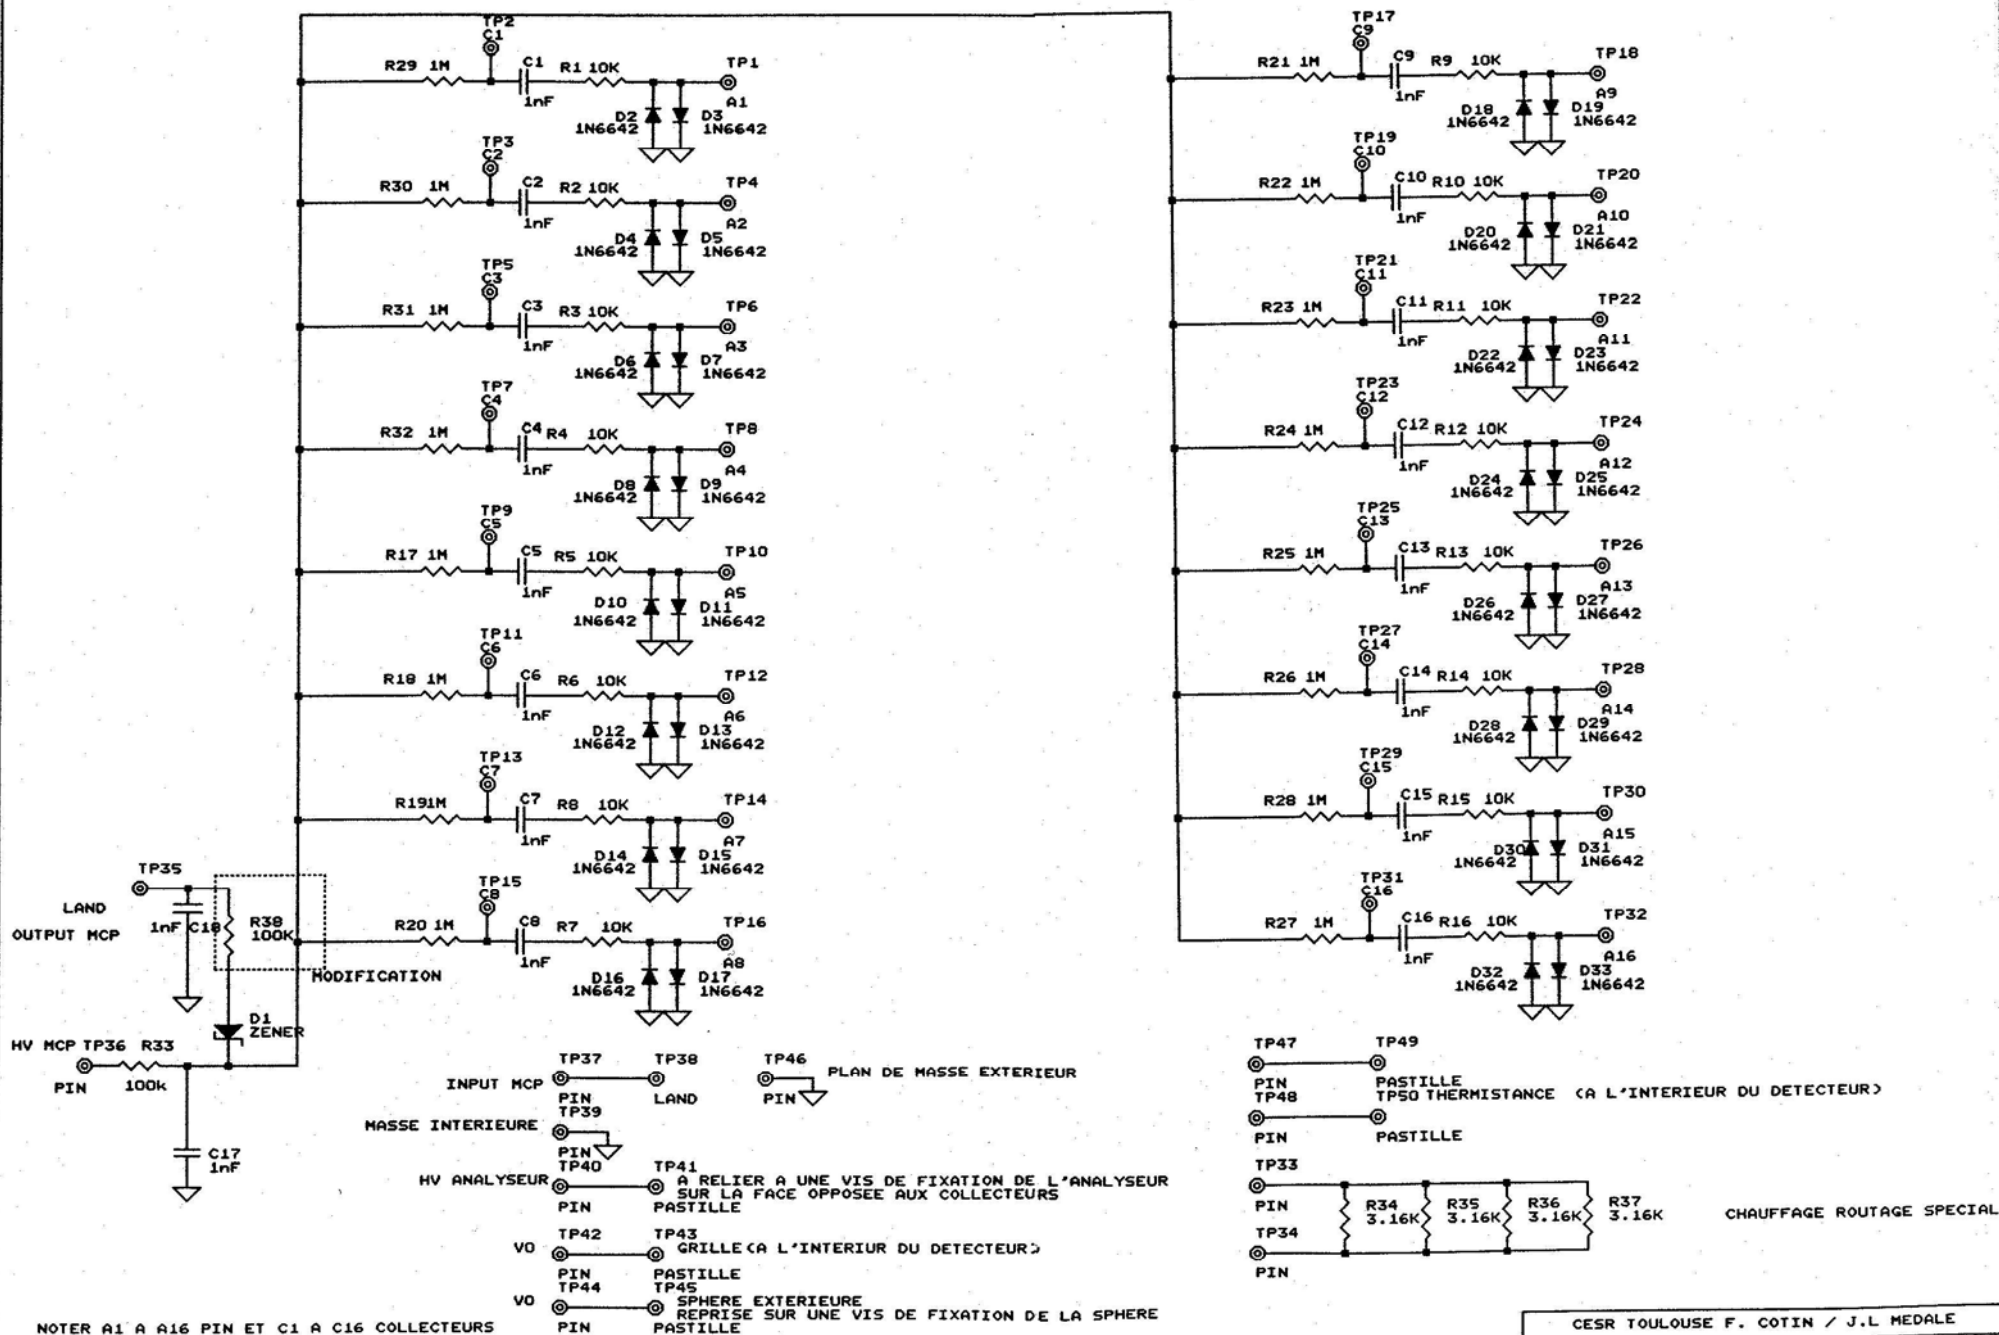
CESR TOULOUSE F. COTIN / J.L. MEDALE		
Size	Document Number	REV
A3	SHEA:HV COUPLING	7
Date:	October 4, 2002	Sheet 1 of 1

The unit was again disassembled and diagnosed. U12 was again found to be failed. The rest of the parts in the signal chain for all amplifiers were measured and found to be nominal. The decoupling capacitor for channel 11 (C12 – see schematic below) was removed from the decoupling board and tested under bias. It was found that the part exhibited fast transients, particularly while the bias voltage is being ramped up. Transients exceeded 2 volts in spite of protection diodes in the test circuit similar to those in the instrument, indicating the transient is faster than the diode can react. This could be the cause for the U12 failures.

C12 and U12 were replaced with spares from CESR flight stock.
