STEREO IMPACT

PROBLEM REPORT

PR-4002

FAILURE ANALYSIS REPORT FOR DEVICE TYPE
RT54SX72S-CQ208B
CASE NUMBER 1-6981277

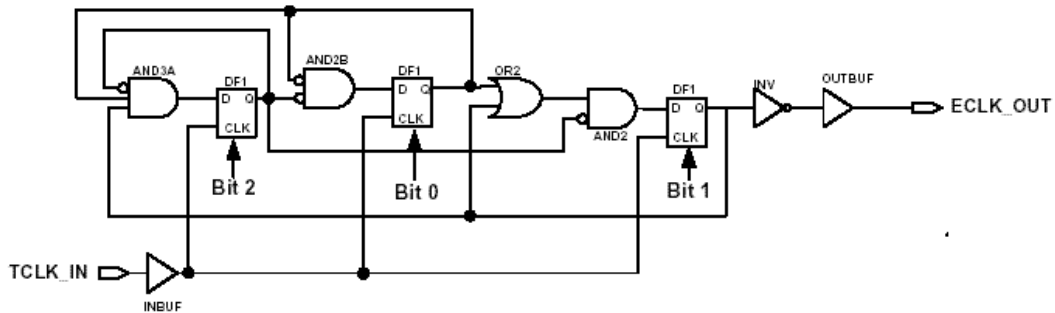
Figure 6: Circuit of the “Divide By Five” Design

To determine if there are possible illegal states in the “Divide By Five” circuit an analysis of the design was performed and it was found that the circuit would not lock up. Illegal states (100, 101, and 111) will be cleared in the first cycle.

Actel was able to observe the reported failure mode using the Silicon Explorer. The internal nodes of the “Divide By Five” circuit (**Figure 6**) and the output pin #189 showed no activity, while the internal nodes and output pin #189 of the reference device toggled as expected. Output pin #189 of the returned device was verified to be tri-stated using a 10 K pull-up resistor connected to V_{cc} . Shown in **Figure 7** are scope plots of signals on input pin #174 and output pin #189 of the FPGA.

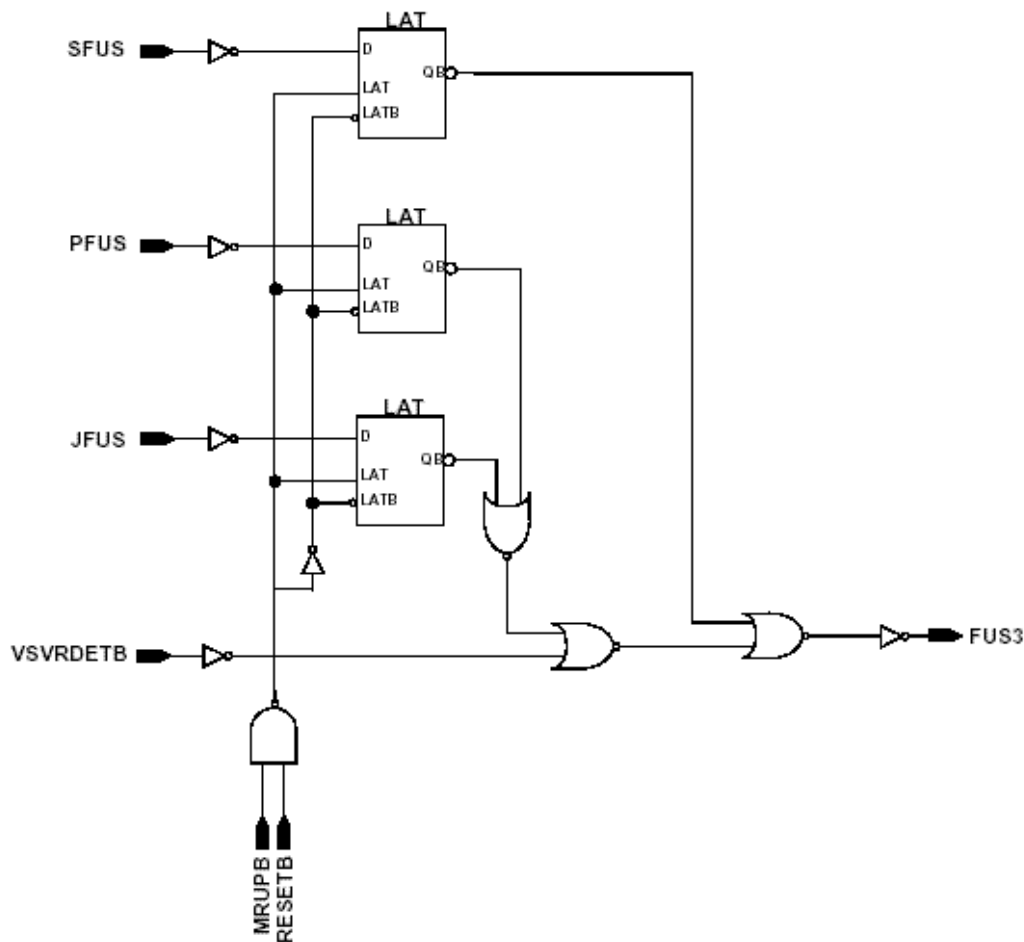
Figure 11: Logic circuit generating the FUS3 signal

The findings and analysis above indicated that signal *FUS3* is likely in the wrong state. To determine the source of this incorrect state, the schematic of [Figure 11](#) was examined. As shown in the figure, the *FUS3* signal is dependent on signals *SFUS*, *PFUS*, *JFUS* and *VSVRDET6*. Any changes in the states of these signals would result in a change in the state on the *FUS3* signal. The next step to narrow down the failure was to check the statuses of the *PFUS* and the *JFUS* by performing the in-house tool MANUAL fuse-check that addresses a specified antifuse. A single 1V magnitude pulse and duration of 250 ns is applied to the VPP pin of the device through a 120Ω resistor as illustrated in [Figure 12](#). By measuring the voltage across the 120Ω resistor, the programming path resistance, which includes the antifuse resistance, can be determined. If an antifuse is damaged such that the path resistance increases significantly, the voltage drops across the 120 resistor will be smaller than that of a reference.

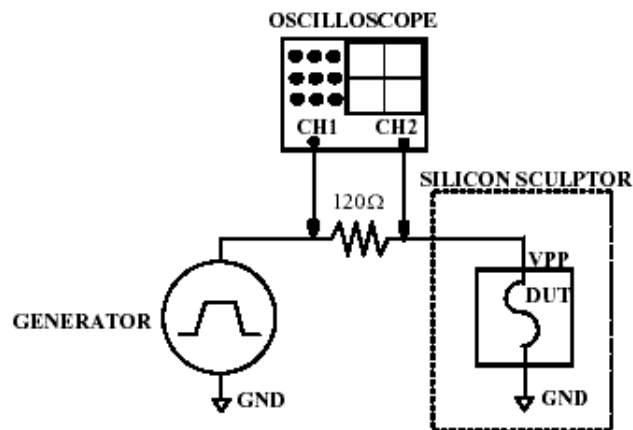
Figure 12: Setup for performing manual Fuse-check

The results of the MANUAL fuse-check test on antifuse J and antifuse P showed no high resistance, indicating that the two antifuses were not damaged.

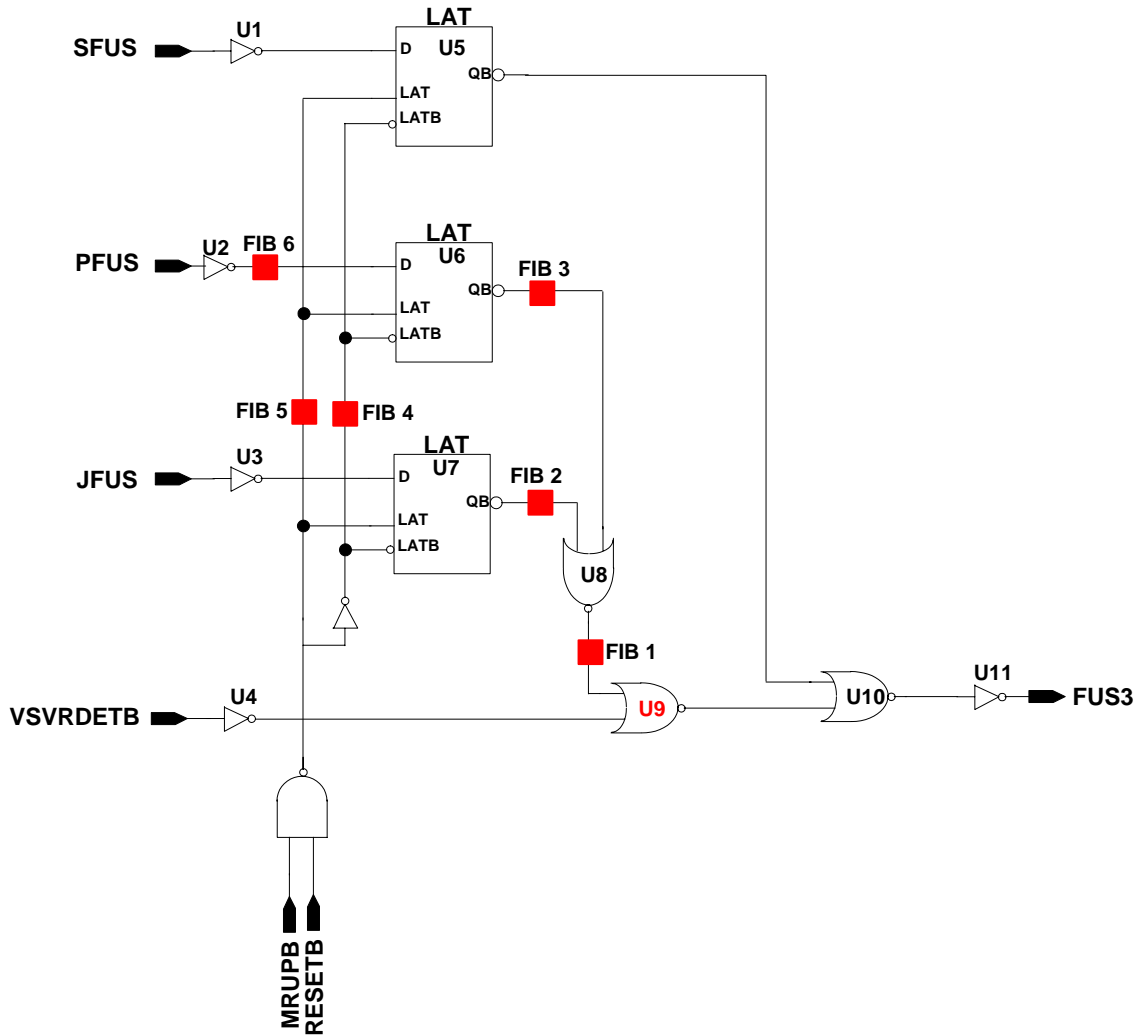
Figure 13: Locations of the FIB pads within the FUS_BLK Circuit

To further narrow the failure to a logic module, the charge pump control circuitry was analyzed thoroughly and FIB (Focus Ion Beam) pads were added to selected locations to observe their logic states. Figure 13 below shows the locations of the added FIB pads. A choice of *Accurel Systems International* was made for the addition of FIB pads as they have the capability to accept relevant Actel design files from which Accurel will overlay the image of the device. This overlay plus the provided coordinates of the desired FIB pad location allows Accurel to accurately position the desired FIB pad.

According to the architecture specification of the RT54SX72S product, a functional device should have the signals *PFUS*, *JFUS*, and *VSVRDET B* at logic HIGH and the signals *MRUPB*, and *RESETB* at logic LOW. Therefore, FIB 1, FIB4 and FIB 6 should be at logic LOW, and other FIB pads should be at logic HIGH as shown below in Table 1.

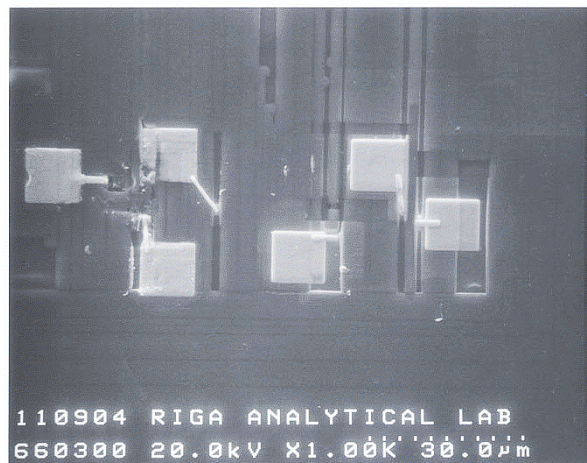
Figure 17: Original 6 FIB Pads

The next action by *Riga Analytic Labs* was to examine the region where FIB pads 1-6 were placed. The 6 pads are shown below in [Figure 17](#) where 1000x magnification of the FUS_BLK section is shown.

Further examination of the FIB pads on the left side of [Figure 17](#) revealed possible surface damage resulting from the first application of FIB pads and subsequent micro probing. This damage may have resulted in the earlier indication of a short between V_{CCA} and the output of *NOR gate U8*. This possibility was further confirmed in examination of the device layout where it was observed that a V_{CCA} metal layer is present in the FIB area along with a V_{SV} metal interconnect line. Shown magnified below in [Figure 18](#) are FIB Pads 1-3 indicating possible corruption of metal layers. As a result of this observation a decision was made to remove the top metal layer followed by addition of a new FIB pad to determine if the FIB1 to V_{CCA} short was still present.

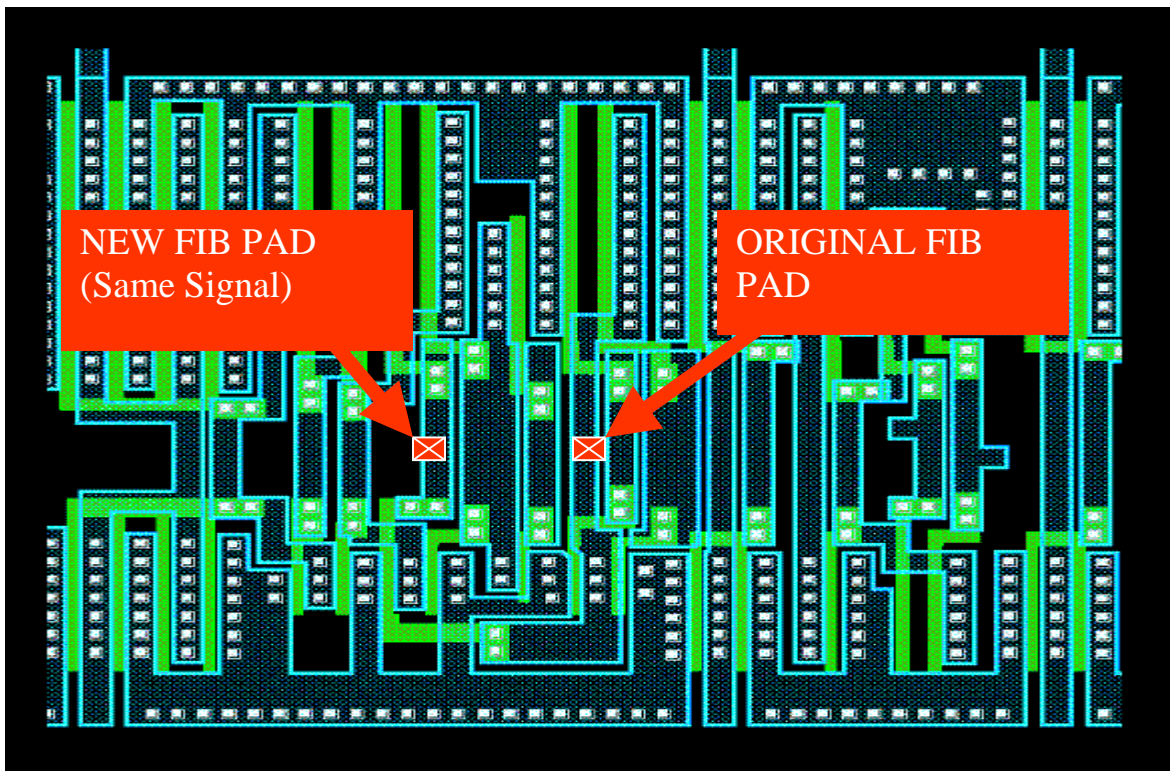
Figure 19: New FIB Location

Placement of new FIB pad following removal of top Metal layer 4 is shown below in [Figure 19](#).

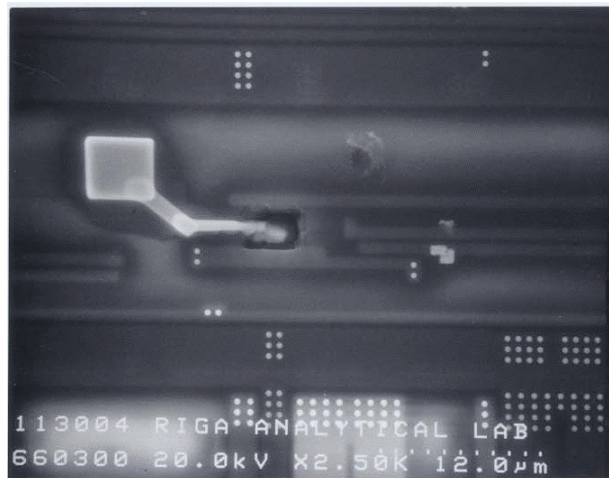
Figure 20: Secondary FIB1 Pad to NOR GATE U9

The new FIB pad added by Riga as shown in [Figure 20](#) is electrically the same as the original FIB1 shown in [Figure 13](#) as it is connected to the original FIB1 via a poly silicon line and Metal 1. Subsequent micro probing of this FIB connection to U9 no longer indicated a short to V_{CCA} as indicated in the curve trace photo shown below in [Figure 21](#) thus providing additional evidence that the short originally measured was a FIB related short.

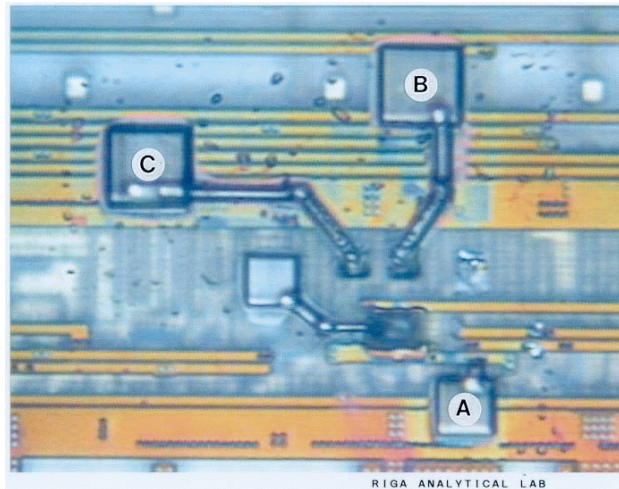
Figure 22: Surface Location of FIB Pads A, B, & C (Metal 3 Removed)

The physical locations of these FIB pads are shown in the micro photo shown below in [Figure 22](#). The additional unlabelled FIB pad shown in the figure is the FIB1 replacement discussed above.

To examine for faults at these locations, micro probing was performed with measured results indicating good I/V characteristics, similar to the results of the secondary FIB shown in [Figure 21](#).
