STEREO IMPACT

PROBLEM REPORT
PR-6001
HVPS_thermal
2003-09-15

PFR- 6001 HVPS VMI Multiplier Failure

Failure Analysis Report

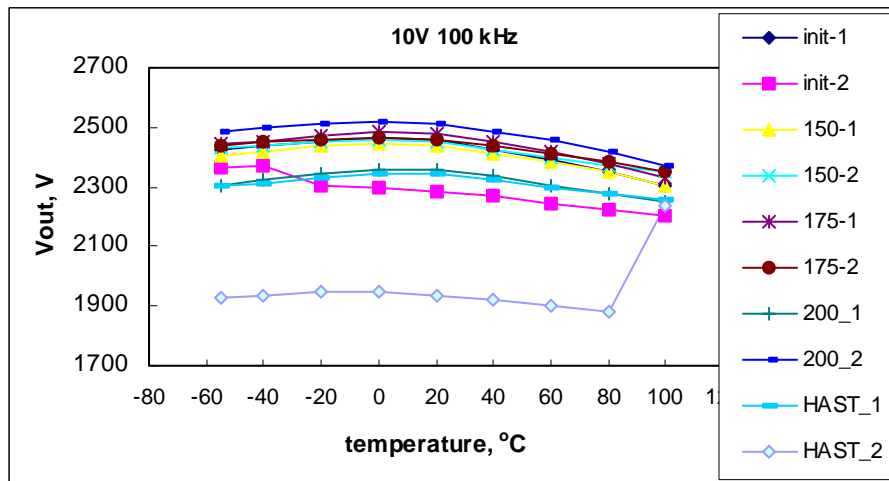
Evolution of the transfer characteristics measured at -55, -40, -20, 0, 20, 40, 60, 80, and 100 during stress testing of the two flight parts are shown in Figure 4. Some degradation of characteristics was observed in SN2 only after HAST. Figure 5 shows an anomaly in the temperature dependence of the output voltage in SN2 after HAST, when the output voltage, which was initially ~400 V below normal recovered after the 80 °C measurement, thus indicating possibly intermittent contact in the part.

Figure 5. Temperature dependencies of the output voltage for the two samples after different stress testing.

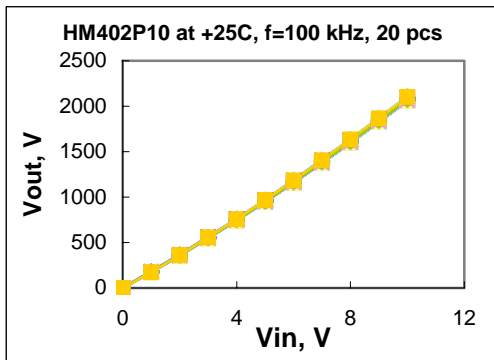
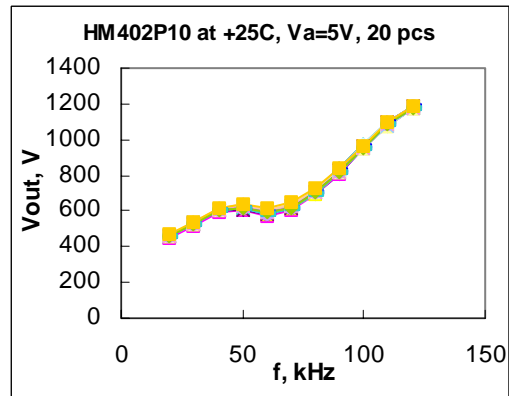
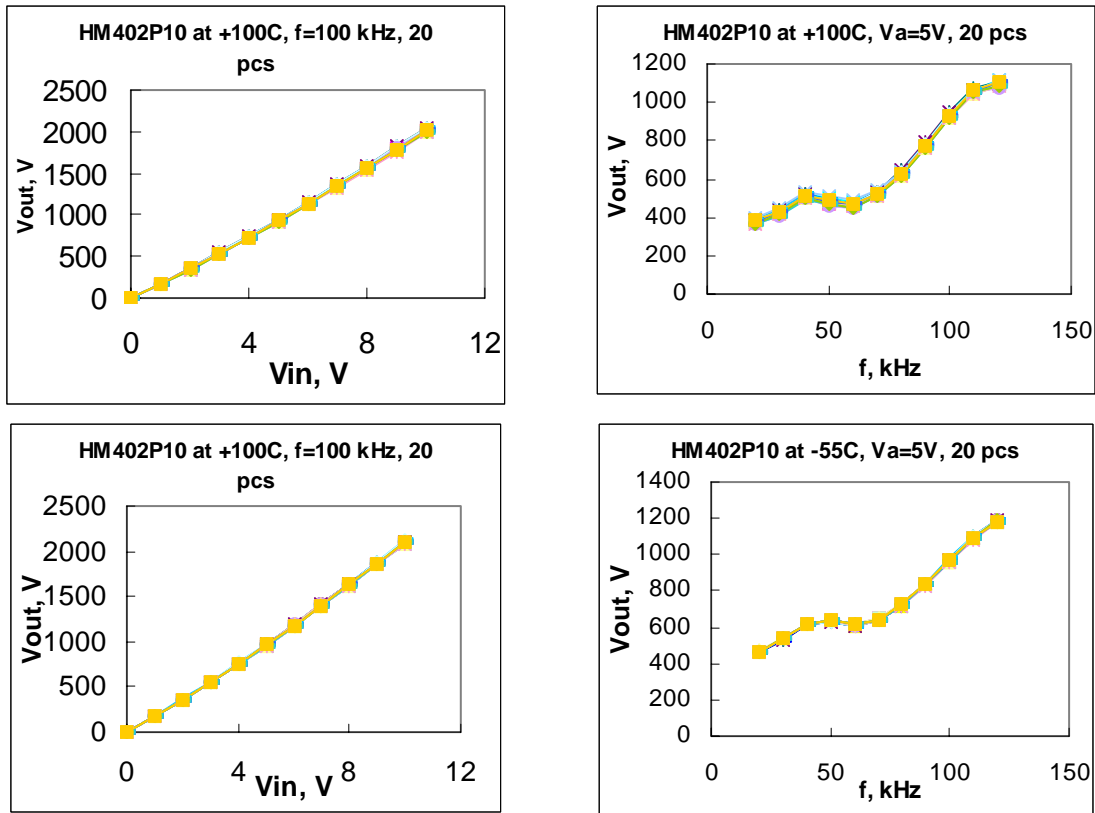
Results of electrical measurements at room temperature, +100 °C and -55 °C for 20 samples from a new lot are shown in Figure 7. The results indicate high reproducibility of the initial characteristics and only minor temperature variations.

Figure 7. Initial characteristics of 20 samples from a new lot.
